Service Scope

NUMBER 13

APRIL 1962

6DJ8 CONVERSION

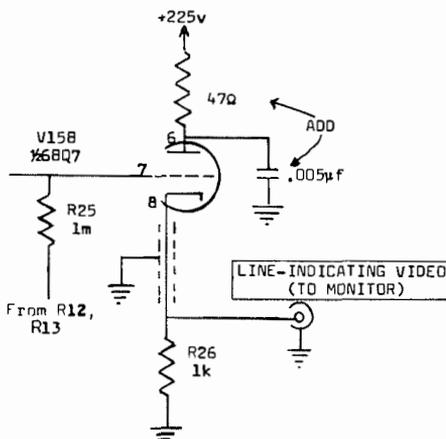
Figure 1. Type 524D/524AD Vertical Amplifier and Delay Line (partial schematic).

1. Decouple the plate of V15B by adding a 47 Ω , $\frac{1}{2}$ w, 10% composition resistor (Tek no. 302-470) and a 0.005 μ f, 500 v discap (Tek no. 283-001) as shown in Figure 1. This prevents the line-indicating video-output circuit from oscillating when V15 is a 6DJ8 and a 52 Ω load is used.
