GRID CURRENT BALANCE CIRCUITRY
REMOVED AND INPUT SELECTOR
SWITCHES CHANGED TO REDUCE INPUT
HOOK AND TRACE SHIFT RESPECTIVELY

M9709

Type 10A1 Plug-in Unit

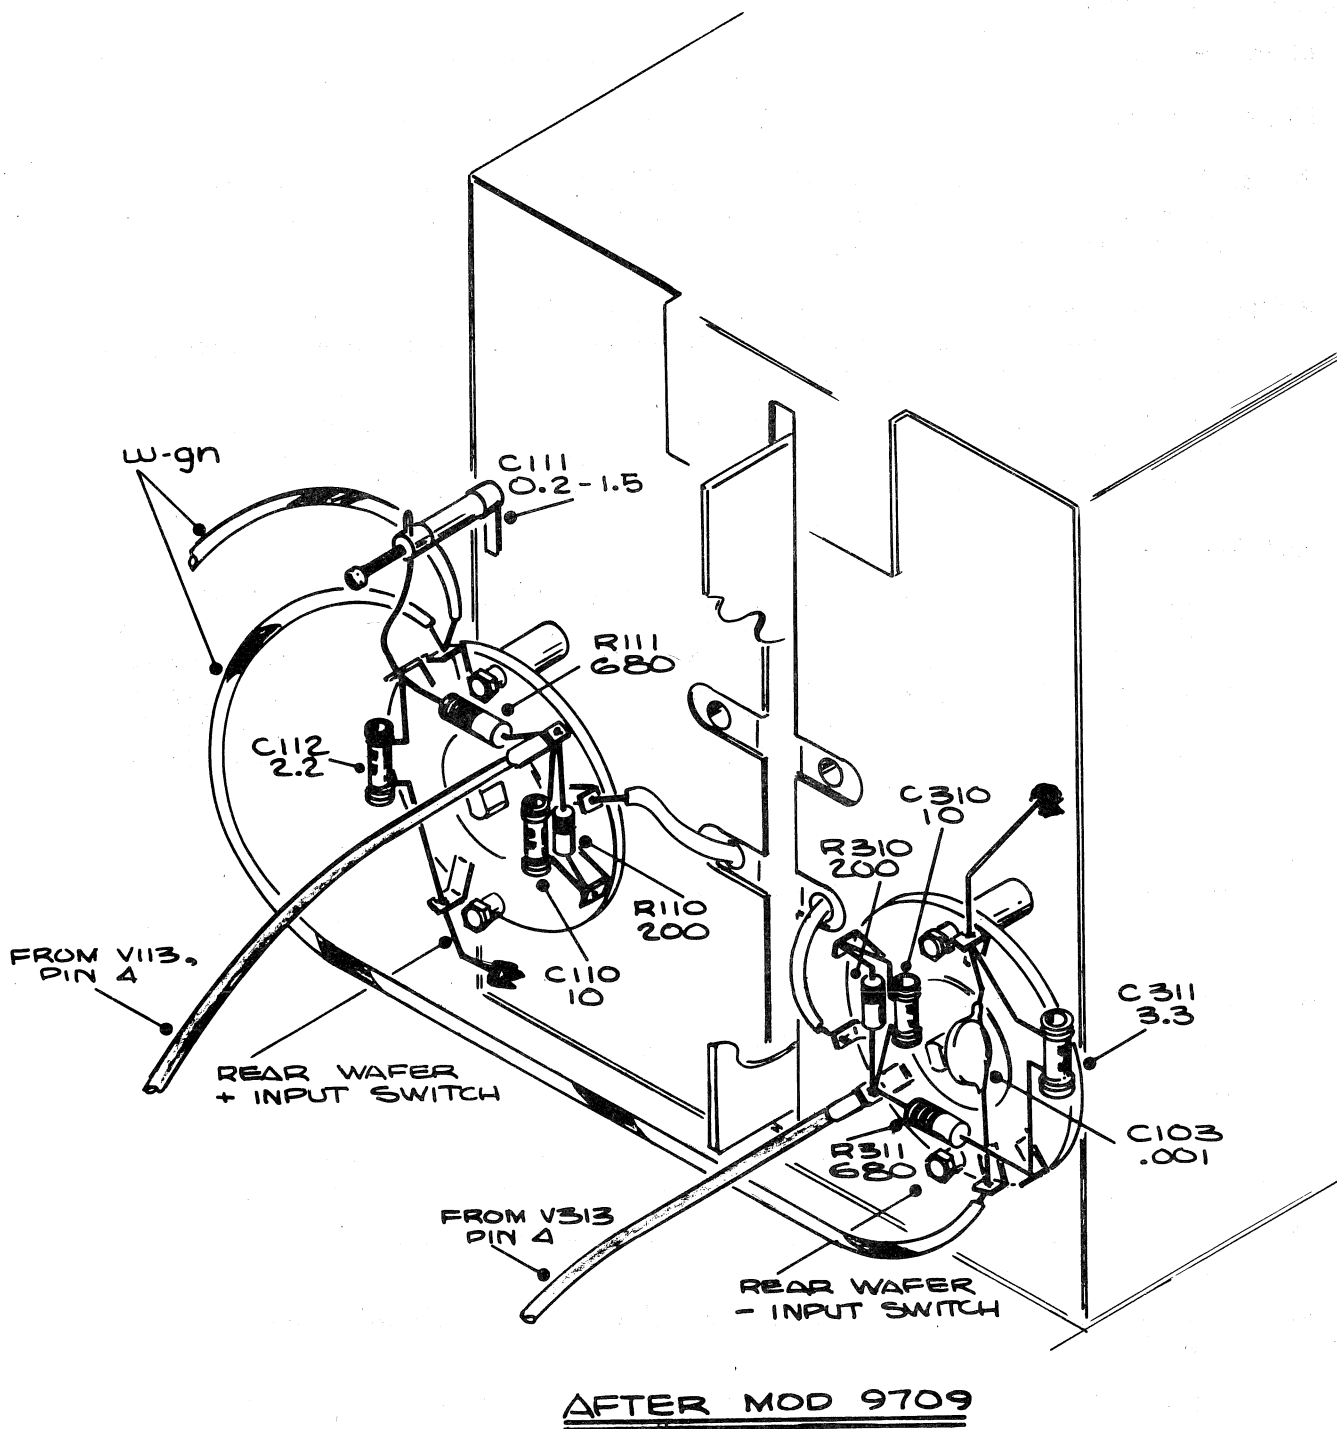
FIG. 1

PROBLEM: The hook is caused primarily by the 100 Meg Grid Current Bal potentiometer isolation resistors, R135 and R335. The Grid Current Bal pots are not needed since grid current is not a problem.

- Remove the white-brown wire from terminal 10 of the +INPUT switch and cut it flush with the cable harness.
- Remove the white-green wire from terminal 4 of the -INPUT switch and cut it flush with the cable harness.
- Replace the rear + and - INPUT switch wafers and wire components as shown in Fig. 1.
- Replace R105C, R106G, R305C and R306G with #22 bare wire straps as shown in Fig. 2.
- Remove R137 (100 k 1/4W 5%) located between forward terminals of the -Grid Current Bal pot (R336) and Int DC Bal pot (R200).
- Remove the white-brown and white-green wires connected to the Grid Current Bal pots and cut them flush with the cable harness.
- Remove the - and + Grid Current Bal pots, R136 and R336, and their hardware from the main chassis.

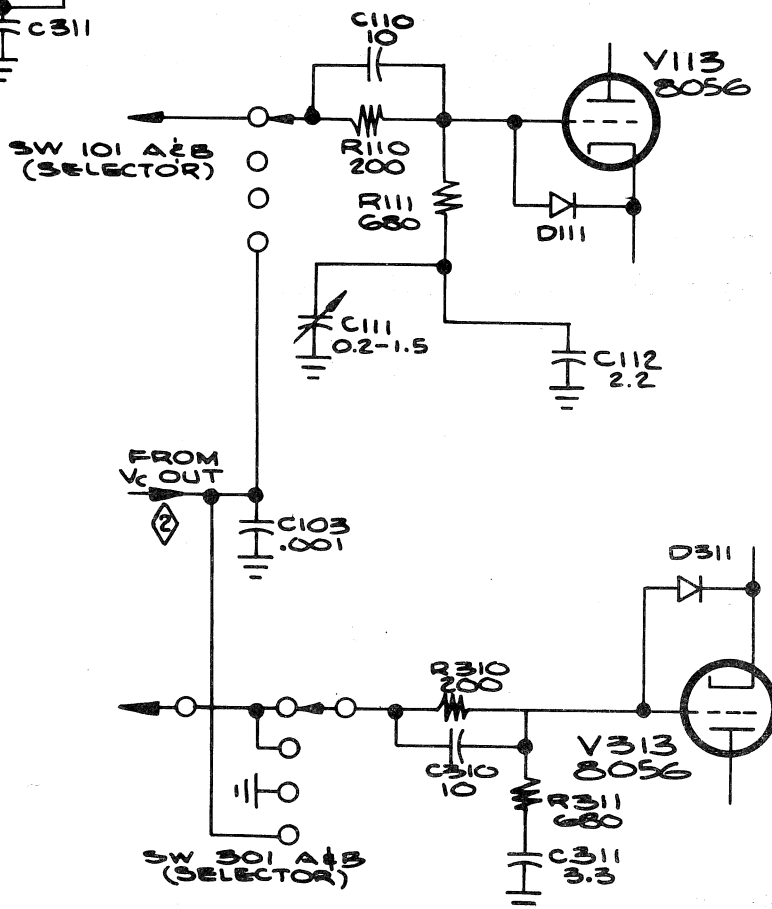
AFTER MOD 9709

PRODUCTION CHANGE: The Grid Current Bal pots and associated components were removed as indicated in the Before and After schematics on a following page. Typical grid current without pots is about 0.2 nA.

After the Grid Current Bal circuitry was removed, it became necessary to replace the + and - INPUT switches with a make-before-brake type, to eliminate any trace shift which would occur with the absence of the Grid Current circuitry.

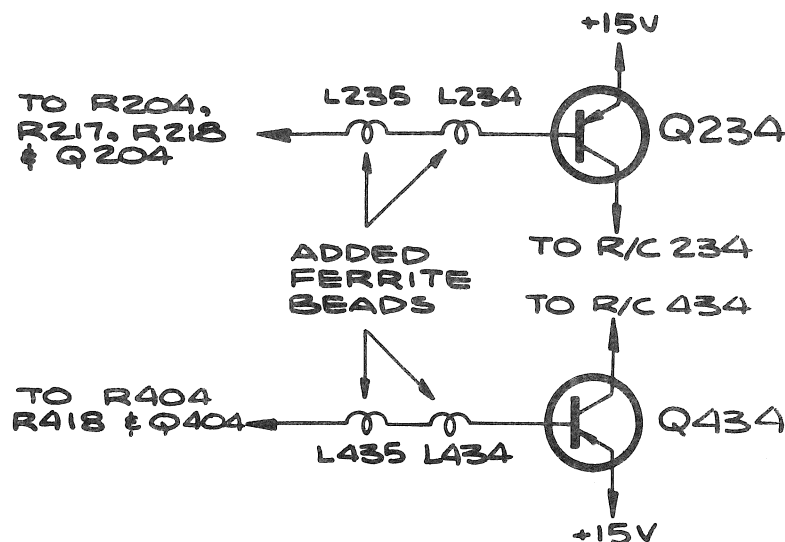
INPUT AMPLIFIER 10A1 (PARTIAL)

PROBLEM: 20 MHz oscillation in operational amplifiers Q204, Q404, Q234 and Q434.

- a) Remove R217 (22k 1/4 W 5%) between base pin of Q234 and CSB-17.
- b) Replace the #22 bare wire between base pin of Q234 and collector pin of Q204 with a new wire, between CSA-17 and collector pin of Q204.
- c) Replace the #22 bare wire, between collector pin Q404 and base pin Q434, with a new wire, between collector pin Q404 and CSB-19.
- d) Remove the #22 bare wire, between base pin of Q234 and CSB-18.
- e) Solder a #22 bare wire to base pin of Q234. Add ferramic cores L234 and L235 to the wire, soldering the free end to CSA-17.

- f) Unsolder the CSB-19 end of a #22 bare wire connected to the base pin of Q434.
- g) Add ferramic cores L434 and L435 on the unsoldered wire (step f). Resolder the wire to CSB-19.
- h) Add a #22 bare wire, between CSA-17 and CSB-18.
- i) Add a new 22k 1/4 W 5% resistor (R217), between CSA-17 and CSB-17.
- k) Add a 1/4" solder lug between flat washer and top of chassis on potentiometer R215 (Var Atten Bal) position toward front of plug-in and tighten nut.
- l) Solder a #22 bare wire, between solder lug in near by metal shield on the VOLTS/CM AND V_c RANGE switch SW710.

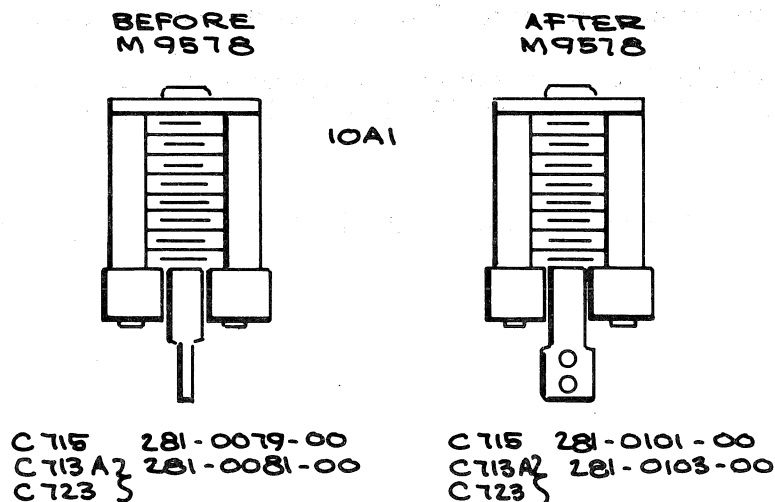
PROBLEM: The contacts on C713A, C715 and C723 were not wide enough to insure stable mounting when the capacitor is adjusted.

Capacitors C713A, C715 and C723 were changed from etched circuit board mounting type to type with wider mounting contacts. See drawings below.
