WIZARD WORKSHOP ARTICLES

SC502 CAMERA MOUNT

PRODUCT

SC 502

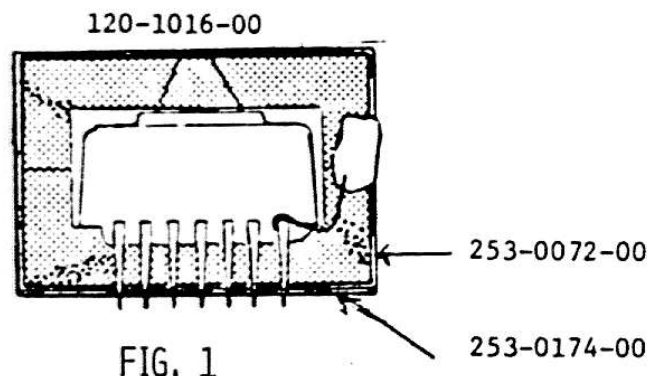
TEKTRONIX TYPE SC502 PREVENT TRANSFORMER CORE FROM SHORTING
TO CIRCUIT BOARD RUNS

It has been found that the high voltage transformer, P/N 120-1016-00, when assembled to the circuit board has had very thin tape placed between the board and the transformer core, which in turn has caused instances where the core has been shorting to the circuit board runs. An internal change has been made to correct this. Refer to Fig. 1. The description of the change consists of adding a layer of .003 press tape (P/N 253-0072-00) to T800 High Voltage transformer. To insure reliability of the instrument they have increased the coverage and total thickness of the insulating tape. Poly-double sided tape (253-0174-00) will still be used, but applied on top of the new tape as shown in Figure 1. It is recommended that any time the transformer circuitry is worked on, this transformer should be removed and this additional tape be installed on the transformer core to prevent future shorting. Also, any transformers in stock should be checked to see if this additional tape is on the bottom of the transformer core. If it is found to be missing it is recommended that you install this additional tape.
