SERVICETEKNOTES

SC 904
492

TABLE OF CONTENTS

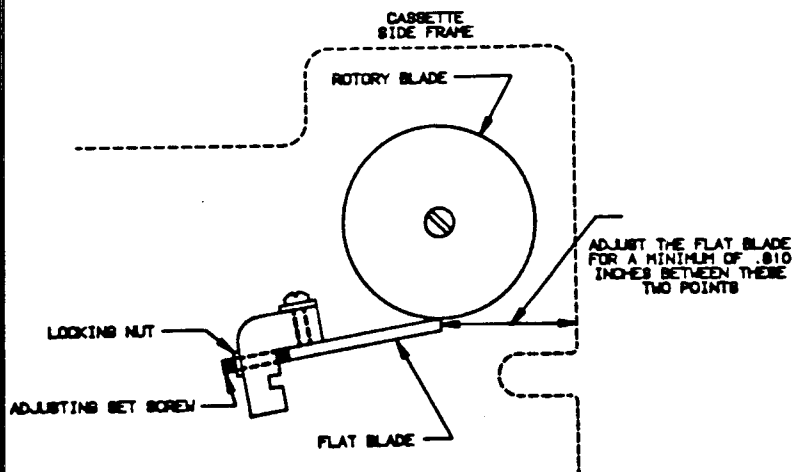
The flat blade on the 4635 can be adjusted forward too far and it will make contact with the paper peeler. This contact results in the motor current limiting upon rotation of the rotary blade. The solution is to adjust the flat blade for a minimum of .81 inches between the blade and the front edge of the cassette chassis. The drawing below details the critical area.

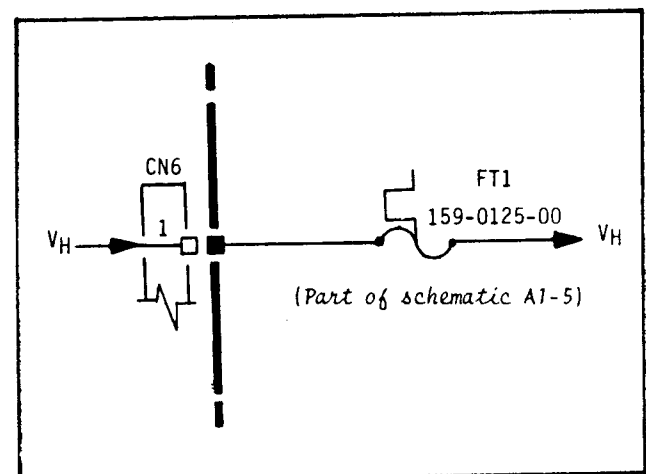
Figure 1. Location of FT1.

The thermal fuse, FT1 was added to production units to shut down the 300 volt supply to the control board in the event of elevated temperatures. The part number of this thermal fuse is 159-0125-00 and its circuit location is given in Figure 1 below.

Fuse FT1 was intended to shut down the +300 volt supply in the event of a failure of the head driver chips, and subsequent overheating. The new drivers eliminated the need for FT1. FT1 was therefore removed. A few -00 control boards were shipped with both FT1 and FT2 on them.

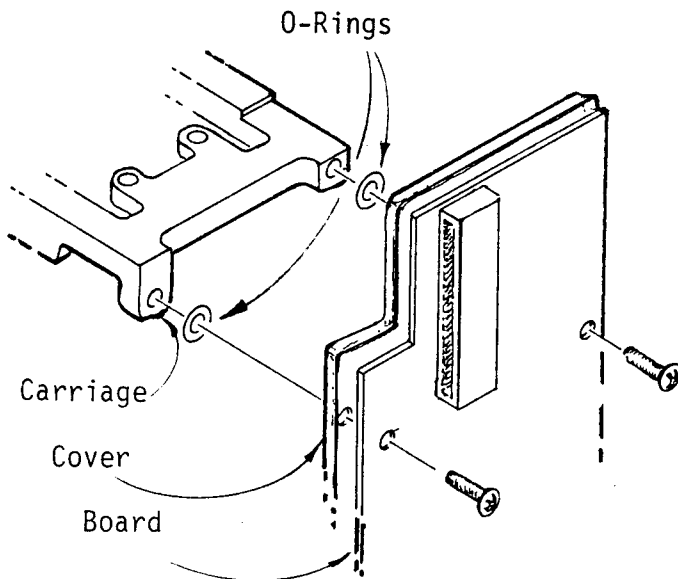
Figure 2. O-rings added.

Finally, O-rings were added between the ink head carriage and the interconnect board around the two board mounting screws. See the detail in Figure 2 for the O-rings' locations. This was done to reduce the likelihood of ink

migrating along contact surfaces and finding its way onto the interconnect board. Once on this board, the conductive ink would short the runs causing a control board failure, particularly during an electronic purge.

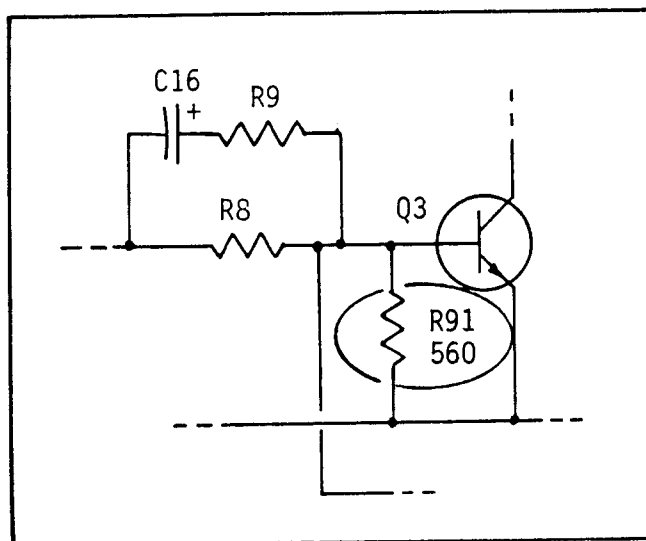
Figure 3. Addition of R91.

Approximately J013500, the values of R70 and R90 were changed. Resistor R70 changed from 8.2K ohms to 12K ohms, and R90 changed from 1.5K ohms to 2.2K ohms. The reason for this change was to prevent the possible misadjustment of VR2 which could damage the ink jet crystals by supplying as much as 400 volts. Errors in earlier schematics have confused the issue on these two components. Please refer to a 4695 Service Manual, printed May of 1984 or later for a correct schematic representation. This change is documented as part of engineering change order 54907.

Ct. No.	Old	New	Part Number
R70	8.2K	12K	315-0123-00
R90	1.5K	2.2K	315-0222-00
R91	--	560 ohms	315-0561-00

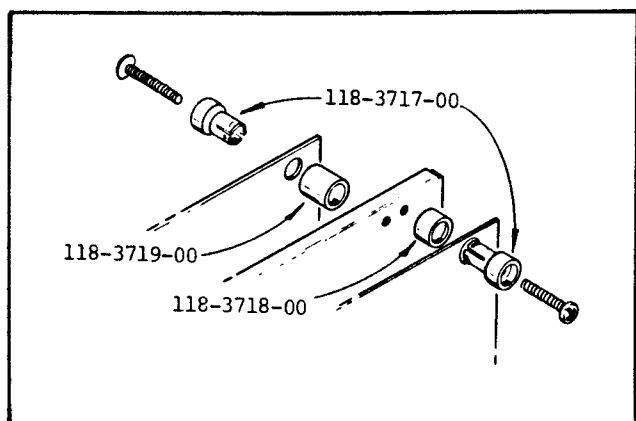
Figure 4. Plastic Spacers

The plastic standoff bushings shown in Figure 4 were originally unavailable as separate components. However, the need for their availability to repair power supplies and control boards prompted change number 53129. Each board uses three 118-3717-00 male bushings. In addition, the control board uses three 118-3719-00 female bushings and the power supply uses three 118-3718-00 female bushings.

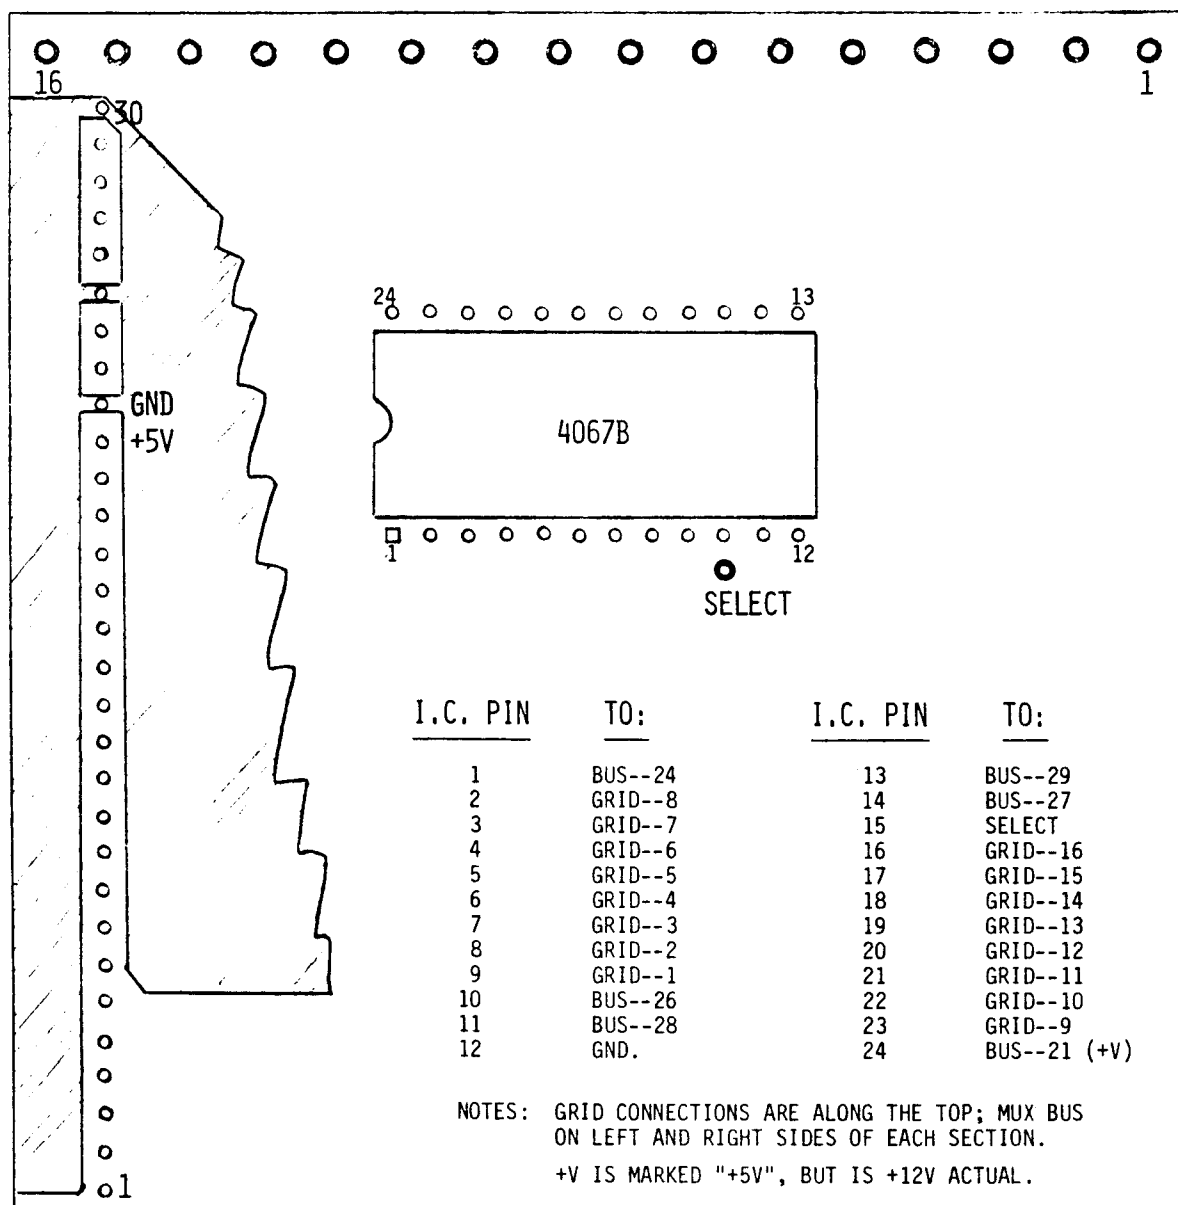
4958 MUX Board (partial)

surface. The wiring information becomes essential if a pad is accidentally lifted during replacement of the IC. And, even though the connection pattern is duplicated for each IC, an ohmmeter is of little help. **ALL** of the grid wires are at DC ground.

So, if you suspect an open connection between an IC pin and a grid connection, an ohmmeter check will tell you if it is really open--and if the IC pin tests open, use the figure below and patch with 30-gauge insulated wire.
