SERVICETEKNOTES

TABLE OF CONTENTS

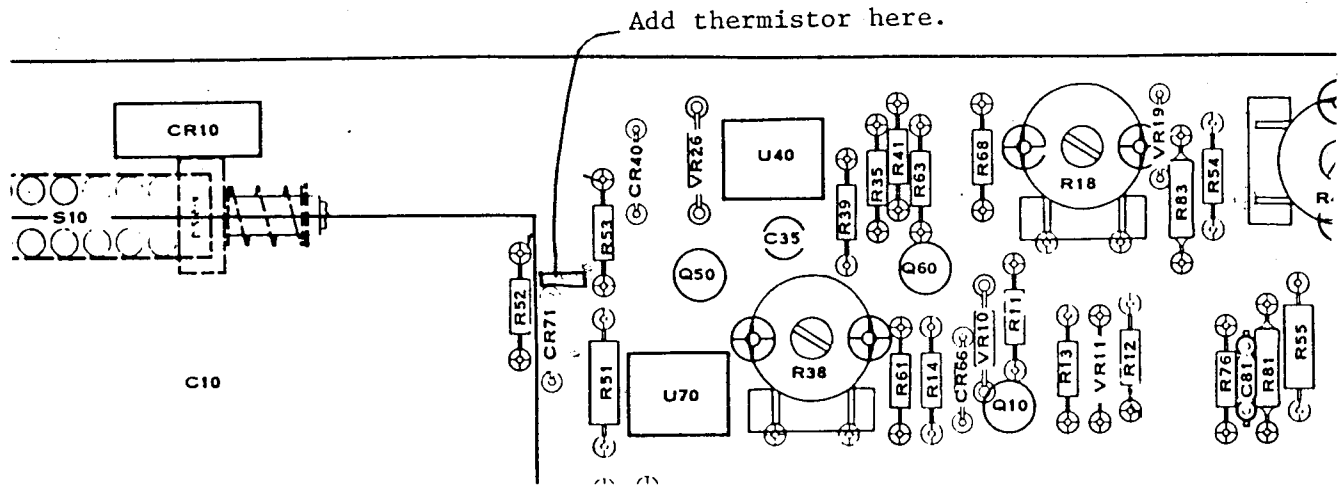
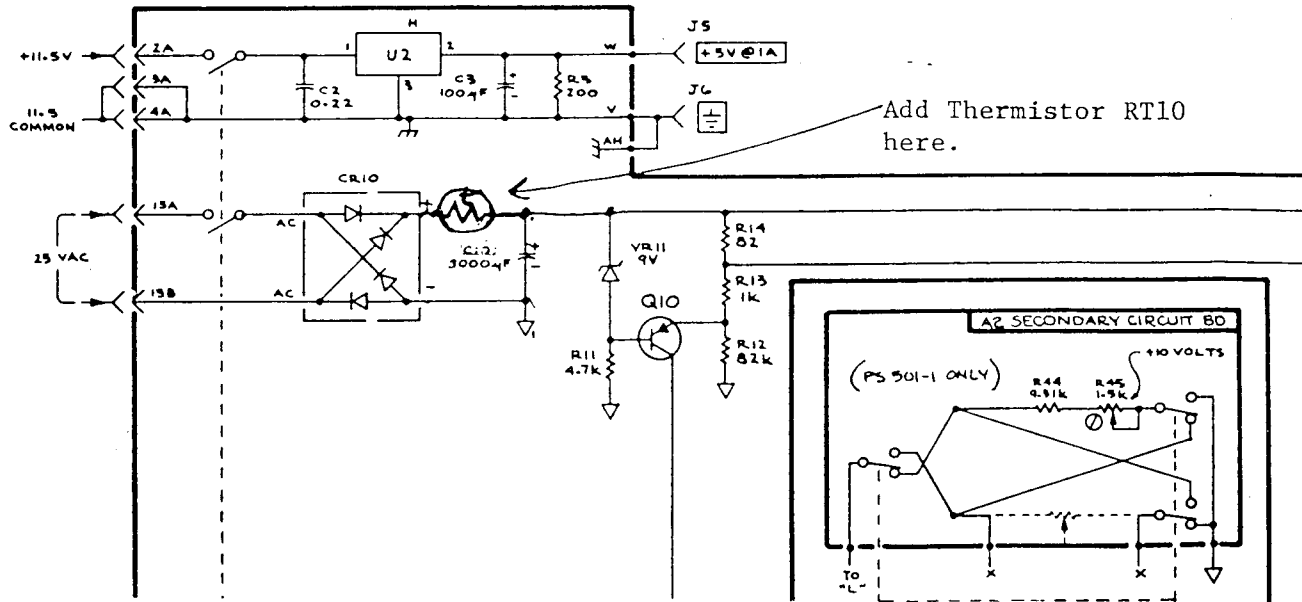
PS501-1 POWER SWITCH RELIABILITY IMPROVED (CONT.)

The reliability of the power switch S10 has been improved by reducing the surge current to C10 at turn-on. This has been done by adding a thermistor in series between the anode of CR10 and the positive lead of C10. The thermistor PN is 307-0746-00. This part is most easily installed by removing the upper bare wire attached to the plus terminal of C10 and replacing it with the thermistor. See attached drawings. This mod should be installed in every PS501-1 that is serviced.

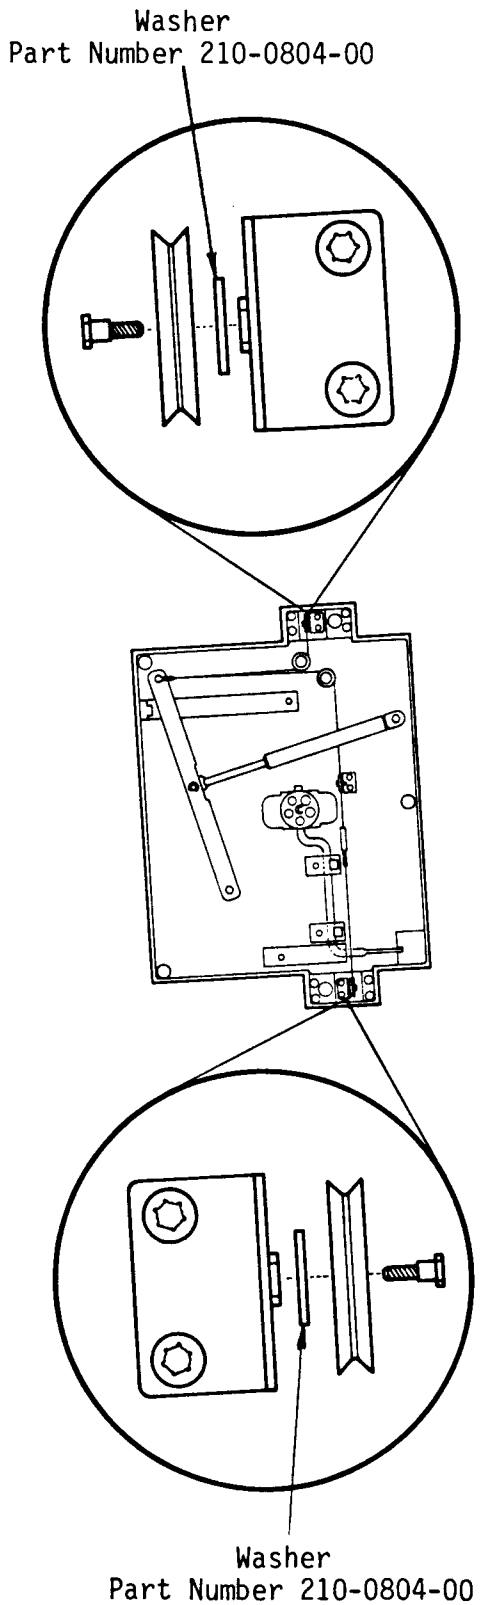
Figure 1

Several ADS01s have had trouble with two of the nylon pulleys pulling off at the bearing (refer to Figure 1). The problem has been identified, and a solution is available.

The solution is to add a 210-0804-00 (dimensions of washer .172 ID, .375 OD, and .30 thickness) steel washer between the pulley and mounting stud (refer to Figure 1).
