SERVICETEKNOTES

CG-5001

Published by Tektronix Service
Operations Support

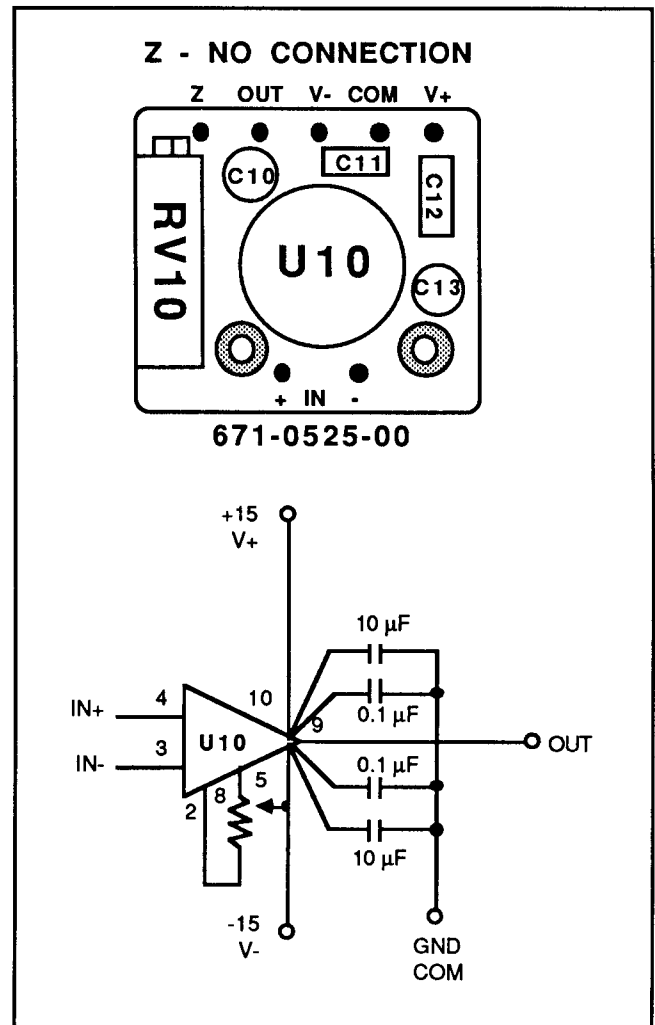
Figure 1

Mod #66798 is being done on the DC Sub-Sys-
tem Amplifier boards for couple of good
reasons. First, the GFC relay, K1050S1,
driven by the coil K1050, does not close
reliably.

The coil, 108-0355-00 does not provide suffi-
cient drive to consistently close the reed switch.
The replacement coil is P/N 108-0966-01. The
original reed switch P/N 260-0722-00, will still
be used. This coil and reed switch replacement
should be done if the board is repaired for any
reason.

The second part of Mod #66798 is for replace-
ment of U250, the Burr-Brown module P/N
156-0370-00, which is no longer available from
the vendor. Additionally, the Burr-Brown
module did not supply enough output voltage
with relation to input current on the 100 mA
range. The replacement for U250 is a plug in
ECB P/N 671-0525-00. It includes an
AD382KH OP Amp P/N 156-3280-00. The
ECB is simply inserted in place of U250. The
offset adjustment, R140 will no longer be
functional, and may be removed from the
Amplifier board if desired. After the mod the
offset adjustment will be on the ECB and will be
labeled RV10.

U10	156-3280-00	AD382KH
C10	290-0536-00	10 μ F 25 V
C11	283-0421-00	0.1 μ F 50 V
C12	283-0421-00	0.1 μ F 50 V
C13	290-0536-00	10 μ F 25 V
RV10	311-1319-00	10K 15 Turn

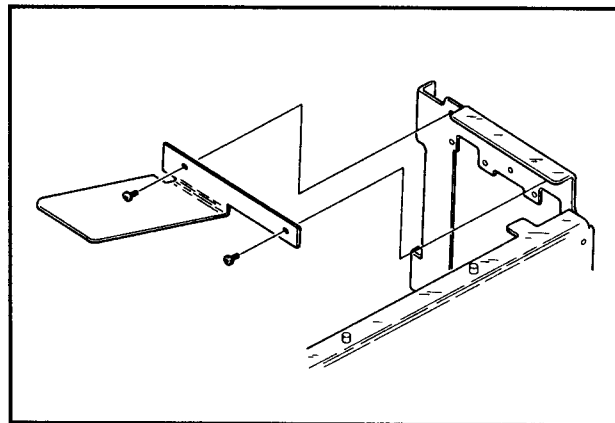
This procedure outlines the process of installing a new guide deflector into the 7612D. This new guide prevents damage to the 7612D Plug-in Interface should the plug-in amplifier be installed at an angle other than 90 degrees to the interface.

While referring to the following illustration (or Fig. 2, at the rear of the 7612D Service Manual, 070-2387-01) locate index number 70 (CHAS, PL-IN UNIT:).

Remove and discard the two machine screws identified by index number 73 (SCREW, MACHINE: 4-40 X 0.25, PNH, STL), these are located toward the rear and top of the chassis.

Install the new guide deflector so that the holes in this guide align with the existing holes in the chassis.
