ISSUE: 18-8

WIZARDS' WORKSHOP

TEKTRONIX INTERNAL USE ONLY

APRIL 29, 1988

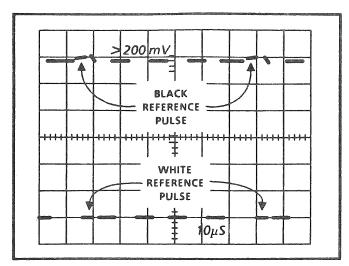
Fig. C-4. Location of 650HR-C black and white reference pulses.

- 5. Repeat step 4 (above) monitoring TP5700 (on A5) and adjusting R9208 (white level) for

CHANNEL 2, and monitoring TP5760 (on A5) and adjusting R9277 (white level) for CHANNEL 3.
