Wizards Workshop

Published by Service Admin Support
56-037 Ext. 8939 Merlo

September 19, 1980
Issue 10-19

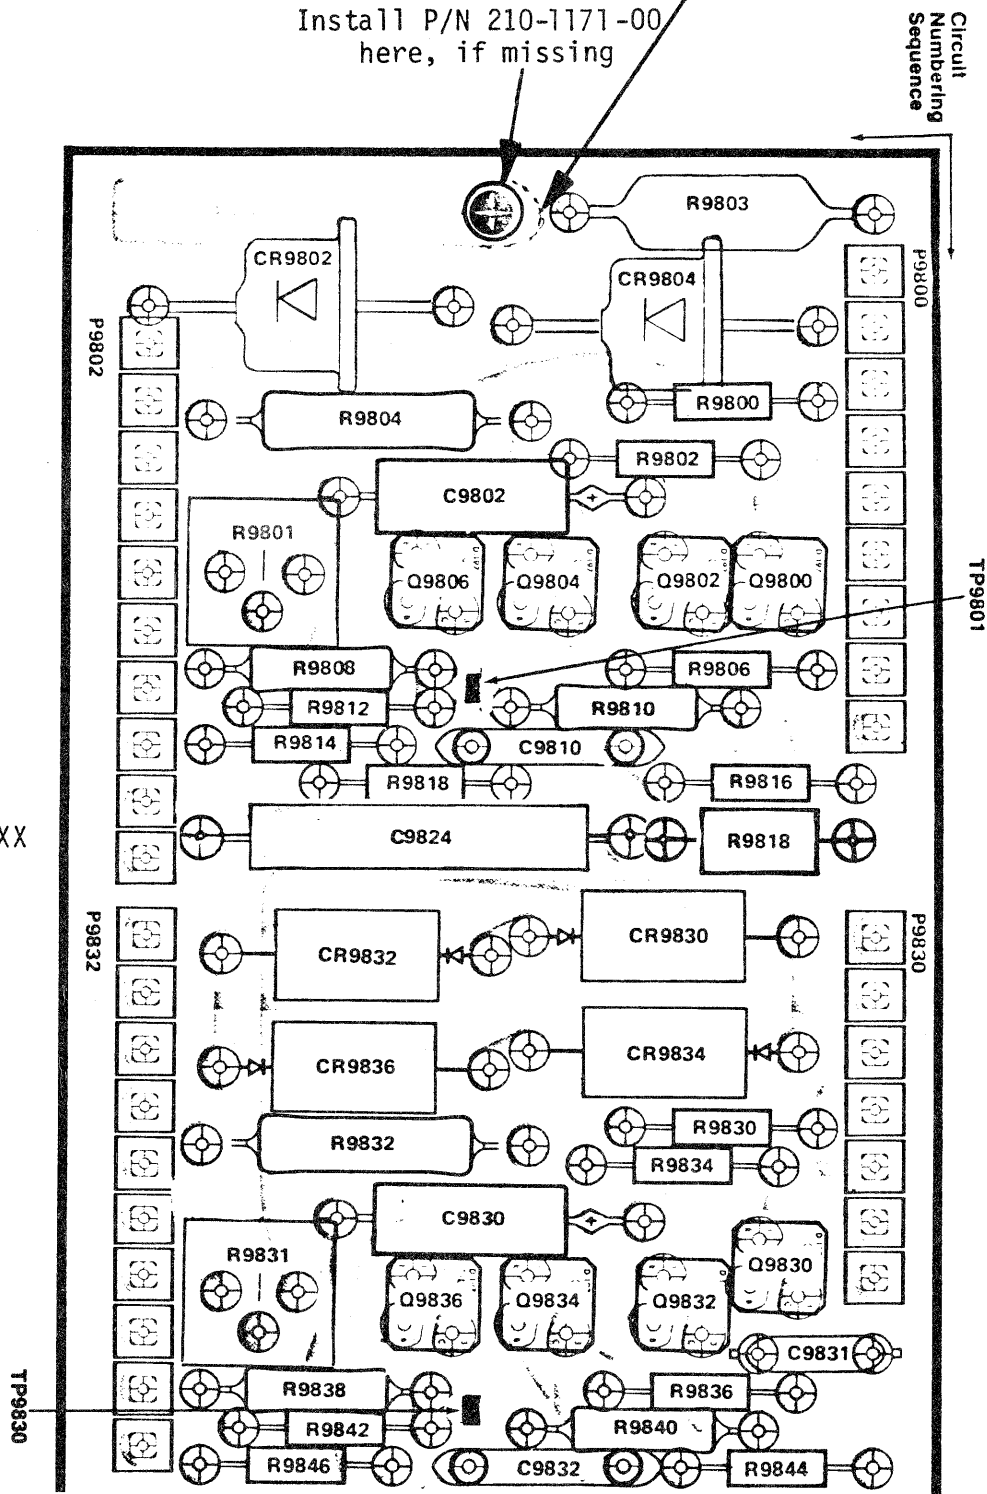
670-1473-XX

The Manufacturing line had been installing a washer (P/N 210-1171-00) under the metal washer on the board mounting screw that is near R9803 (see the following board layout of power supply board, 670-1473-XX). This washer was to prevent R9803 from being shorted to ground due to close spacing of the circuit board pads. An unknown number of instruments have been shipped without this washer. It is possible that any slippage of the circuit board could cause R9803 to contact the mounting screw. When R9803 is grounded, the +5 volt supply will increase to approximately 9 volts. The power supply is normally not damaged, but other components in the instrument may be.

Install P/N 210-1171-00
here, if missing

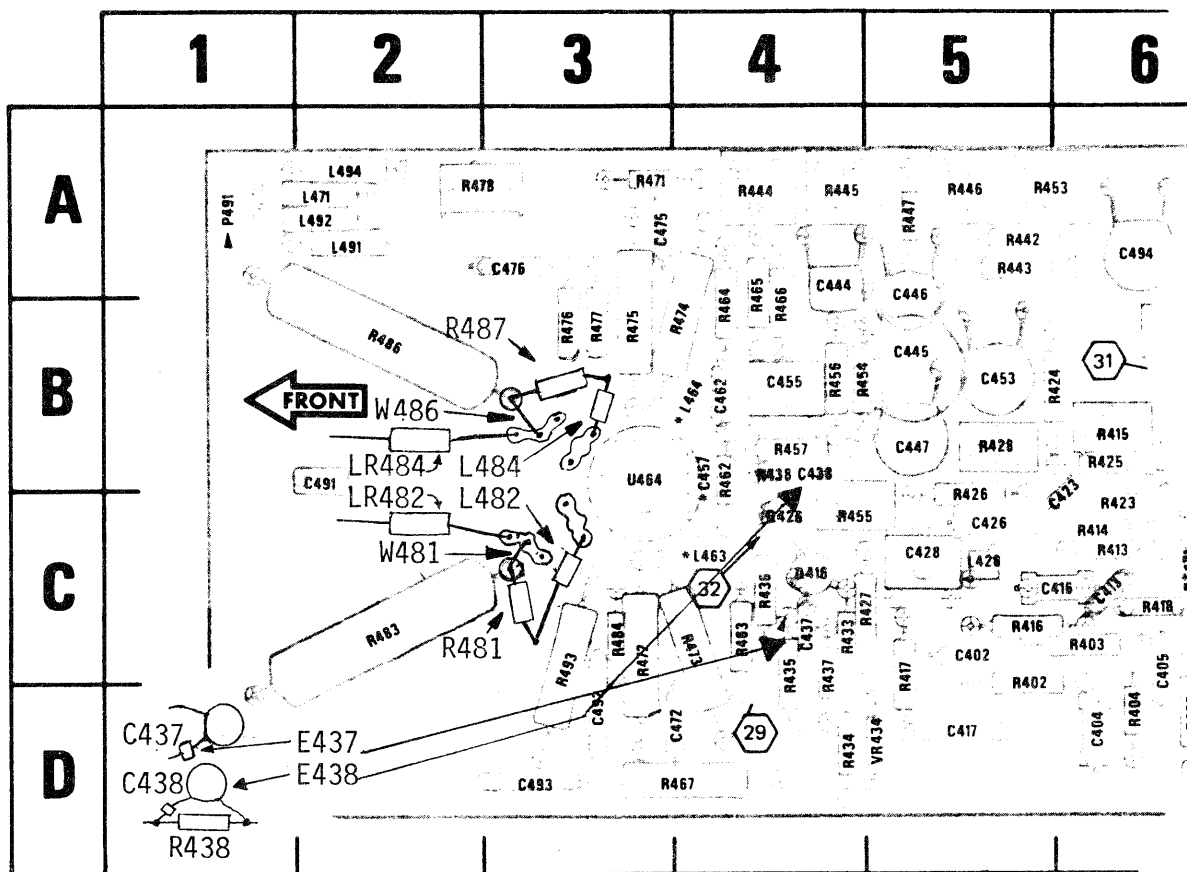
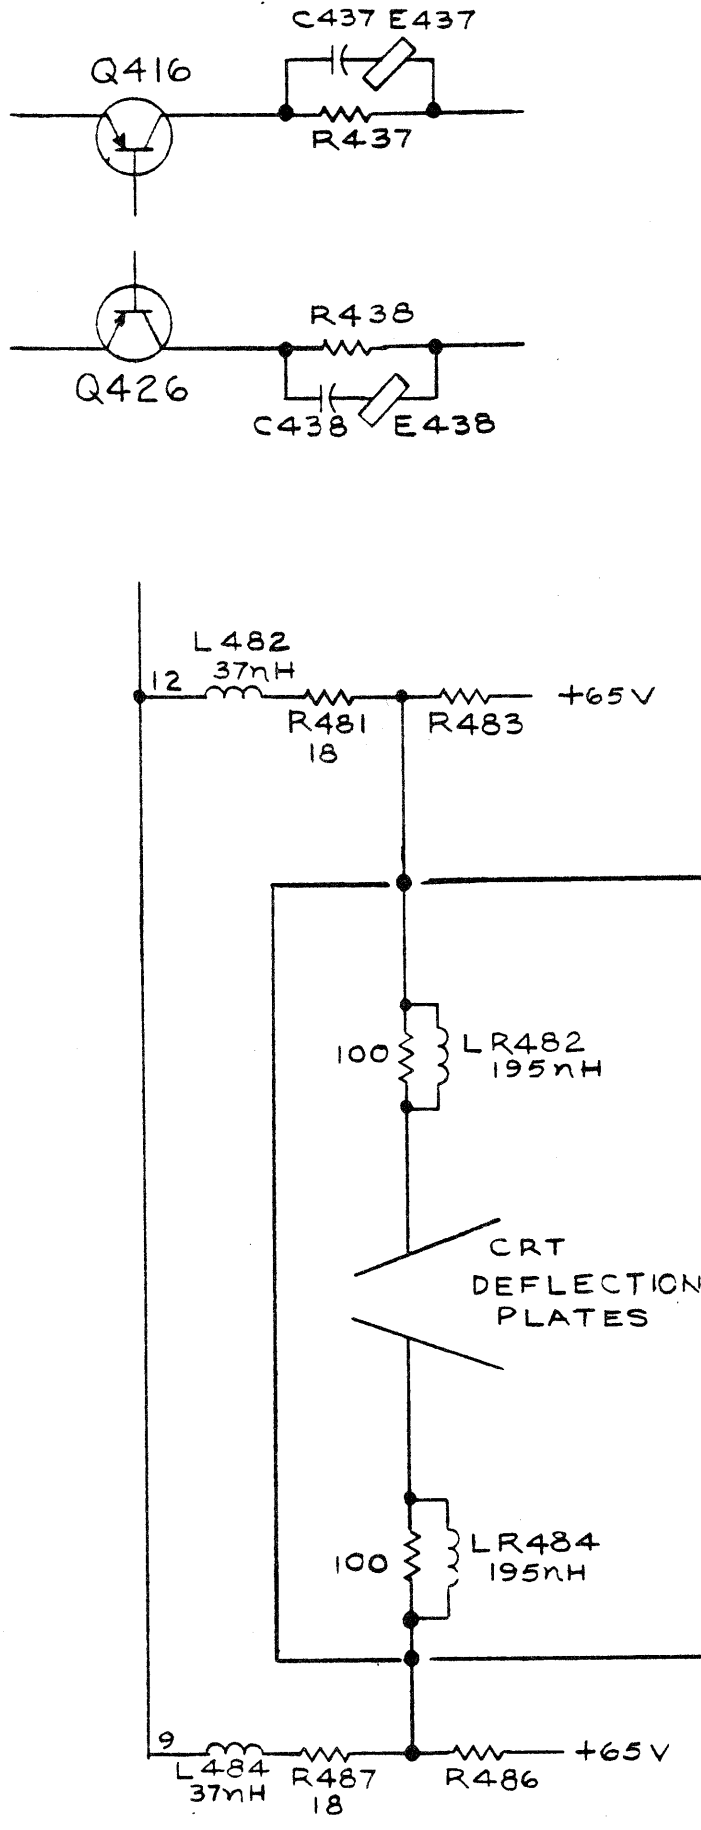
Due to a process change to U464, P/N 155-0115-00 the vertical may oscillate. If U464 is replaced the following modifications must be made:

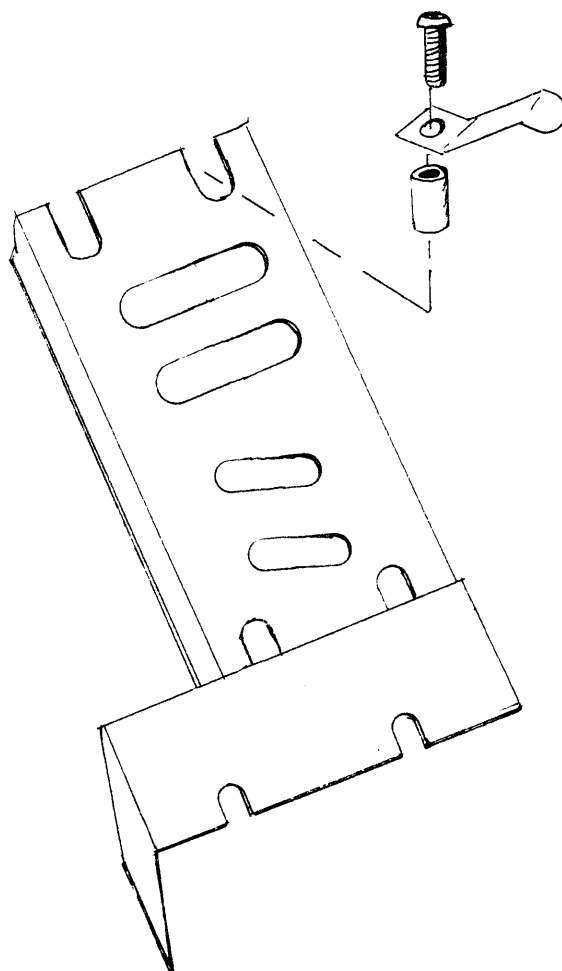
Illustration 1

The 5 Volts/Div position on CH 1 and CH 2 vertical preamps may not meet risetime specifications. In order to improve grounding of the attenuator shield, which will improve the risetime to meet specifications, a ground clip is added to the top of the shield (see illustration for location).

The parts added are:	2 ea	P/N 131-1428-00	Ground clip
	2 ea	P/N 166-0030-00	Spacer
	2 ea	P/N 211-0012-00	Screw

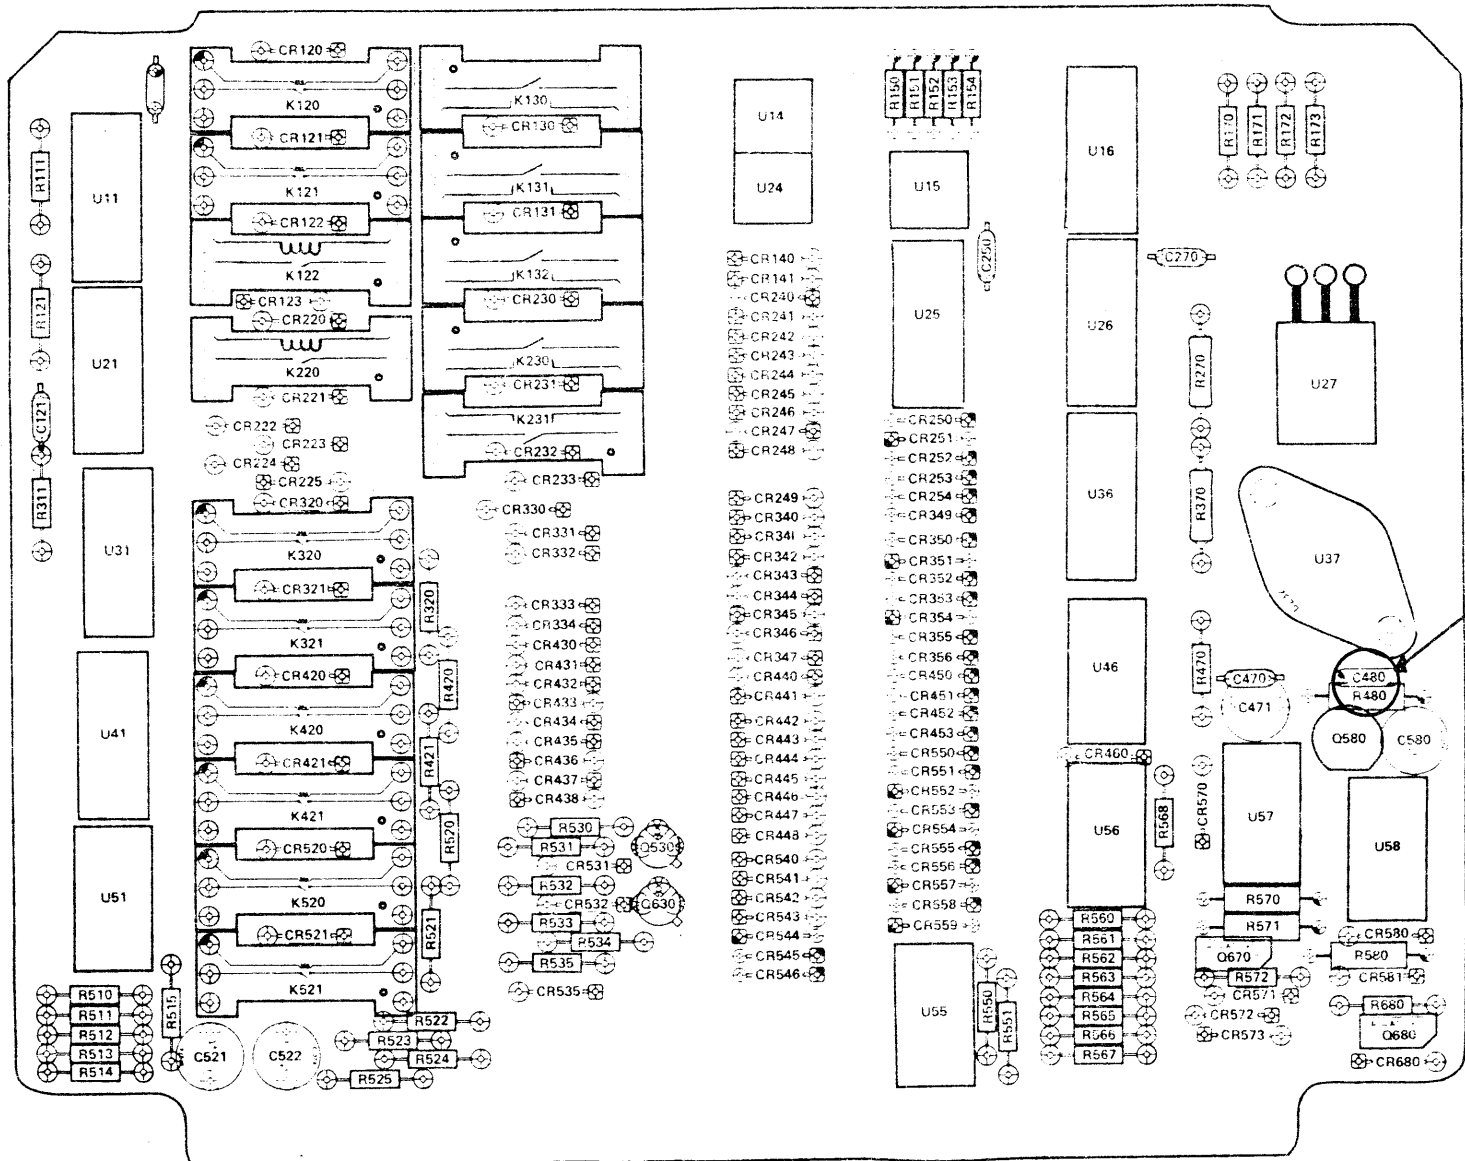
Figure 7-43. DCSS Logic Card (A28) Component Locations

It has been determined in some cases there is an oscillation on the +7V regulator which is coupled to the 15V supply. This oscillation may cause a false initialize signal to be generated. Mod #40301 calls for replacing C480 on the DC Sub-System Logic circuit board. Remove the .001 micro farad capacitor (283-0065-00). Install a one micro farad capacitor (283-0177-00). The assembly number for the DC Subsystem Logic board will change from 670-2828-03 to 670-2828-04. This mod applies to all test tables 1803, 1804 and 1805. See the attached parts placement diagram for the logic Board.

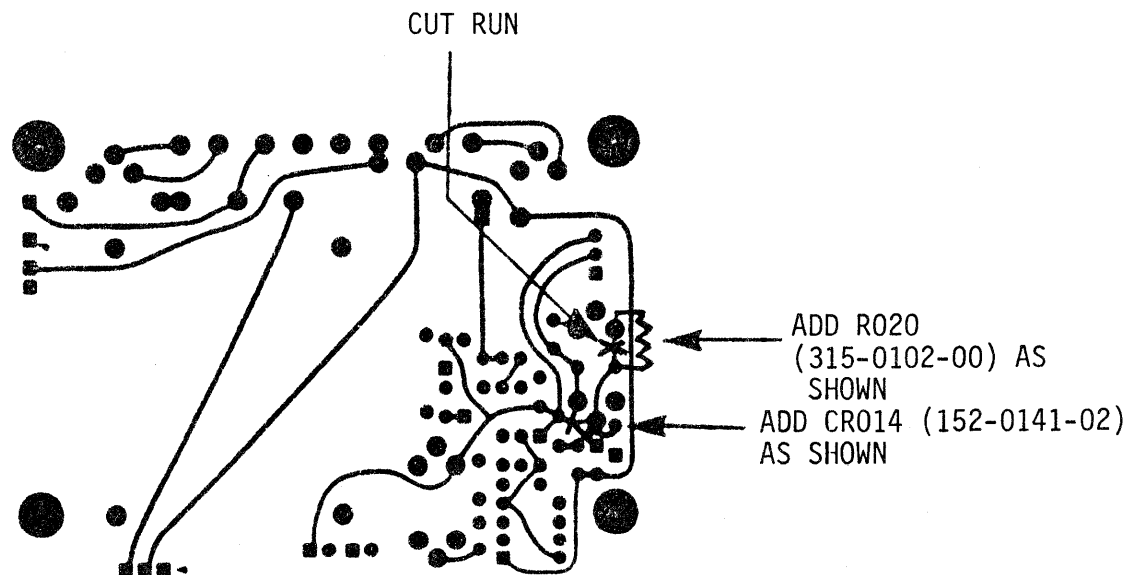
DIAGRAM 'A'

Symptom: If a failure occurs in the filament supply the majority of the active components on the Hi Voltage Oscillator Circuit Board will be destroyed. This mod adds protection to the circuit to prevent this type of catastrophic failure.

Solution: On the front side of the Hi Voltage Oscillator Circuit Board 670-5155-01, add two heat sinks (214-0269-00), one to Q016 and one to Q018. Remove VR016 and replace with Part Number 152-0304-00.
