PG 506

SERVICETEKNOTES

TABLE OF CONTENTS

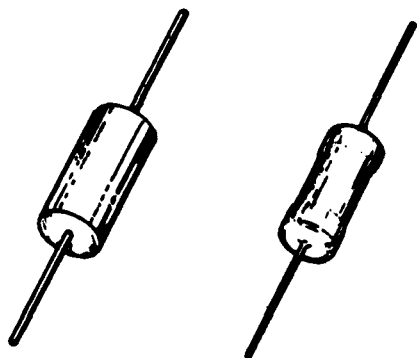
Figure 1.
Composition and Film, respectively.

Various resistors in the 606(A), 606B and 608 are exhibiting a high failure rate. They are as follows:

Product	Circuit No.	Part Number
606(A)	R770	301-0181-00
606B	R162	301-0391-00
608	R858	301-0470-00
	R879	301-0151-00
	R880	301-0221-00

Prior to 1980, all 301-XXXX-00 and 302-XXXX-00 were carbon composition. During 1980/81, a projected shortage of composition parts required the purchase of carbon film and metal film resistors to maintain production. As a result, inventories of 301- and 302- components became mixed with both film and composition parts.

In high voltage applications, the film components have shown some distinct disadvantages. Metal film parts tend to open up without giving any visible evidence of their failure. Carbon film parts may drift in value due to migration of conductive particles (the Lorenzo effect). It is therefore advisable to avoid film resistors in any high voltage application.

To correct this, only the carbon composition versions of the above part numbers should be used for these applications. Use of carbon film or metal film versions of these parts should be avoided. The distinction between composition and film parts is easily seen in the illustration below.

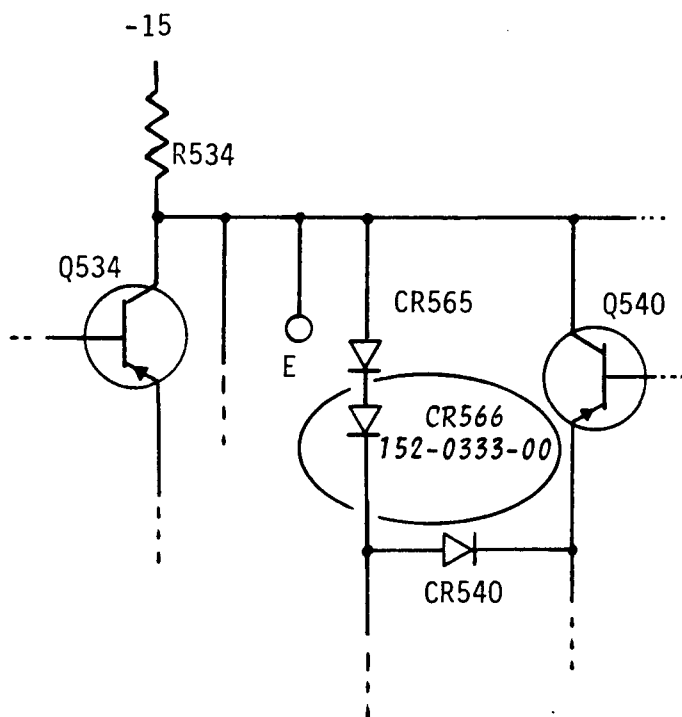
Figure 1. CR566 Added.

The 608 CRT specifications exceed the range of the Z-axis amplifier. As a result, setting cutoff on the 608 may not be possible with some CRTs.

To correct for this problem, a diode is added in series with CR565 in the Z-axis amplifier. The new diode, CR566, is part number 152-0333-00 and is mounted in tee-pee fashion. The part number of the Z-axis amplifier board rolls from 670-5216-02 to 670-5216-04 with this change.

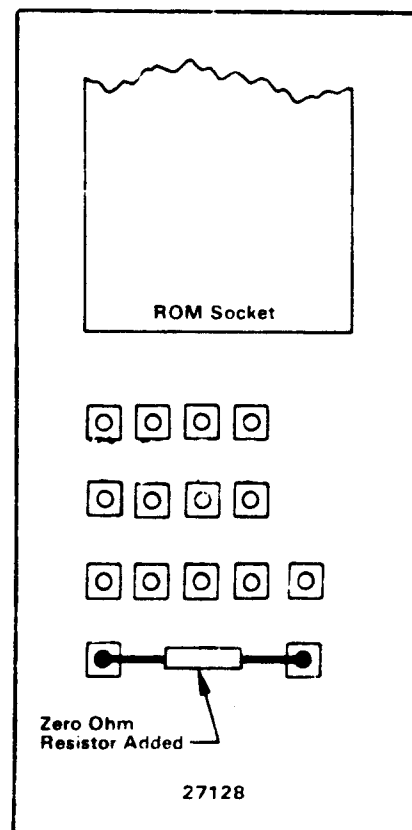
Beginning with shipments of the 80186/80188 Emulator, 8540 control firmware and diagnostics will be contained in 27128 (16K x 8) EPROMs.

NOTE: This strap enables address line 13 to pin 26 of the corresponding ROM socket. Pin 26 of a 2764 EPROM is not connected internally; therefore a socket that has been modified to accept 27128 EPROMs will work fine with a 2764. New System ROM boards shipped from Manufacturing and Board Exchange have zero ohm resistors installed for all ROM locations.

A wire strap or zero ohm resistor must be added to each chip location of the System ROM board before they will accept the 27128 devices. The strap should be added as shown in the following illustration:
