COMBINATION WIZARDS

Tektronix®
 COMMITTED TO EXCELLENCE

October 3, 1980
 Issue 10-20

TABLE OF CONTENTS

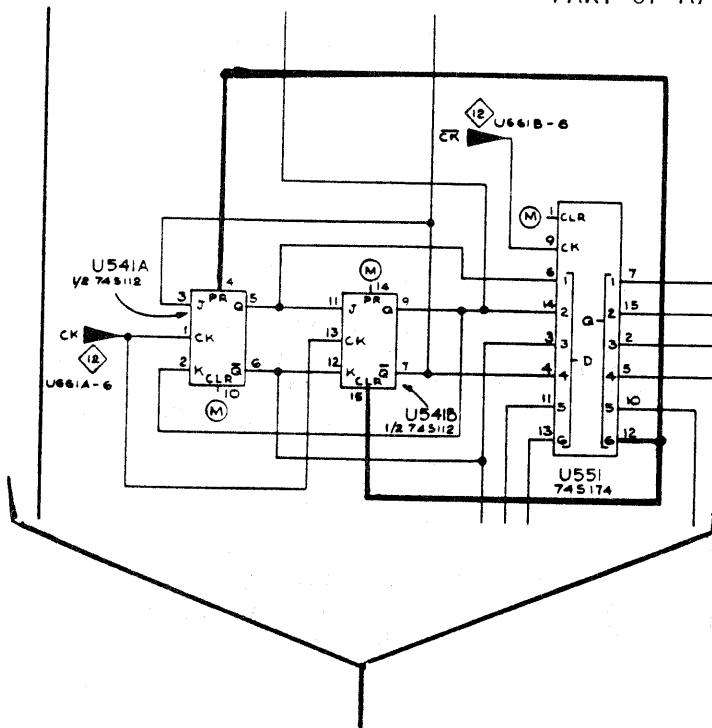
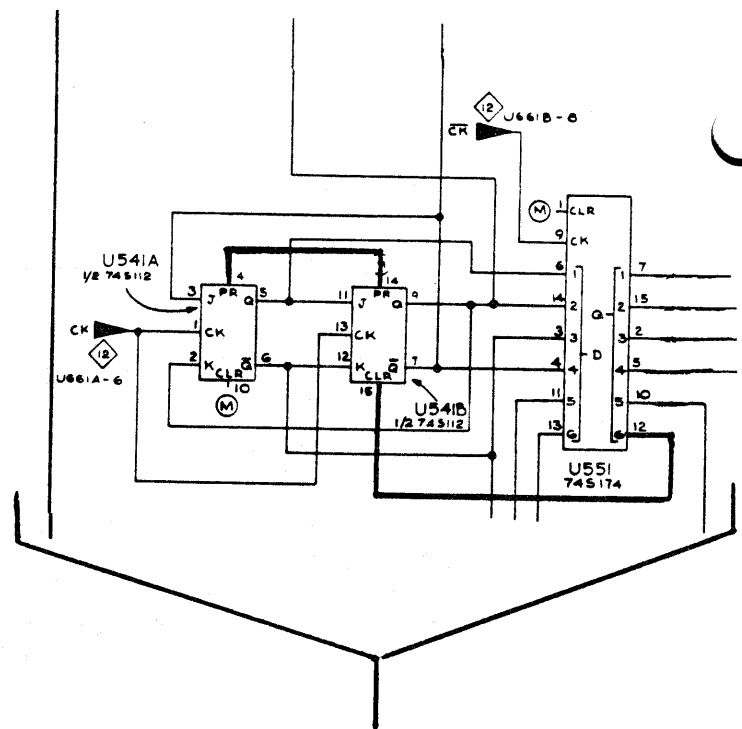
PART OF A7 BOARD

If A7U541 is not properly cleared the phase relationship between SUBCARRIER OUT and FULL FIELD OUT burst may be random. This failure can occur only in the non-gen locked mode. The solution is to remove the wire strap on the bottom of the A7 board that runs from A7U541 Pin 4 to A7U541 Pin 15 at Pin 15 and reconnect it to A7U541 Pin 14. Check that there is still a strap from A7U551 Pin 12 to A7U541 Pin 15. All units in the affected serial number range should have this change made as they come in for service. The changes to be made are outlined in the following drawings.

PRESENT WIRING SCHEME

WIRING AFTER REQUIRED CHANGE

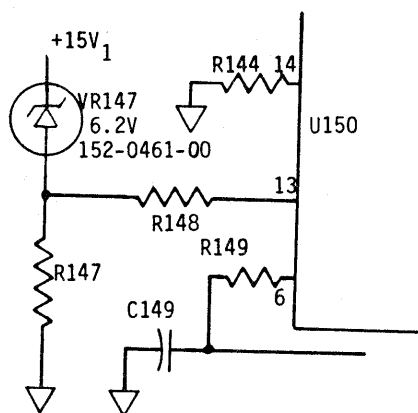
The two interface circuit boards share some changes. On both boards, VR147 is replaced by a zener diode with better thermal characteristics. This improves display intensity stability when temperature changes (see figure 1). Both boards also have metal oxide varistors RV72, RV73 and RV92 added to limit power supply fluctuations in the event of a high voltage arc (see figure 2). Varistor RV92 is connected between pins 1 and 3 of J500. Varistors RV72 and RV73 are soldered in parallel across C72 and C73 respectively.

Figure 1: VR147 has been changed to improve brightness stability.

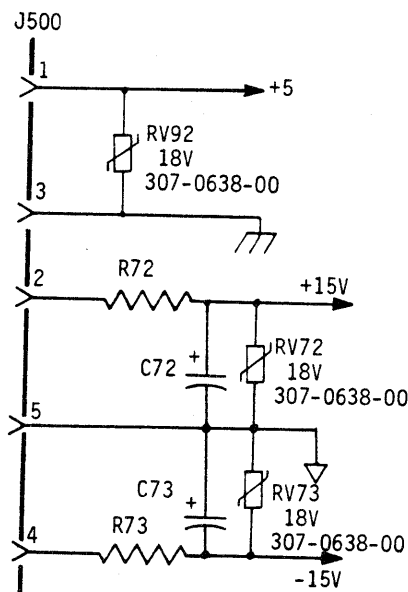
Figure 2: RV72, RV73 & RV92 are added to minimize supply variations if CRT arcs.

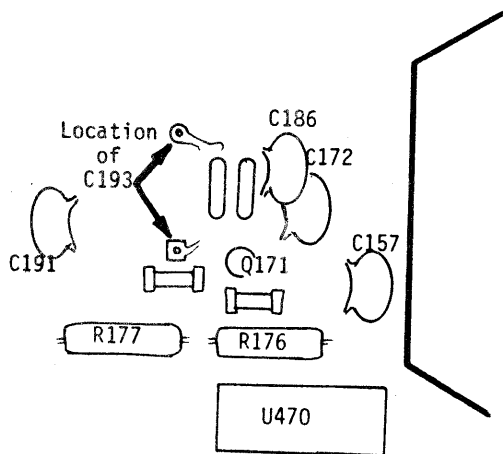
The standard interface, A6, also has C193 added to the video output amplifier. This reduces the 45 kHz component in the -100 volt power supply. Pads and runs for the inclusion of C193 already exist on the A6 layout next to R188. Their location is shown in figure 3.

Figure 3: Location of C193 pads on A6 video board.

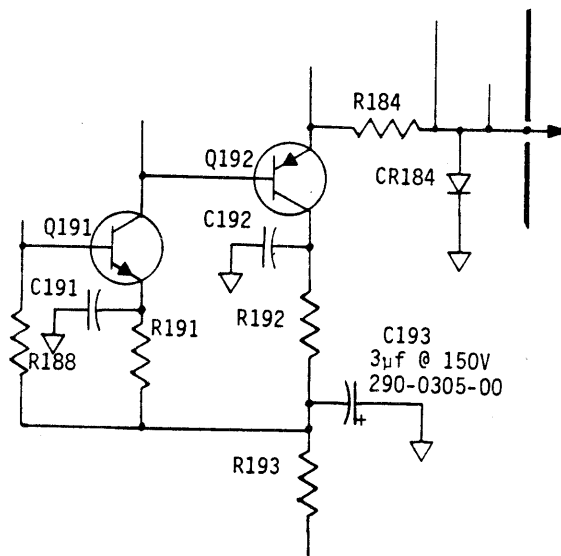
Figure 4: Partial schematic showing addition of C193 to A6 board.

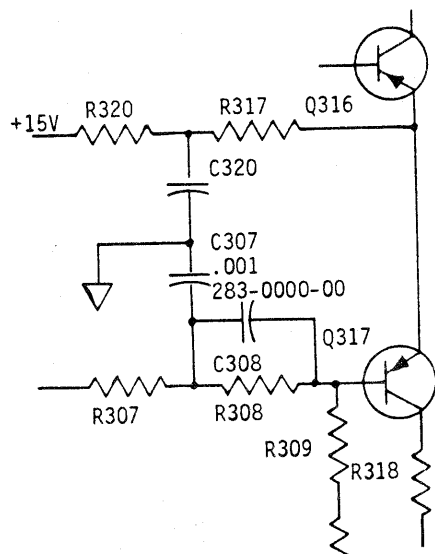
The ripple in the vertical driver has been reduced by adding capacitor C307 to the base circuit of Q317 and by rerouting one lead of C320. One lead of C307 is soldered to the node at R307, R308 and C308. The grounded lead of C320 is then lifted from its "dirty" ground and soldered to the unattached lead of C307. This remaining long lead is then dressed with sleeving and soldered to the "clean" ground at the anode of CR322 (see figure 5). Please note that mention of rerouting C320 was inadvertently omitted from the 045-0015-00 kit instructions.

Figure 5: Rerouting of C320 and addition of C307 to yoke driver boards.

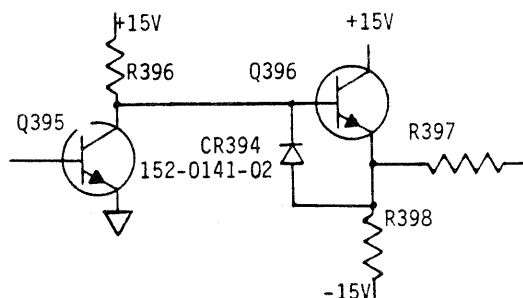
To prevent damage to Q396 in the retrace blanking circuitry, CR394 is added to the back of the boards between the base and emitter of Q396 (see figure 6).

Figure 6: CR394 added to retrace blanking circuit.

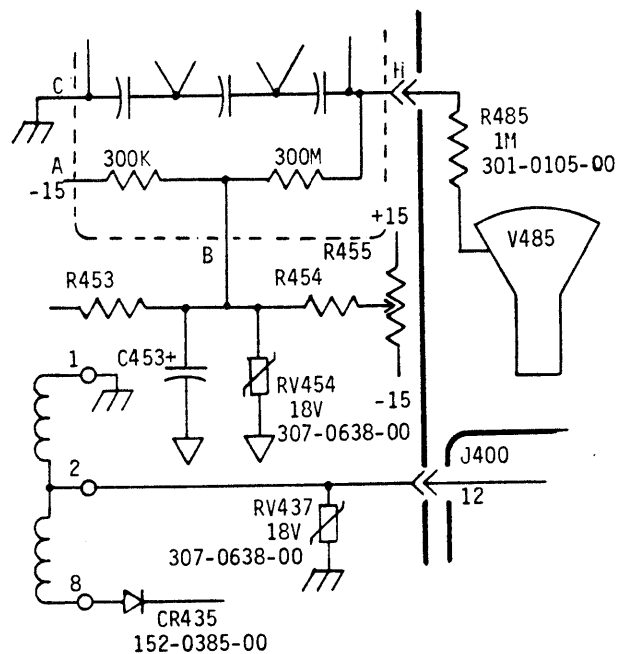
Metal oxide varistors RV437 and RV454 are added to the back of the boards as well. They limit voltage spikes caused by arcing (see figure 7).

Figure 7: R435, CR435, VR437 & VR454 affected on high voltage board.

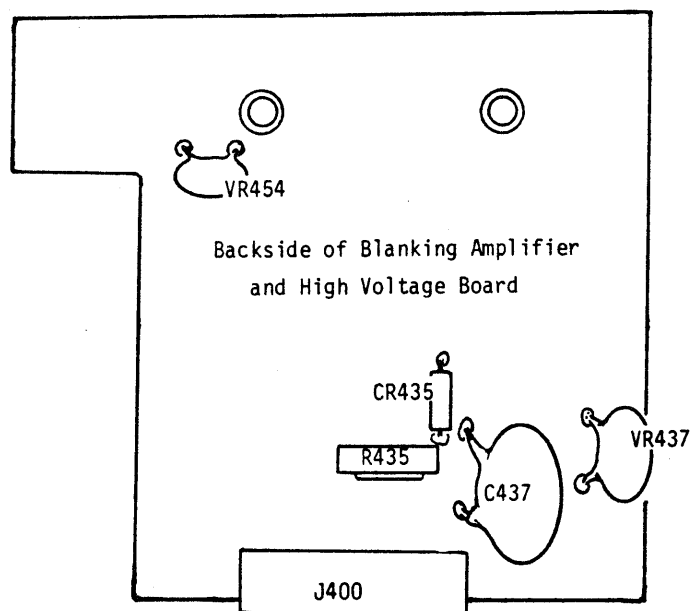
Figure 8: Locations of RV437 & RV454

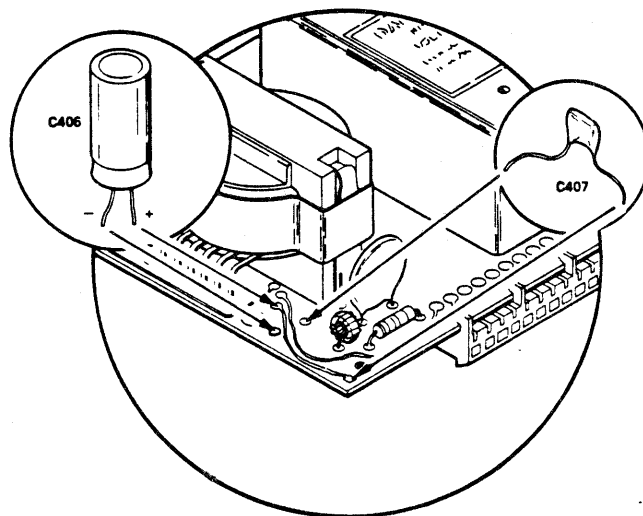
The value of C406 is increased for better decoupling of the +20 volt supply line and to better withstand the high surge current. However, the large size of C406 requires that the positioning of C406 & C407 be changed as shown in figure 9. The correct value for C406 is 180 μ f @ 40V. Please note this correction to the 045-0015-00 kit instructions.

Figure 9: Repositioning of C406 & C407

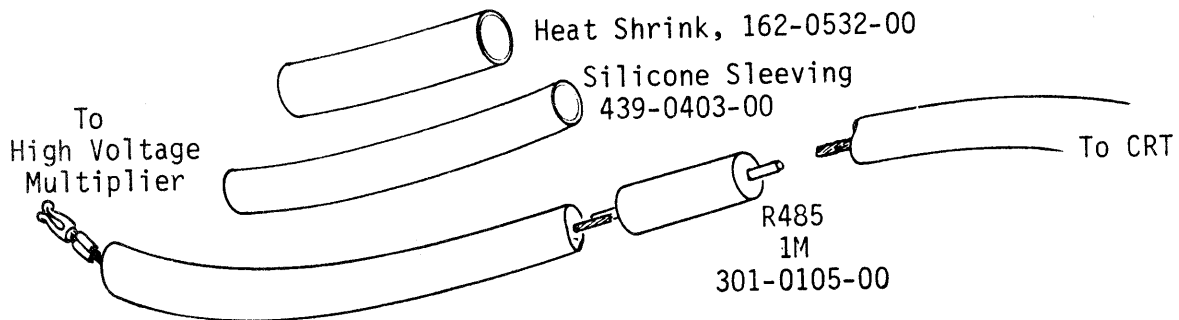
Figure 10: Installing R485 into the CRT anode lead

For a time, R485 was being installed on the CRT beneath the metal foil shielding. These CRTs were identifiable by a red mark painted onto the very end of the lead where it plugs into the multiplier. This practice was discontinued as the lead's strength at the R485 joint was impaired.

First, the CRT anode lead is cut three and one half inches from the end that plugs into the high voltage multiplier, then the cut ends are stripped of $\frac{1}{4}$ " of insulation. Next, the one megohm resistor (P/N 301-0105-00) is soldered onto the free wire (the part that attaches to the high voltage multiplier). A dab of silicone rubber sealant (P/N 006-1171-00) is put around the solder joint to prevent contamination or leakage. Now, a three inch section of silicone sleeving is dressed over the resistor and lead leaving the unsoldered end of the resistor protruding beyond the sleeving. This end of R485 is then soldered to the remaining part of the CRT anode lead. Another dab of silicone rubber sealant is applied and the sleeving is centered over the resistor. Finally, a two inch piece of heat shrink tubing (P/N 162-0532-00) is centered over the sleeve and shrunk into place to prevent the sleeve from sliding off.

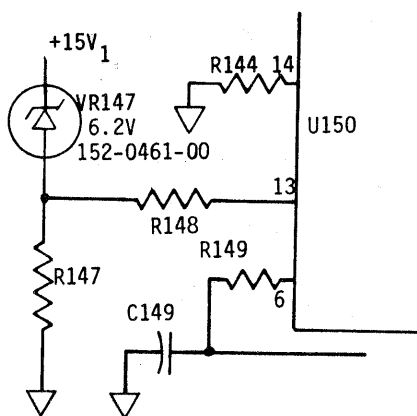
The two interface circuit boards share some changes. On both boards, VR147 is replaced by a zener diode with better thermal characteristics. This improves display intensity stability when temperature changes (see figure 1). Both boards also have metal oxide varistors RV72, RV73 and RV92 added to limit power supply fluctuations in the event of a high voltage arc (see figure 2). Varistor RV92 is connected between pins 1 and 3 of J500. Varistors RV72 and RV73 are soldered in parallel across C72 and C73 respectively.

Figure 1: VR147 has been changed to improve brightness stability.

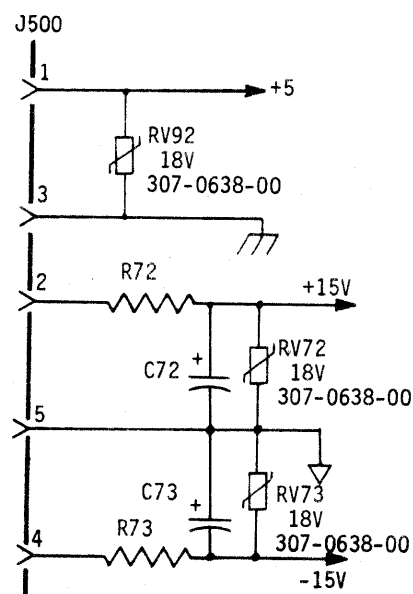
Figure 2: RV72, RV73 & RV92 are added to minimize supply variations if CRT arcs.

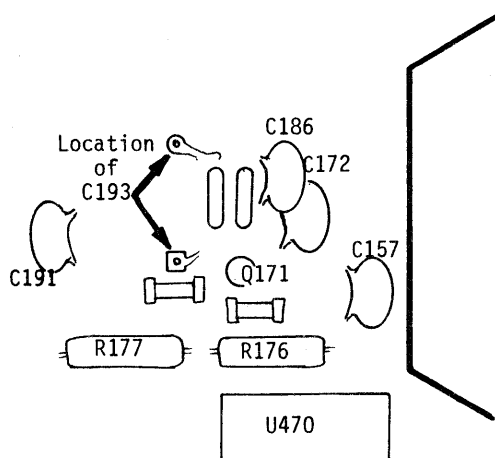
The standard interface, A6, also has C193 added to the video output amplifier. This reduces the 45 kHz component in the -100 volt power supply. Pads and runs for the inclusion of C193 already exist on the A6 layout next to R188. Their location is shown in figure 3.

Figure 3: Location of C193 pads on A6 video board.

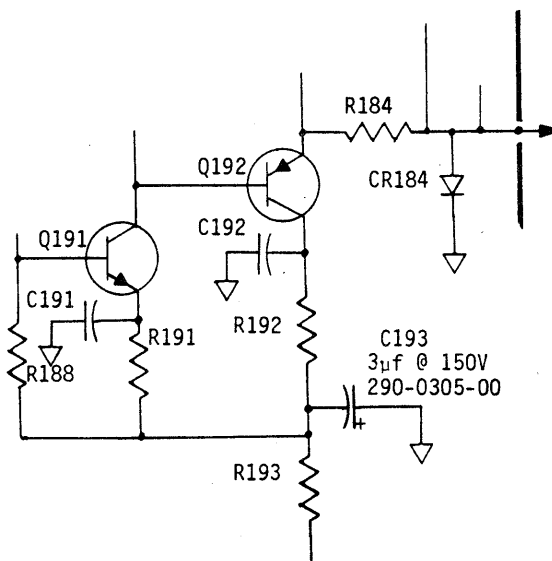
Figure 4: Partial schematic showing addition of C193 to A6 board.

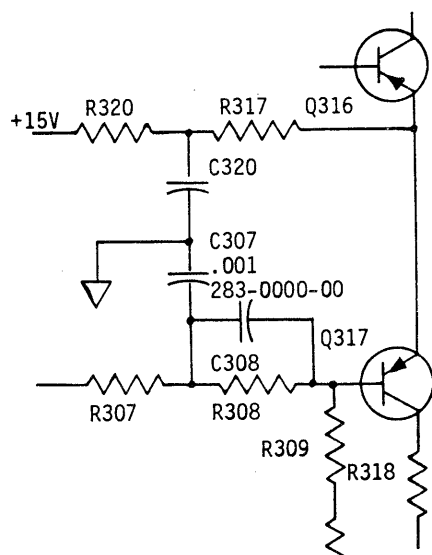
The ripple in the vertical driver has been reduced by adding capacitor C307 to the base circuit of Q317 and by rerouting one lead of C320. One lead of C307 is soldered to the node at R307, R308 and C308. The grounded lead of C320 is then lifted from its "dirty" ground and soldered to the unattached lead of C307. This remaining long lead is then dressed with sleeving and soldered to the "clean" ground at the anode of CR322 (see figure 5). Please note that mention of rerouting C320 was inadvertently omitted from the 045-0015-00 kit instructions.

Figure 5: Rerouting of C320 and addition of C307 to yoke driver boards.

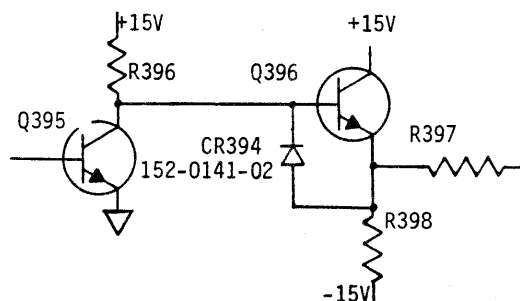
To prevent damage to Q396 in the retrace blanking circuitry, CR394 is added to the back of the boards between the base and emitter of Q396 (see figure 6).

Figure 6: CR394 added to retrace blanking circuit.

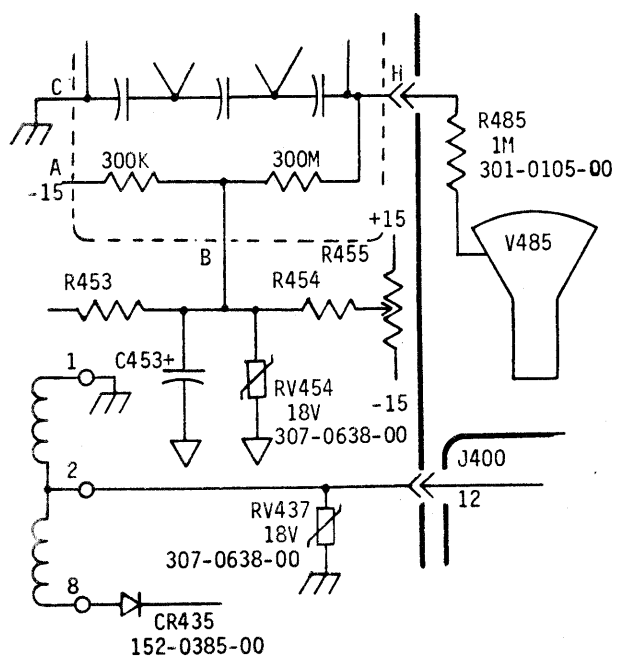
Metal oxide varistors RV437 and RV454 are added to the back of the boards as well. They limit voltage spikes caused by arcing (see figure 7).

Figure 7: R435, CR435, VR437 & VR454 affected on high voltage board.

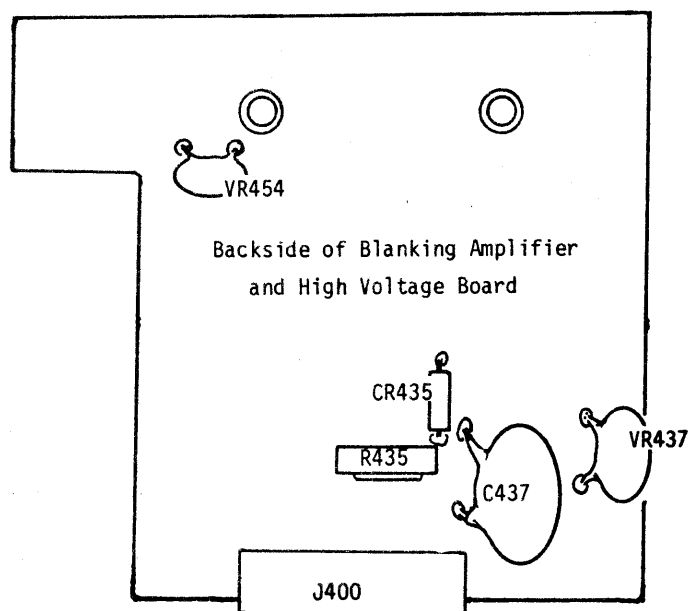
Figure 8: Locations of RV437 & RV454

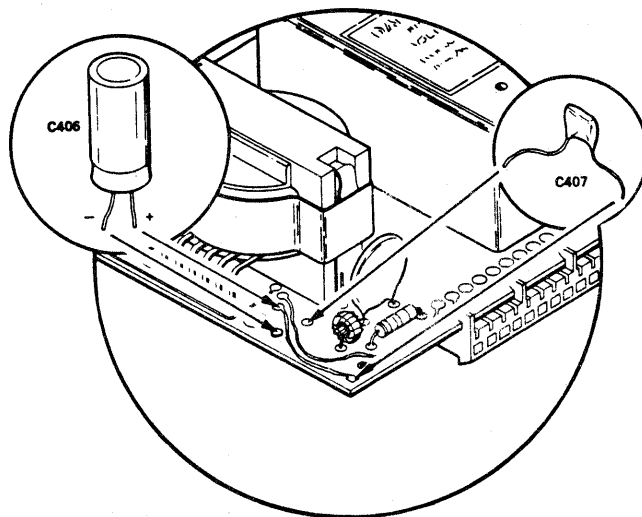
The value of C406 is increased for better decoupling of the +20 volt supply line and to better withstand the high surge current. However, the large size of C406 requires that the positioning of C406 & C407 be changed as shown in figure 9. The correct value for C406 is 180 μ f @ 40V. Please note this correction to the 045-0015-00 kit instructions.

Figure 9: Repositioning of C406 & C407

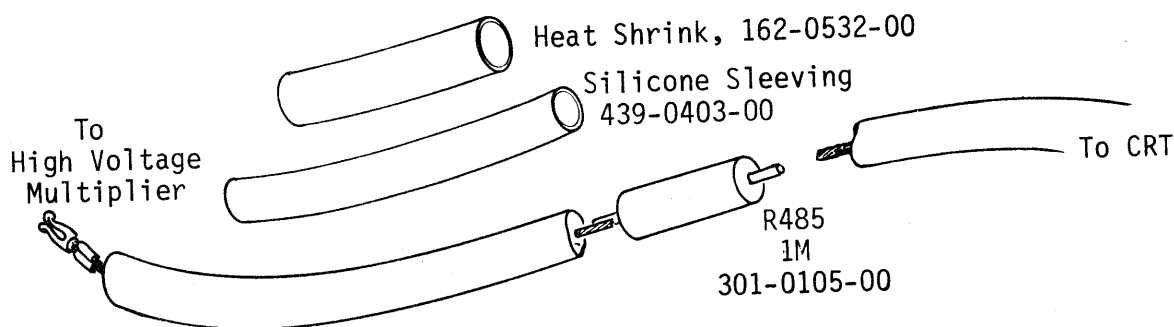
Figure 10: Installing R485 into the CRT anode lead

For a time, R485 was being installed on the CRT beneath the metal foil shielding. These CRTs were identifiable by a red mark painted onto the very end of the lead where it plugs into the multiplier. This practice was discontinued as the lead's strength at the R485 joint was impaired.

First, the CRT anode lead is cut three and one half inches from the end that plugs into the high voltage multiplier, then the cut ends are stripped of $\frac{1}{4}$ " of insulation. Next, the one megohm resistor (P/N 301-0105-00) is soldered onto the free wire (the part that attaches to the high voltage multiplier). A dab of silicone rubber sealant (P/N 006-1171-00) is put around the solder joint to prevent contamination or leakage. Now, a three inch section of silicone sleeving is dressed over the resistor and lead leaving the unsoldered end of the resistor protruding beyond the sleeving. This end of R485 is then soldered to the remaining part of the CRT anode lead. Another dab of silicone rubber sealant is applied and the sleeving is centered over the resistor. Finally, a two inch piece of heat shrink tubing (P/N 162-0532-00) is centered over the sleeve and shrunk into place to prevent the sleeve from sliding off.

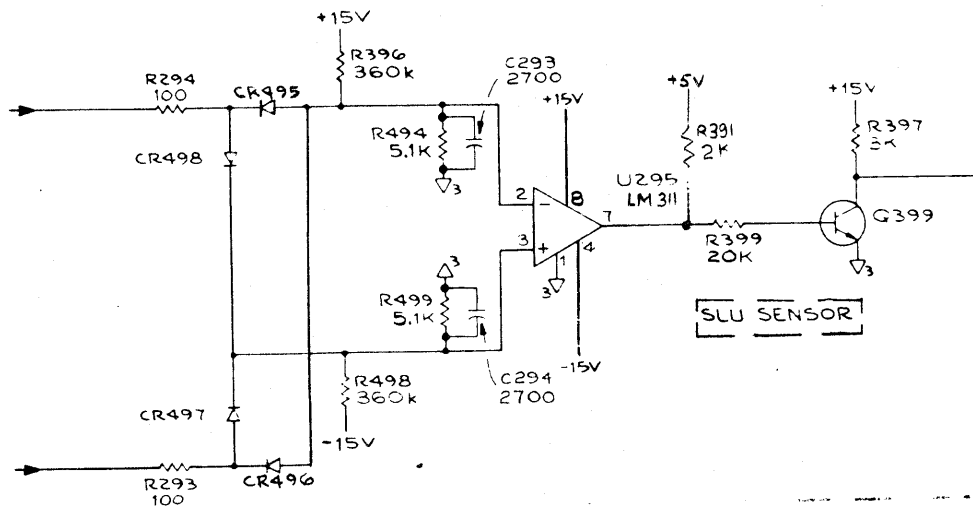
Figure 2 #M38624; Schematic 9-2 4054 Service Manual
Deflection Amp; SLU Sensor Circuitry

Modification #M39710 has been superseded and replaced by modification #M38624. Change #M38624 addresses both the -02 and -03 level Deflection Amp for both the 618 and 4054. This change is being implemented in both the 618 and the 4054 Deflection Amp and rolls both the -02 and -03 level boards to a -04 level board. There is a kit available which includes the instructions for the implementation of #M38624 and the kit number is 040-0977-00. In addition to correcting the refresh graphics break-up this new modification solves the insufficient resolution of the hard copy gain trim due to extreme range of the variable resistors. (Figure 2)

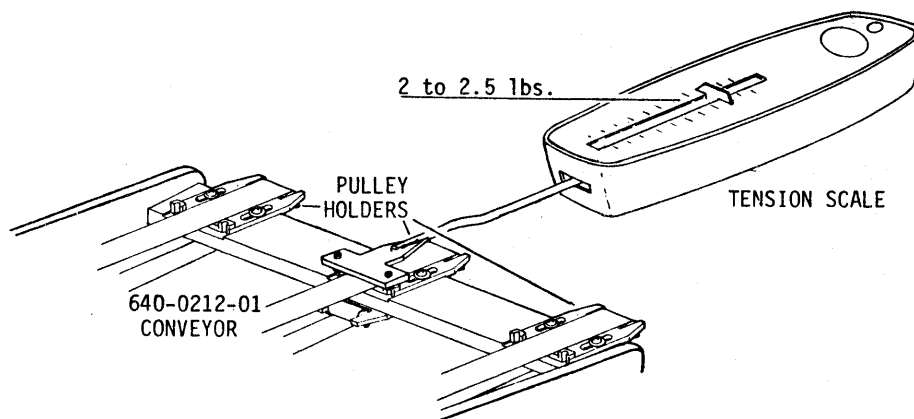
The 640-0212-00 conveyor assembly used in the 4633A and the 4634 has been prone to early belt failure and paper jamming.

- a. Loosen the two screws securing one of the holders.
 - b. Engage the tensioning scale with the holder as shown in the figure.
 - c. While pulling at a tension of 2 to 2.5 pounds, tighten the two bracket mounting screws.
 - d. Check that the belt rides the center of the rollers and does not rub against the sides.
 - e. Repeat for the remaining two holders.
- (continued)

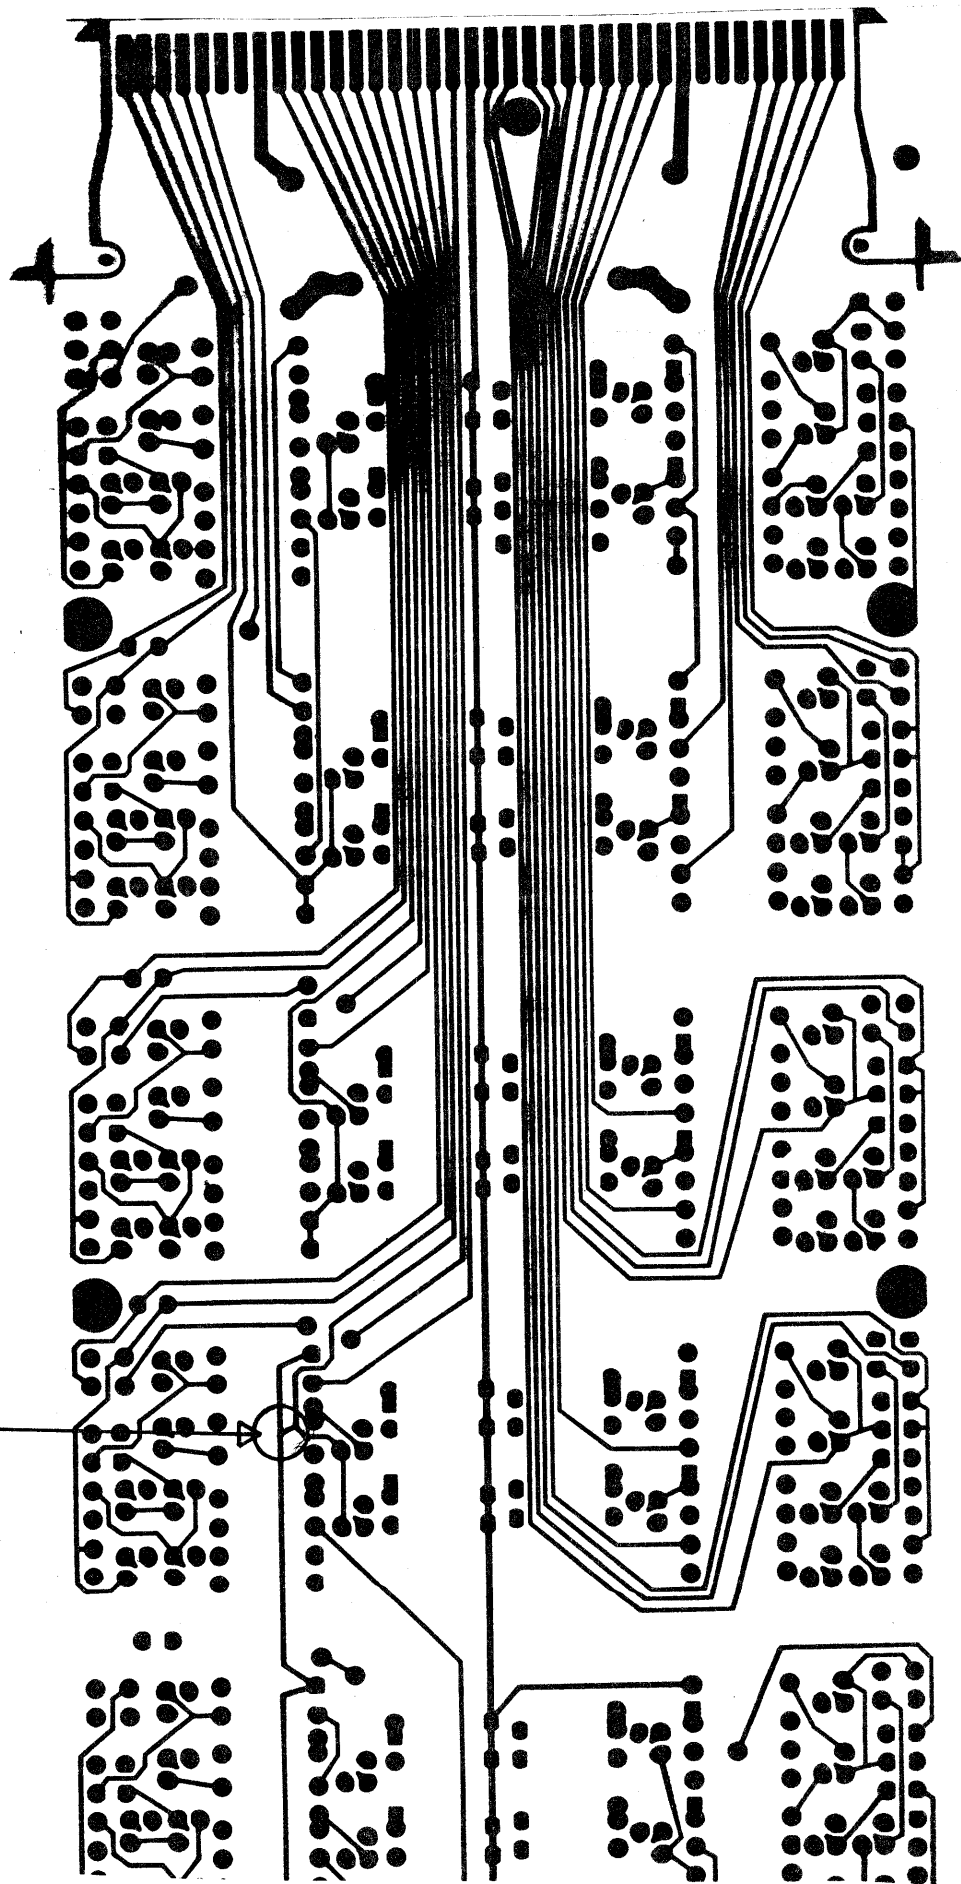
Some unprogrammed modules have been shipped which have a serious wiring error. This error may destroy channel 10 and the power source connected to channel 10. Inspect any 067-0919-99 Plug-ins in your area. Look for the board number. If it is PA6544-03 find the channel 10 area on the back of the board. Look for the run as shown in the diagram. Cut and remove the 2.5 mm error. The error was caused by a tape scrap.

REMOVE 2½ mm
