# SERVICETEKNOTES

## TABLE OF CONTENTS

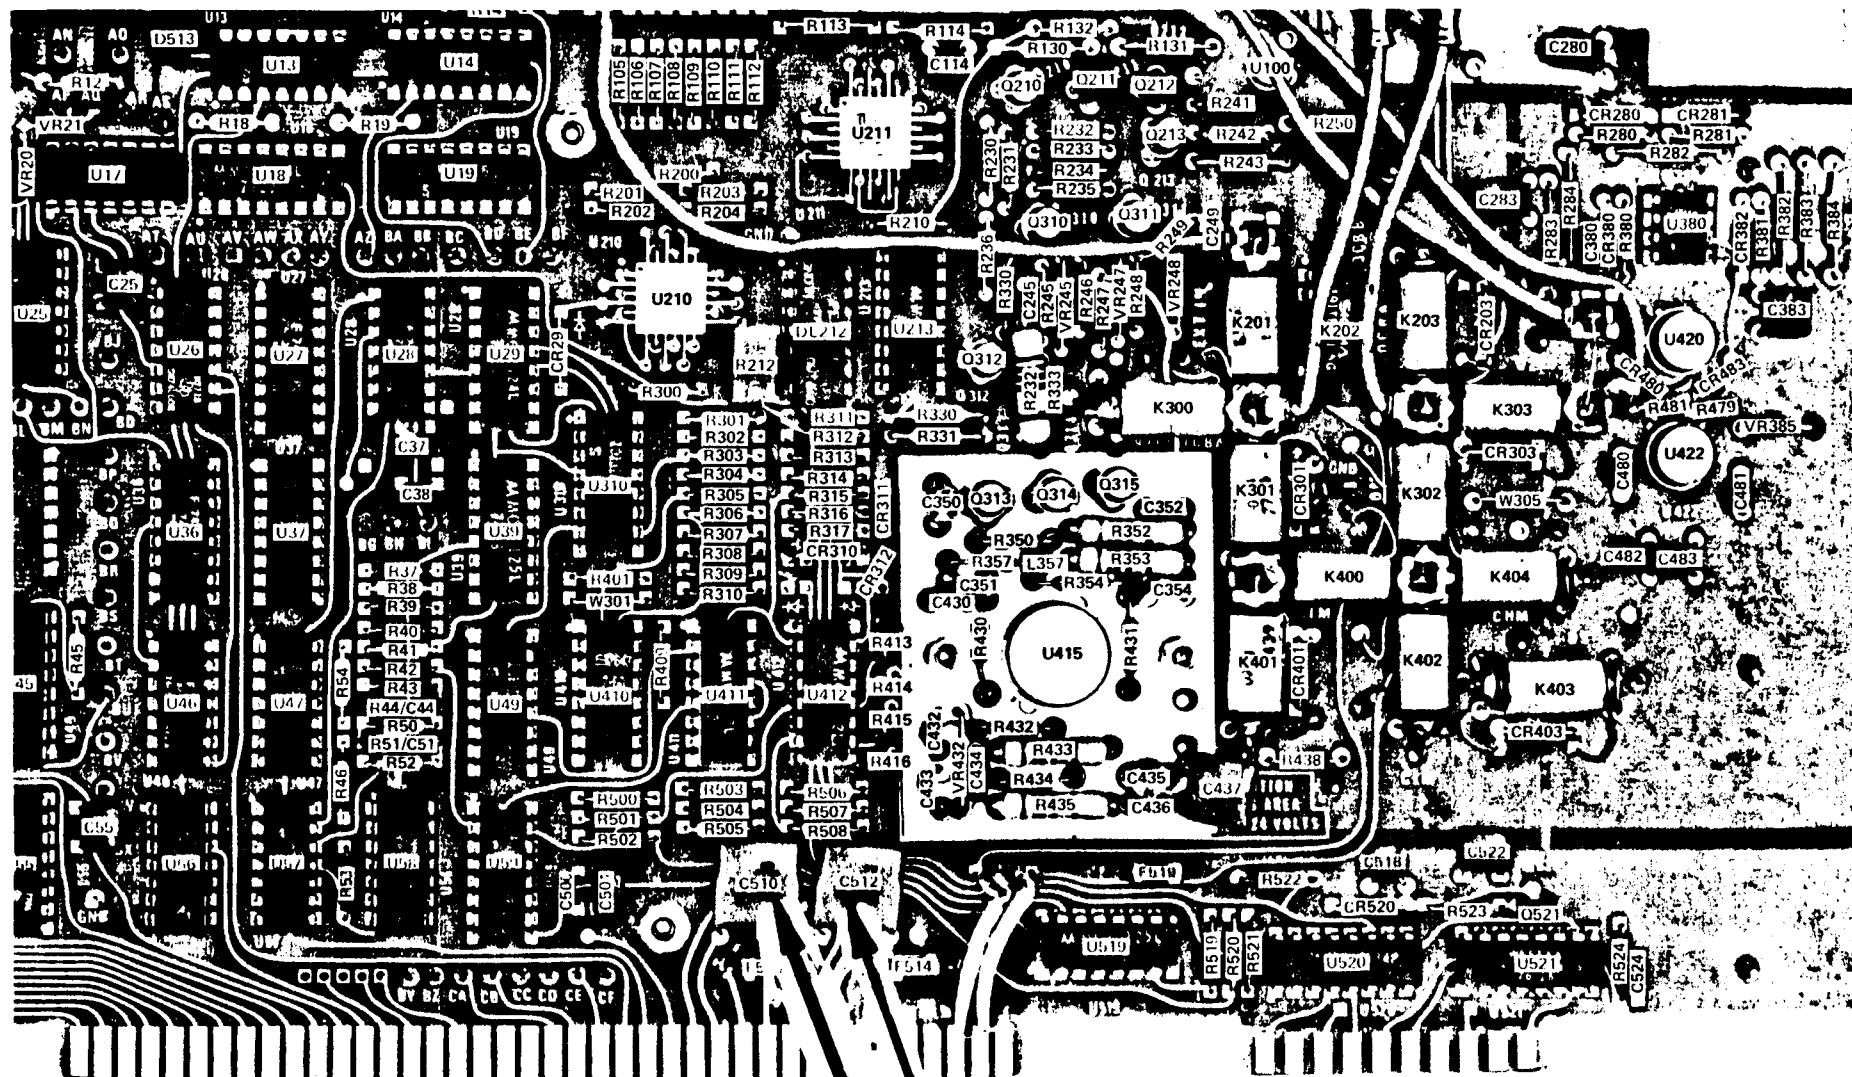
FIGURE 1

C510, C511, C512, and C513 with 4 each, Capacitor 0.22uf, 10%, 100V (285-1241-00). Replace 2 each, Capacitor 1uf, +80-20%, 25V (283-0177-03) located at C443 and C453 with 2 each, Capacitor 0.1uf, 20%, 50V (283-0111-00). The D70 Pin Electronics Card changes from 670-5347-03 to 670-5347-04. See Figures 1, 3, 4, and 6.

Backside of Circuit Board

C510 & C513

C511 & C512

C443 & C453  
Remove: 1.0uf(283-0177-03)  
Add: 0.1uf(283-0111-00)

Remove: 4.7uf(283-0194-00)

Add: 0.22uf(285-1241-00)

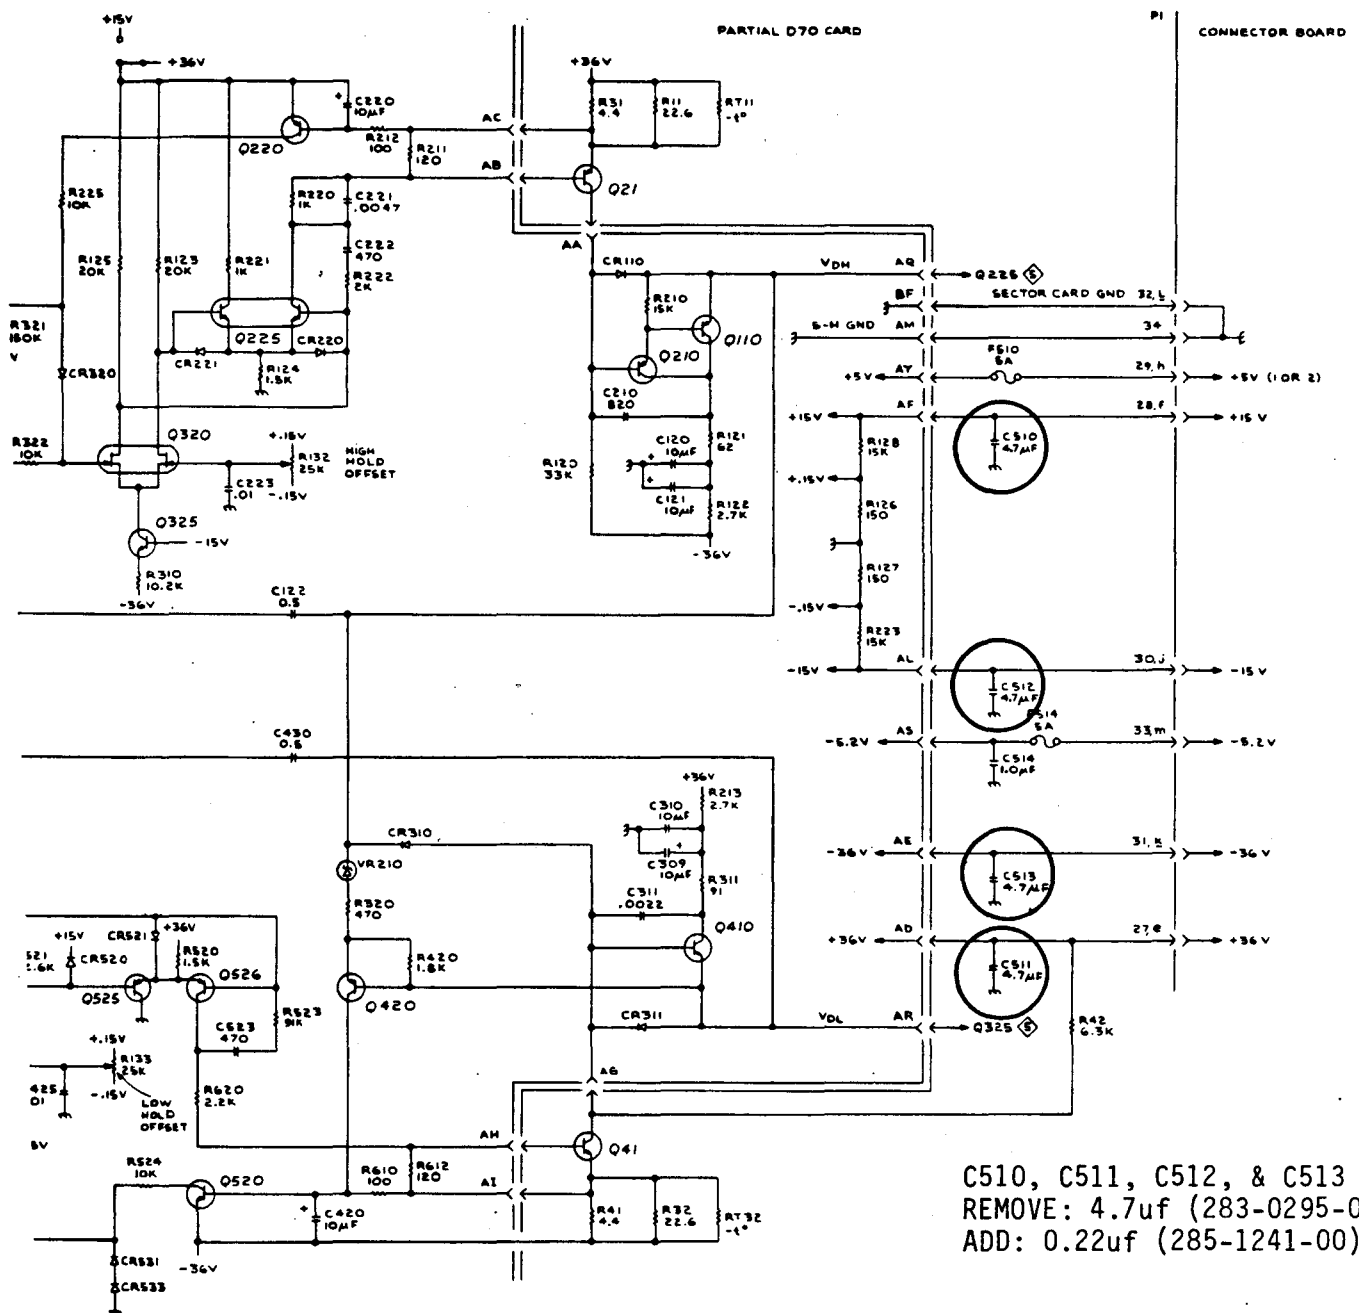
FIGURE 3

CAPACITOR LOCATIONS FOR D70 & D80 PIN CARDS

D70 & D80 BACKSIDE PIN ELECTRONICS CARDS

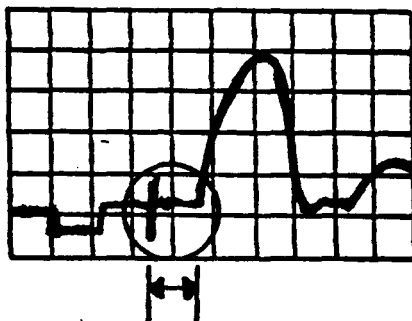
Figure 1

Mod Kit 050-1369-00 was designed to provide correction to horizontal deflection problems that were caused by unspecified turn off times of Q5030. Some of the effects of this defect are horizontal breakup and oscillations, an apparent heat sensitivity associated with T5090, and failures of Q5030.

As vendors for Q5030 have changed, and since there is no specification for the turn-off delay of Q5030, a problem has been discovered where installation of the mod kit will cause the circuit to malfunction, whereas the original values of L5085 and R5085 may be the appropriate values to use under certain conditions.

1.5 to 5 usec

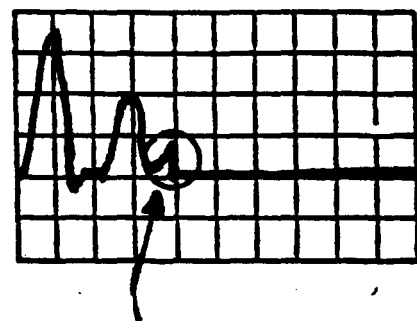
Figure 2 illustrates a waveform that may be seen with the mod kit installed. The extra overshoot noted in the figure is caused by the mod, and is a normal waveform to be expected. This does not affect performance of the circuit.

Area of interest

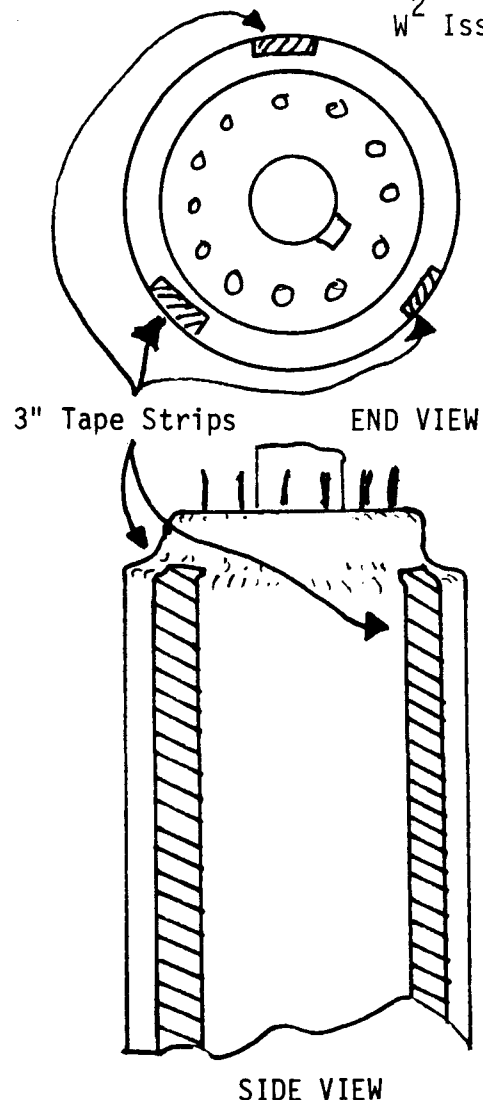
Some people have experienced difficulties with the tape on the CRT retaining clamp falling off during replacement. This will necessitate removing the clamp from the CRT shield to replace the tape, thereby adding unnecessary time to the repair function.

When replacing the CRT, install three (3) pieces of tape approximately 3" long laterally on the CRT neck, equidistant about the neck circumference. (See illustration). The tape is 006-3436-00 for a 9 foot roll.

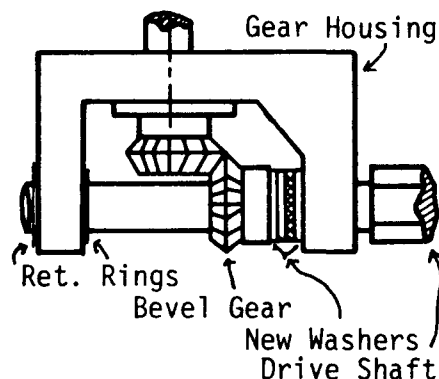
There is an 050-1555-00 kit that will improve the operation of the actuator arm that lifts the test head. On some test stations the drive shaft retainer (snap) rings have come loose causing the gears to misalign and making the actuator arm assembly (crank) inoperable.

The 050 kit replaces the drive shaft with a new drive shaft, P/N 384-1298-01. The new drive shaft has had two snap ring slots made deeper and has had the third retainer ring slot deleted. A combination of steel and brass washers are used to obtain proper gear alignment.

Typically, it takes three steel washers and one (or two) brass washers. The thrust washers remove the stress of cranking the table from the snap rings. The stress is now on the level gear, washers, and gear housing, thereby keeping the level gear aligned. (See figure on next page).

Periodic lubrication of the washers should be performed every six months.

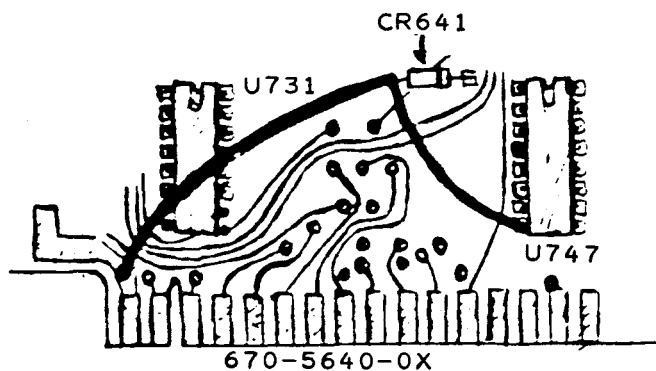
GROUND IMPROVEMENT

A sparkling effect, where vertical lines  
and horizontal scan lines jump back and  
forth may be observed on the screens of  
4027s and 4027As. This effect may be  
more noticeable on the "A" version than  
the non "A"s.

The cause of this phenomenon has been  
traced to noise on the Display Control  
boards, 670-5640-02 and below. The  
final fix will be a layout change to the  
ECB which will add a ground plane and a  
+5 volt plane. On the current boards  
there are only runs for these functions.

The manufacturing line has been hand ad-  
ding number 26 gauge wire in strategic  
points to better ground out the noise.  
This is not considered a modification  
because the ground runs are already  
there. Also the revision level of the  
board does not change.

The wire is added from Buss pin 72 to  
the anode of CR641 and to U747 pin 8 as  
shown in the drawing.
