SERVICETEKNOTES

TABLE OF CONTENTS

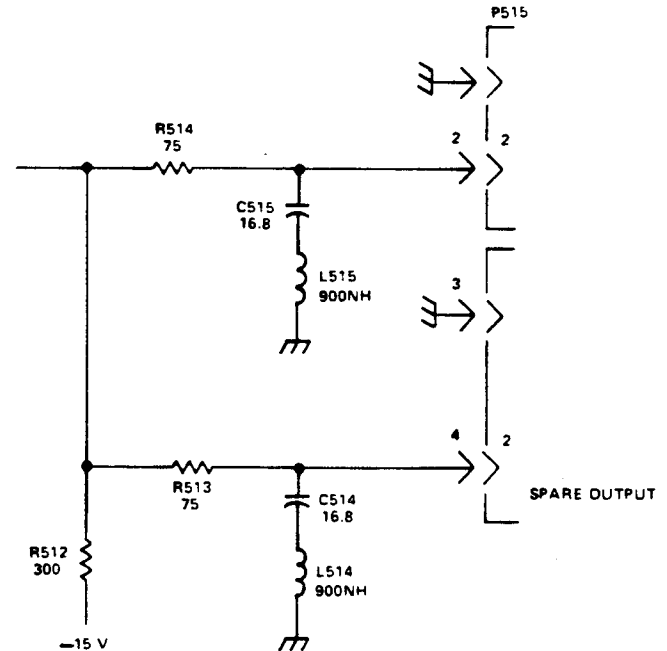
TSG 6/16/26 FREQUENCY RESPONSE & HARMONIC DISTORTION PROBLEMS

In order to provide a more predictable flat frequency response, and to eliminate some high order harmonics, Mod 56813 has made the following changes:

- o Q508 was changed from 151-0410-00 to 151-0220-03

- o L514 (P/N 108-0683-00) was added, "teepee" fashion, in series with C514
- o L515 (P/N 108-0683-00) was added, "teepee" fashion, in series with C515.

The schematic below illustrates the circuit changes.

The parts required to implement this mod are available as a kit, P/N 050-2056-00, and should be installed upon failures of Q508 or Q352, or upon receipt of customer complaints concerning frequency response or the presence of excessive high order harmonics.

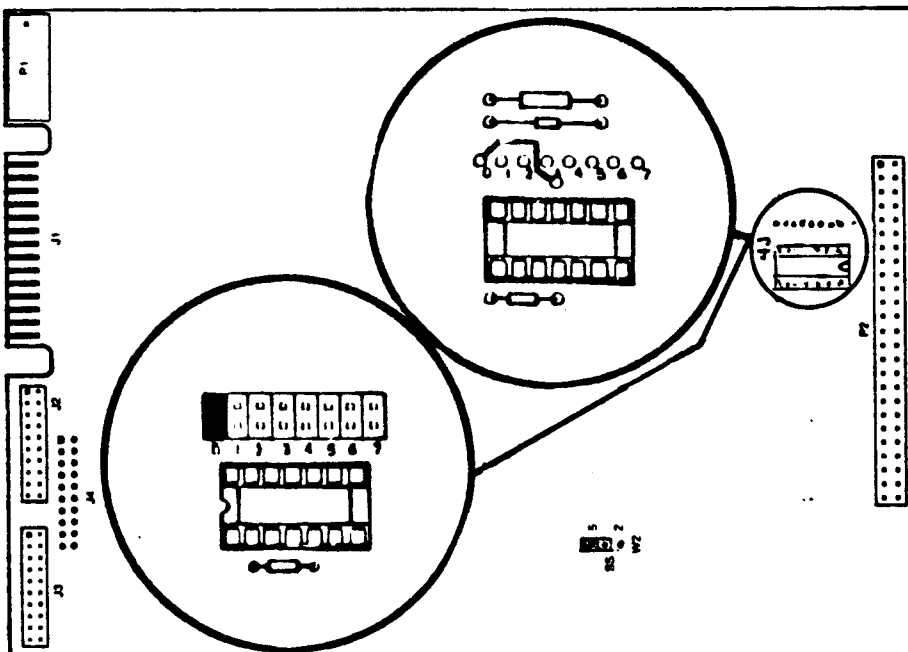
Figure 1

The 670-8437-00 rolled to -01 when the wire jumper at board location 4J, to select a device address, changed to a double row of pins and a moveable jumper, see figure 1. Xebec rolled the board assembly number from 104526 to

104527 when they began to install the double row pins. Two other significant changes done by Xebec, when the board assembly number rolled, where straps W1 and W2 (which are not used by the field) where omitted and strap W3 got renomenclated to W2.

Sector size should be set for 512 bytes, strap W2 (on the 104526) or W2(on th- 104527) should be set at 5, as shown in Figure 1.

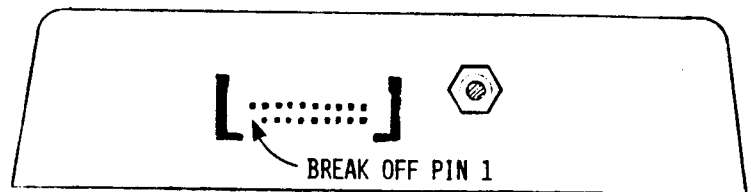
T.V. Pattern Generator Connector

The ribbon cable from the T.V. Pattern Generator is polarized at the 4692 end to prevent reversal. Unfortunately we failed to polarize it at the other end and it can still be reversed, which typically blows two axial lead fuses, F851 and F855 (P/N 159-0090-00), on the 4692 Drive Module.

To prevent this occurrence, you can easily polarize the plug at the test fixture end. Use a needle-nose pliers to "wobble" and break off pin 1 at the test fixture. Insert a plug, P/N 134-0153-00, into pin 1 on the ribbon cable (it is marked with an arrow and is on the red stripe side). See the figure below.
