# Wizards Workshop

TEKTRONIX INTERNAL USE ONLY

June 13, 1980  
Issue 10-12

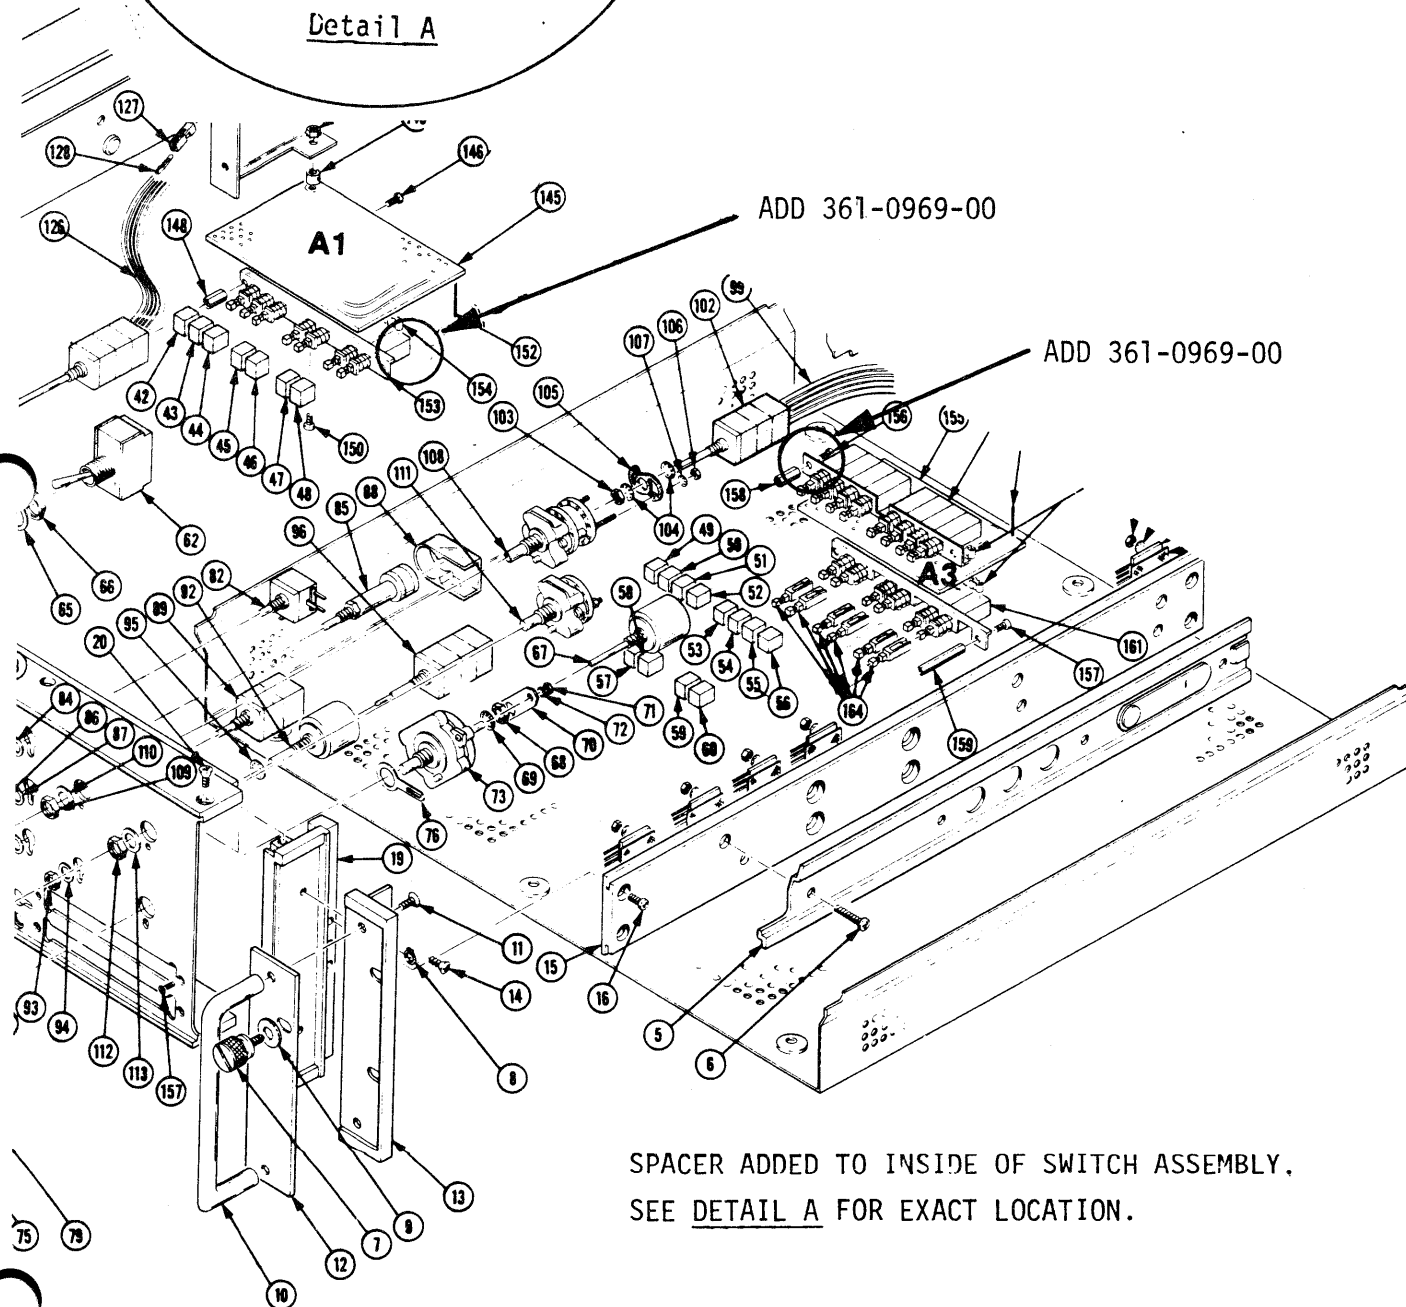
1480R

Some months ago the vendor for the pushbutton switches (P/N 260-1674-00/01, 260-1675-00/01 and 260-1676-00/01) changed the design of the switch. Now the latch spring bar movement is restricted by the head of the mounting screw. To prevent this a spacer (P/N 361-0969-00) was added to the instrument and the screw type changed from P/N 211-0262-00 to 211-0232-00. The spacer is added to the inside (nearest CRT) edge of the switch assembly. When replacing a switch assembly, the vertical switch circuit board (670-3486-00) or the horizontal switch circuit board (670-3489-00) this spacer must be added and the screw type changed. The addition of a small solder lug (P/N 210-0261-00) placed as shown in the following drawings also helps prevent the screw from tilting the spacer and provides additional clearance. A modification is in process to eliminate the need for this spacer. That information will be provided when available. A manual change request has been generated to update mechanical parts lists.

SPACER ADDED TO INSIDE OF SWITCH ASSEMBLY,  
SEE DETAIL A FOR EXACT LOCATION.

CHANGE (6) MOUNTING SCREWS FROM 211-0267-00  
TO 211-0232-00.

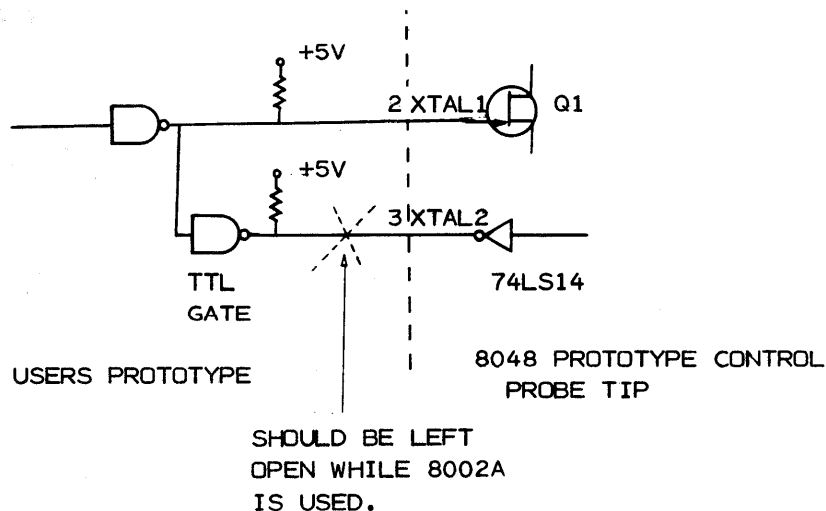
To provide the MCS 8048 with an external clock, Intel recommends driving both the XTAL 1 and XTAL 2 connections with TTL devices. The TTL devices provide the MCS 8048 with a clock and clock not signal to the XTAL 1 and XTAL 2 connections.

In this type of configuration the clock circuitry in the prototype control probe tip will not function properly. At this time the output of a 74LS14 on the prototype control probe tip is connected to the output of another TTL device on the user's prototype.

To avoid this problem, we recommend the user allow the MCS 8048 XTAL 2 connection (Pin 3) to float while the 8001 or 8002A microprocessor design lab is being used with the user's prototype. Once the design of the prototype is complete and the MCS 8048 is being used in the prototype the clock circuit may be configured as Intel recommends.

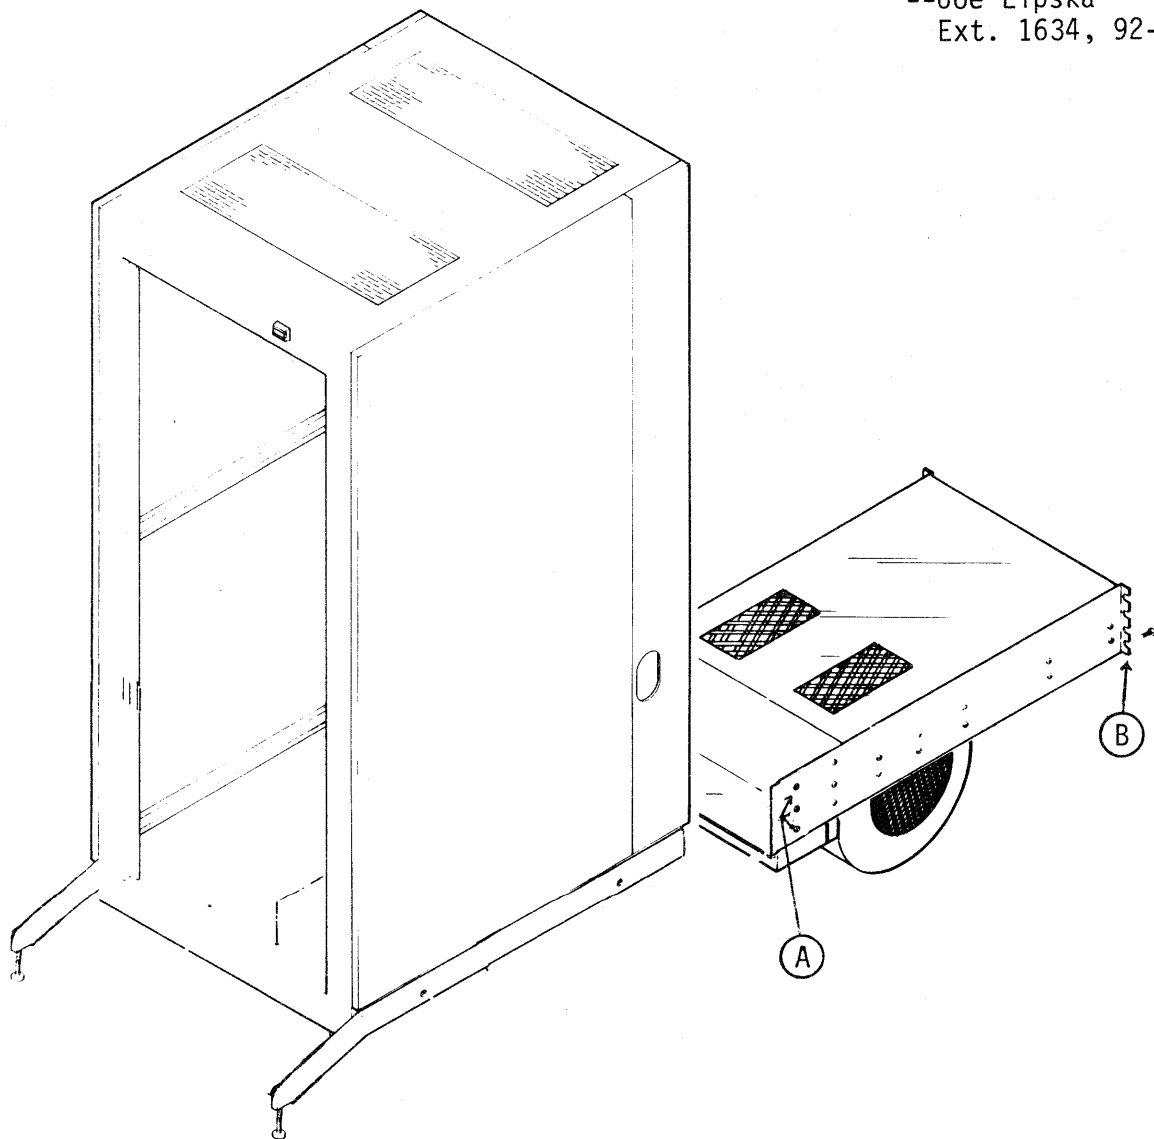
Cleaning of the intake and exhaust screens at least every six months is important. Cleaning of the exhaust screen can be difficult in systems that use the 'F' crate. Because there is no set procedure in cleaning the fans, the time it takes to clean them runs from thirty minutes to three hours.

The quickest and most thorough way to clean the blower is to remove the blower completely. By removing the screws shown at location A and B on each side, the blower assembly will be free. This should allow you to pull the fan assembly out for easy cleaning.
