SERVICETEKNOTES

Published by Tektronix Service Administrative Support,

May 1982, Issue 23

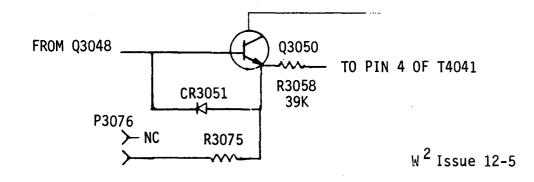
The above parts are located on A38 Optical Pulse Generator board and shown on Diagram 2 OPTICAL PULSE GENERATOR - Partial

CHANGE TO:

ADD:

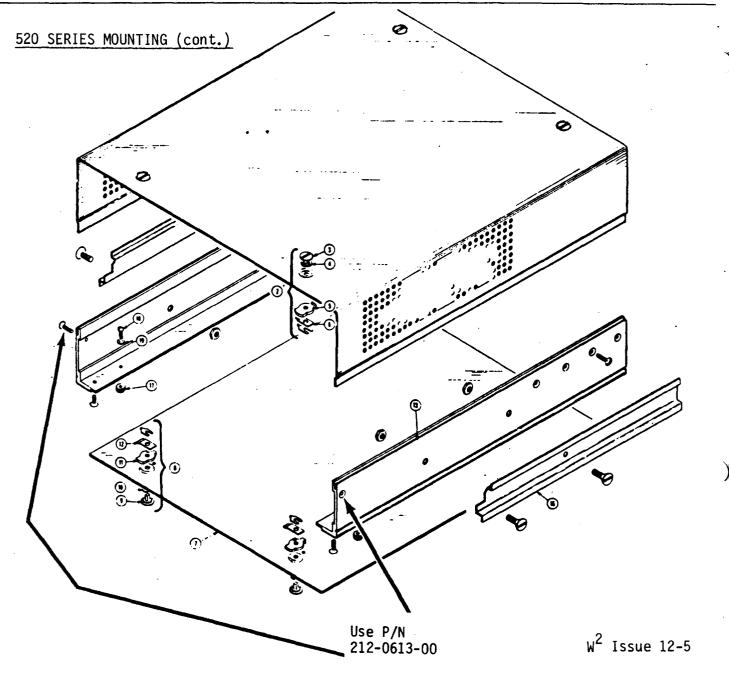
A screw of insufficient length has been used to fasten the side rails to the main chassis, causing stripped threads. Where a bad screw is found, replace with 212-0613-00 (see illustration).

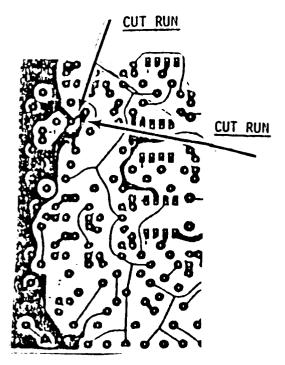
DECODER BOARD 670-2611-07

The Decoder Board (670-2611-07) has an ECB lavout error which shows up as a 400KHz ripple of about 200mV P-P riding on the R-Y output. The cause is one end of R2739 being shorted to ground. The suggested fix is to cut the ground plane surrounding the bottom pad of C2641 (See illustration).

INTERIUM SOLUTION

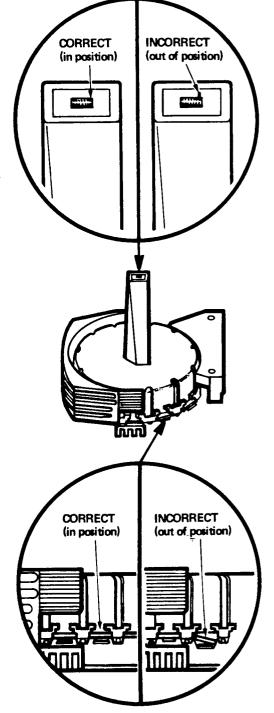
The metal plates that cause the printhead wires to move can be jarred out of position during handling or replacement.

solenoid plates out of position it will result in a damaged printhead.

Be sure to inspect printheads after product shipping or during printhead replacement. If a wire is protruding from the printhead, it indicates that the metal plate is lifted from its normal position. Be sure to reseat the metal plate back to its proper position. See illustration.
