Wizards Workshop

Published by Service Admin Support
56-037

February 20, 1981
Issue 11-3

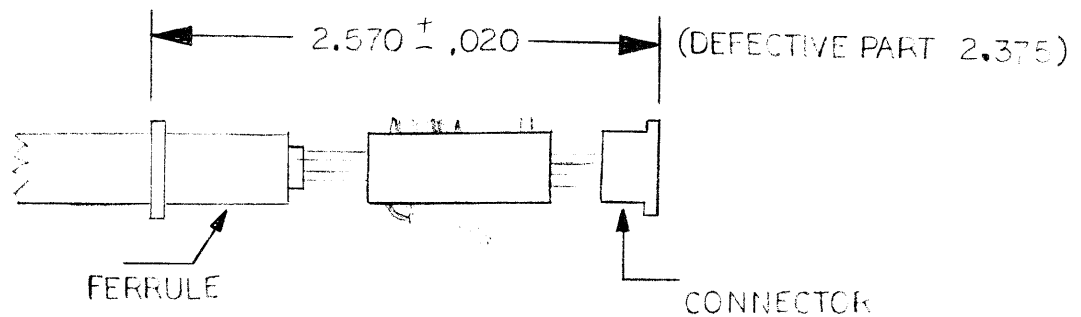
FIGURE 1

The P6042 probe cable, P/N 175-0431-01, is about 3/16" too short and cannot be plugged into the transformer, (see Figure 1). Since the cable cannot be lengthened, I suggest the present stock be checked and purged as necessary.

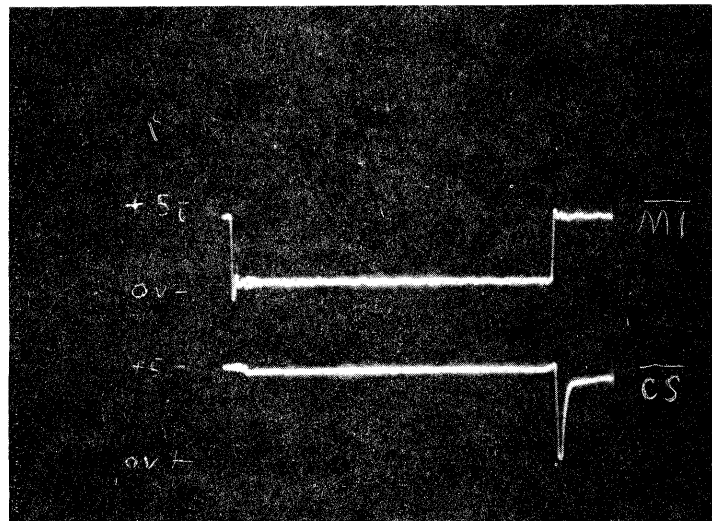
FIGURE 1

The symptoms can be seen while looping 30 to 50 times on the internal data test resident in ROM. If the instrument experiences chip-select glitches, loss of some character segments on the display will become apparent while running the data test.

The glitch can be seen with a dual trace oscilloscope such as a 475. Attach Channel #1 to U461 Pin 4 (\overline{MI}) and trigger on the falling edge. Select and run the internal data test. Run the test once and check for proper trigger. Next attach Channel #2 to U141 Pins 5, 6, or 7 (these are the chip-select lines for the ROMS). A glitch may occur on either the falling edge or rising edge of \overline{MI} . Pictured in Figure 1 is a gross example of a glitch at the trailing edge of \overline{MI} , indicating a problem. Any glitch exceeding .5 volt in magnitude should be considered a problem.

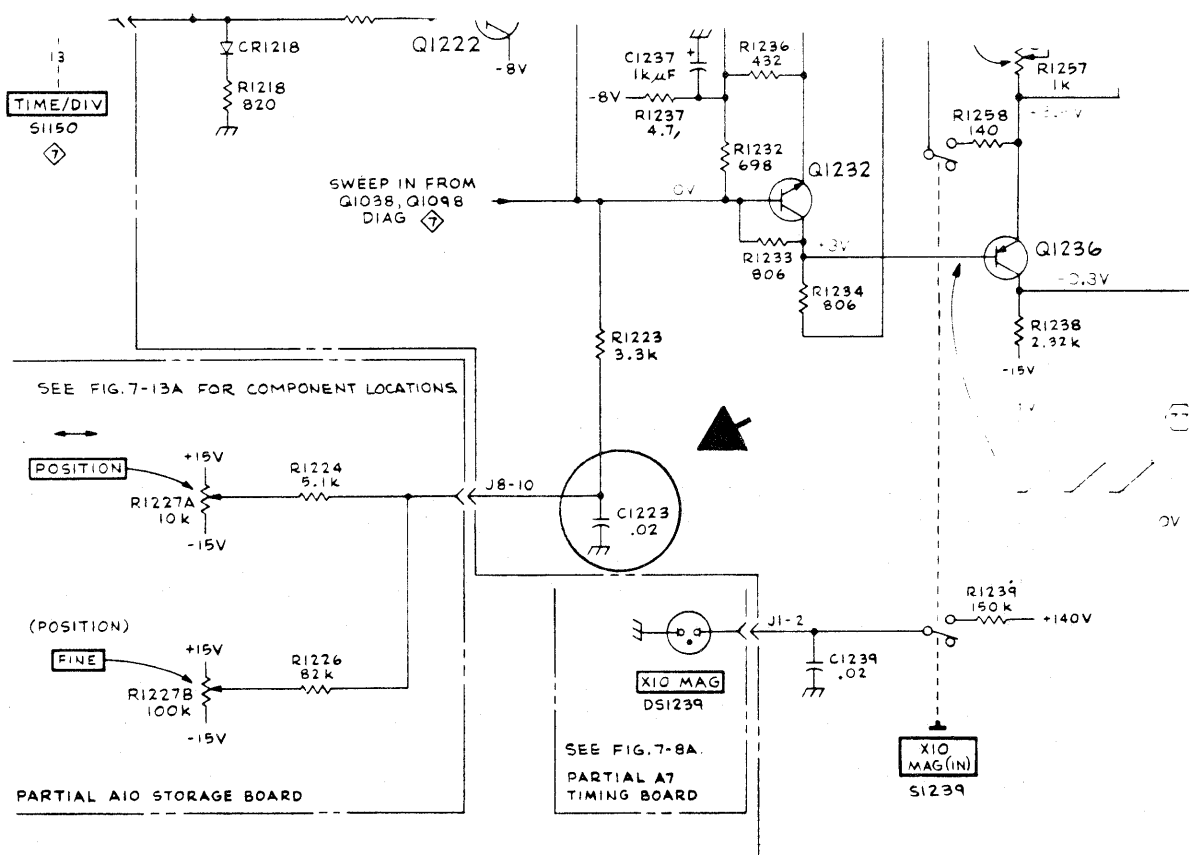
With the timing set for 50 μ sec/div X 10 magnification, the first 10 divisions of display may be out of specification. To bring the timing into specification, C1223 changes from a .02 μ f capacitor to a 2000PF, 500 volt capacitor, P/N 283-0104-00.
