WIZARDS WORKSHOP

TEKTRONIX INTERNAL USE ONLY

Published by Service Administration Support,
d.s. 56-037, ext. 642-8940

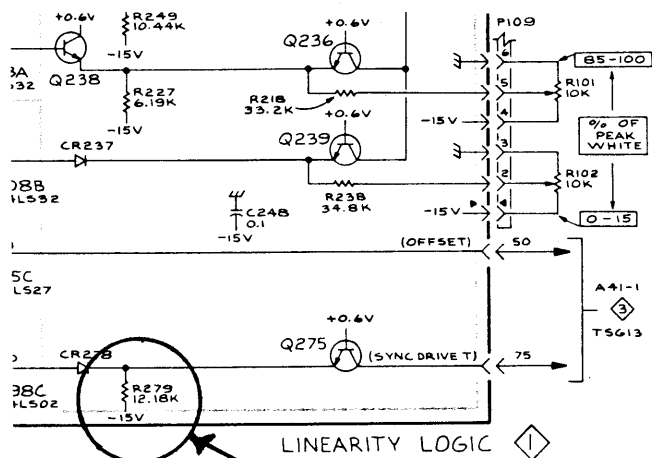
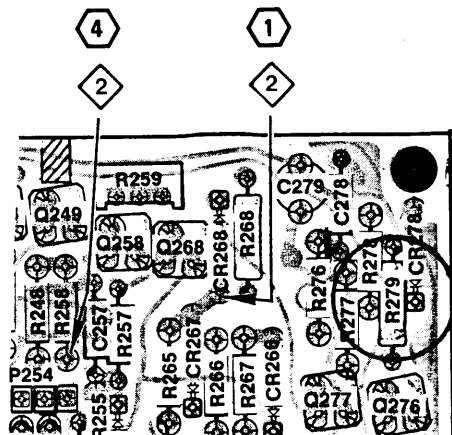
A possible problem has come to light
where the sync pulses are very close to
specified limits, creating the need to
adjust other amplitudes to slightly
out of position.

To correct this, change R279 from a 321-
1711-04 to a parallel combination of
two resistors, 321-1705-04 and 321-0147-
00. The new resistor added (321-0147-00)
is to be designated as R289.

Add: R279 321-1705-04
(13.05K)

R289 321-0147-00
(215K)

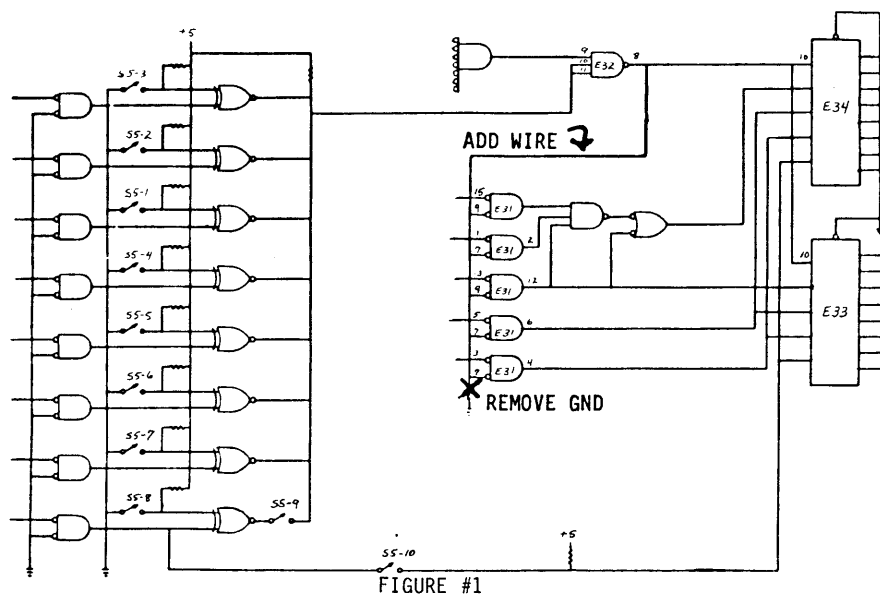
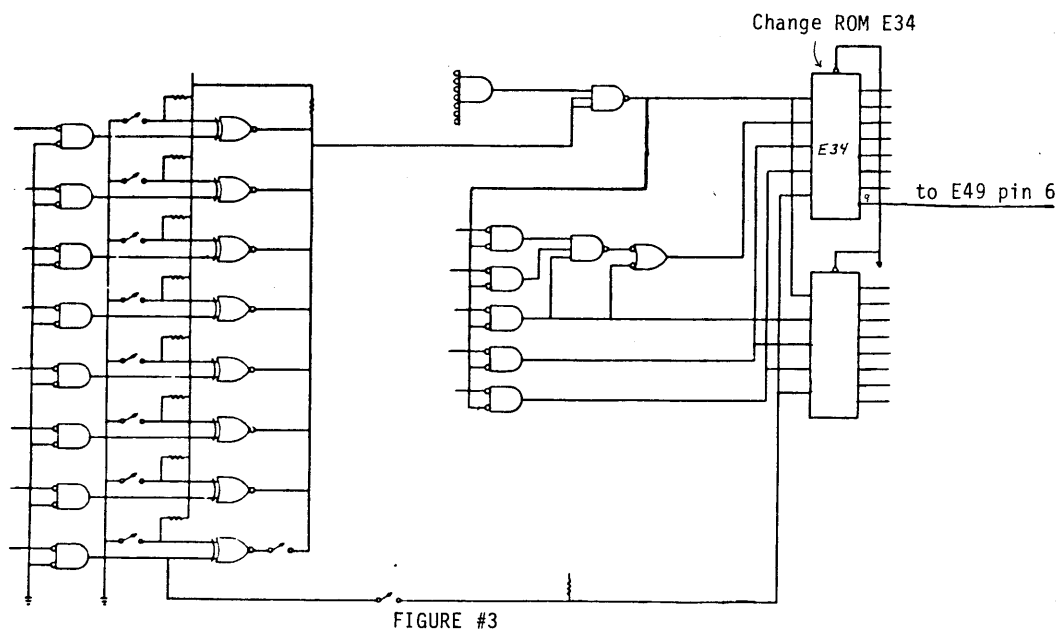
The address lines on the ROM change with the unibus address lines. This causes random spikes to appear on the output of the ROM. These spikes cause the INTR ENABLE (interrupt enable) bits in the DL11-W receiver control and status register (RCSRJ) and transmitter control and status register (XCSR) to clear. The spiking can also cause the DL11-W line time clock (LTC) to interrupt randomly. This will show up when INTFAC is run. The INTFAC error message will be "a bad interrupt happened." The modification disables the gates which feed the ROM.
