## WIZARD WORKSHOP ARTICLES

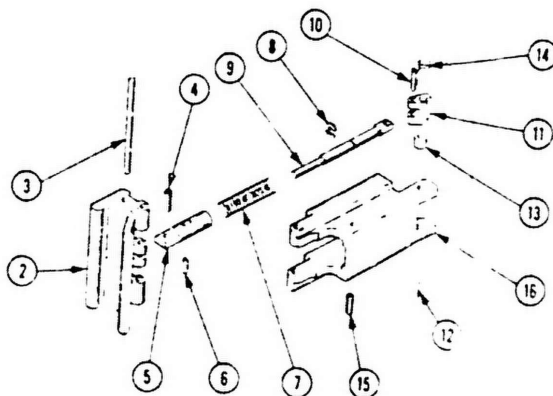
Manufacturing has pointed out a potential problem that can exist concerning the 1502-1503 front cover latch. Item 6, Fig. 1, (Pin-hollow) can break due to the pin being defective and fall out of the shaft. If this

happens and the cover latches are closed, they cannot be opened and the cover stays on the instrument.

The check you can perform to see if the pin is loose or broken is as follows:

1. Move the handle to the point where Item 6 (pin) does not rest against the back of Item 5 (guide shaft).
2. Bang the cover to jar the pin loose; if pin does not fall through - it's okay. If pin falls through, replace it with pin (214-1721-00). This is a longer pin and will not come out when latch is in closed position.

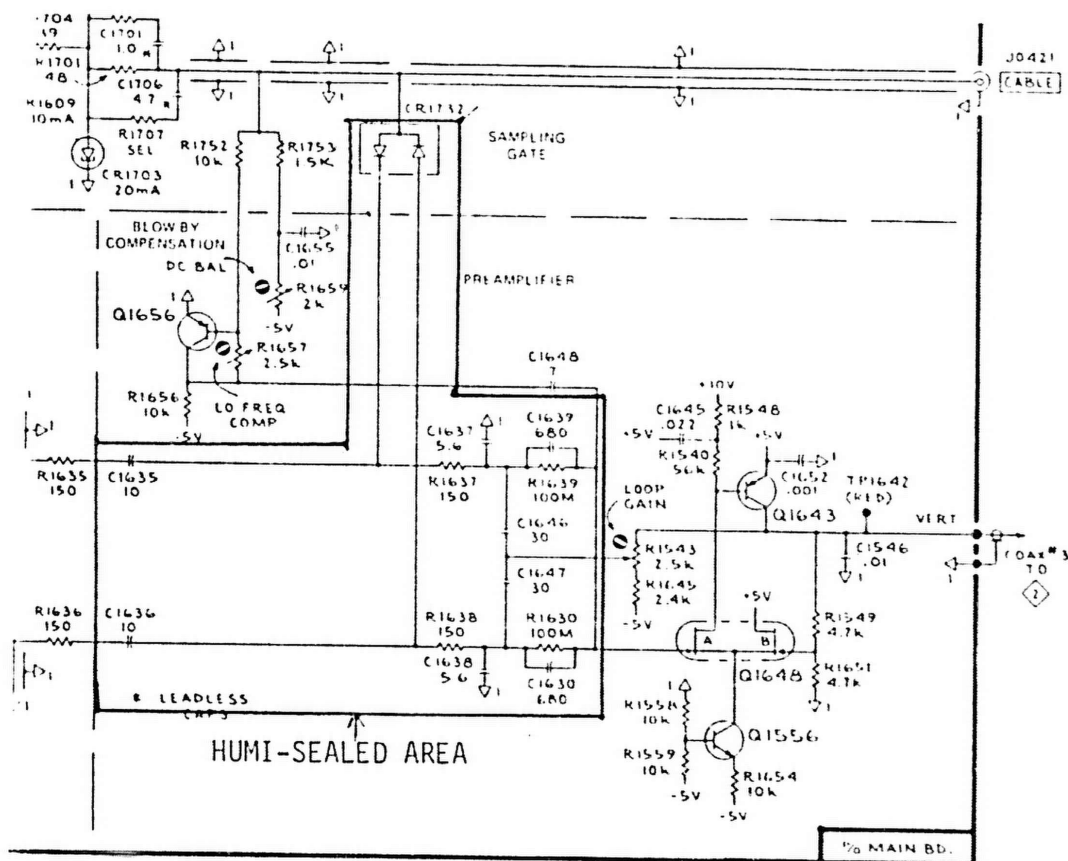
Pulser/Sampler 1A

To prevent humidity or moisture from degrading resistors or causing aberrations some parts are coated with humi-seal at the factory.

NOTE: Until humi-seal is dry (24 hours), do not make any measurements. The result appears as a leaky bridge, CR1732. (humi-seal part 006-1744-00.)

C1630	R1630
C1635	R1637
C1636	R1638
C1637	R1639
C1639	CR1732, Bridge
C1646	Also the FET (01648) base
C1647	on the solder side of the
C1648	board is sealed

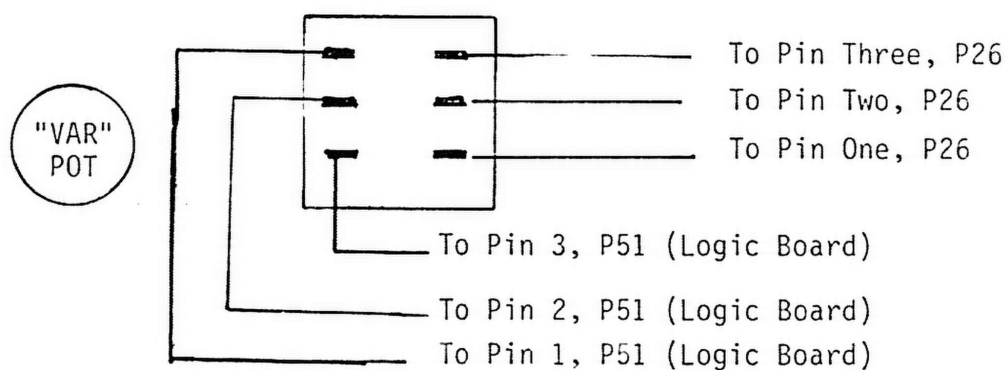
Camera Switch

Now that the dust has settled, further explanation is in order. The camera function has been deleted from the 1502 and 1503 due to low usage and a patent problem in Japan. The incorporation of this deletion has caused some misunderstanding and inconvenience. There are ~120 1502's and 220 1503's in which the function was deleted, but not the word "camera" from the front panel. Some have new front panels with "Camera", some have "Camera" covered with a sticky back tag.

7. Connect wire from pin one of P26 (marked with a small triangle) to lower unused pole of "Camera" switch.
8. Connect center wire (pin 2) of P26 to unused center pole of "camera" switch.
9. Connect remaining wire (from Pin 3 of P26) to remaining unused pole.
10. Turn on 1502-1503 and obtain a trace.  
Press and hold switch to "record". Check to see that dot remains stationary at left hand side of CRT until record switch is released.  
Press and hold switch to "camera". Adjust R3237 on OUTPUT AMP board for flooding of entire CRT. Trace should return to normal when camera switch is released.

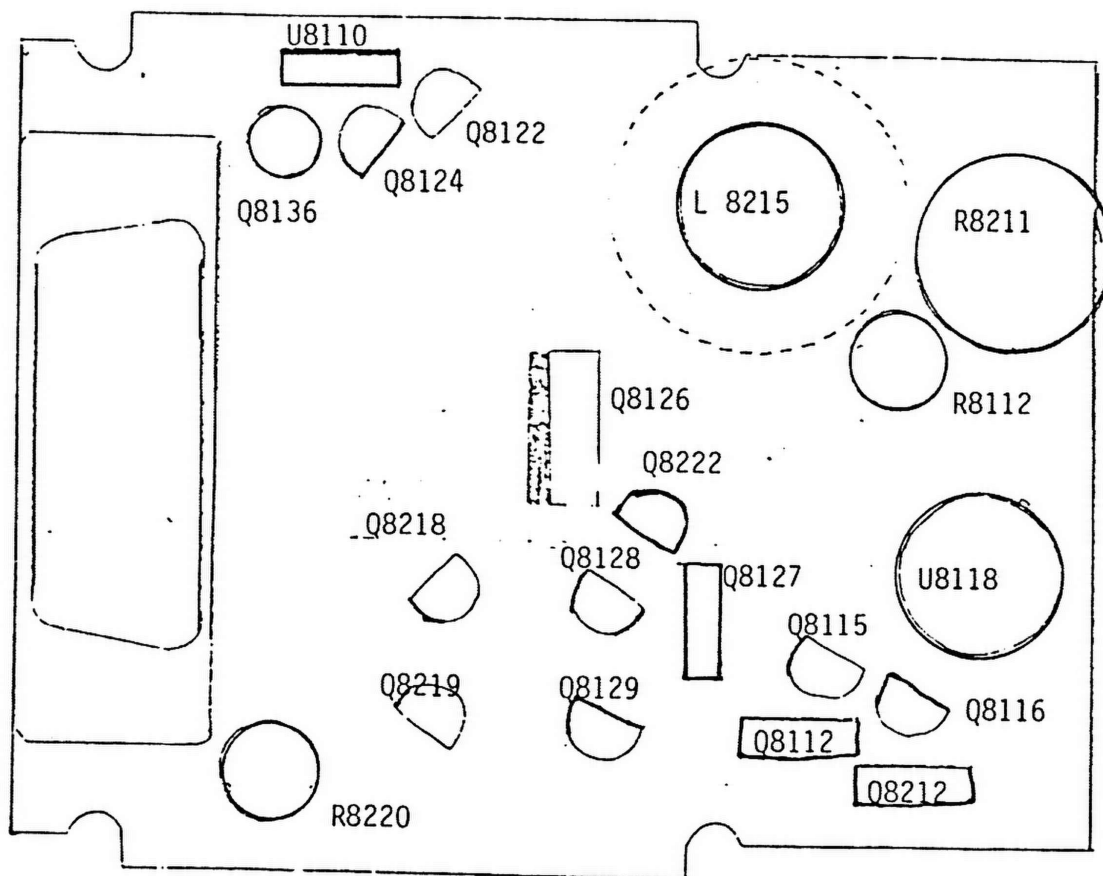
CHART RECORDER  
670-1742-04

The 1502 and 1503 chart recorder circuit board 670-1742-03 has been relayed out. It is now 670-1742-04. Following is the new semiconductor location. I recommend ordering a new manual.

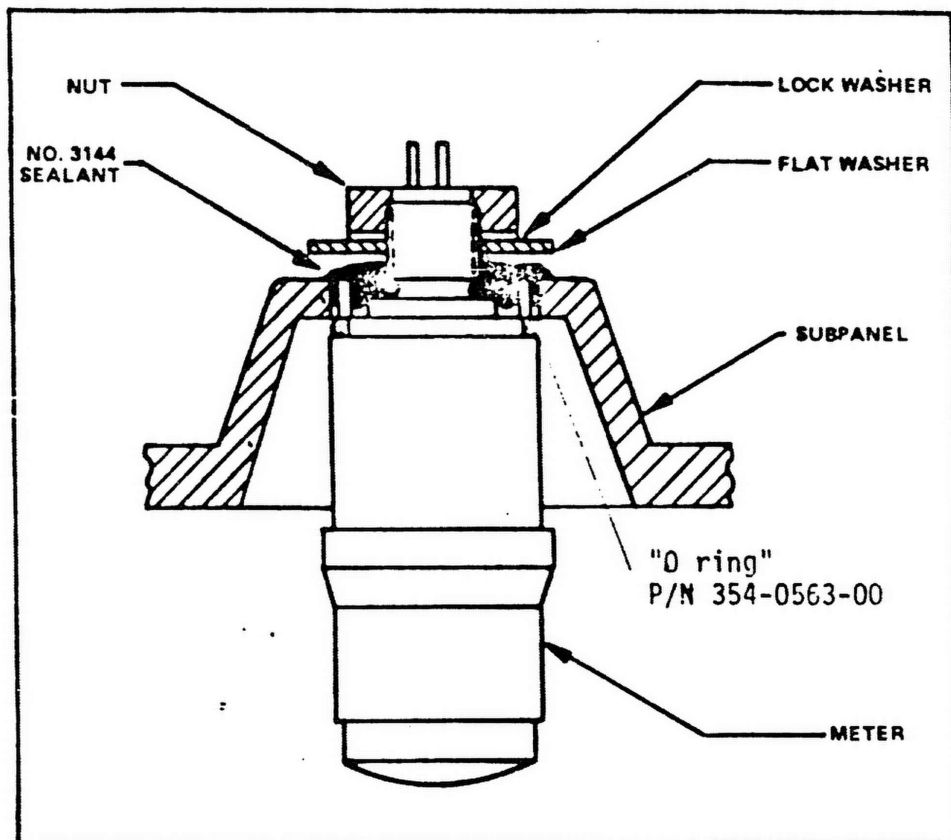
The sealing Ring between the subpanel and the Distance Meter was omitted from the 1502/1503 Sealing Manual. The part number is 354-0563-00.

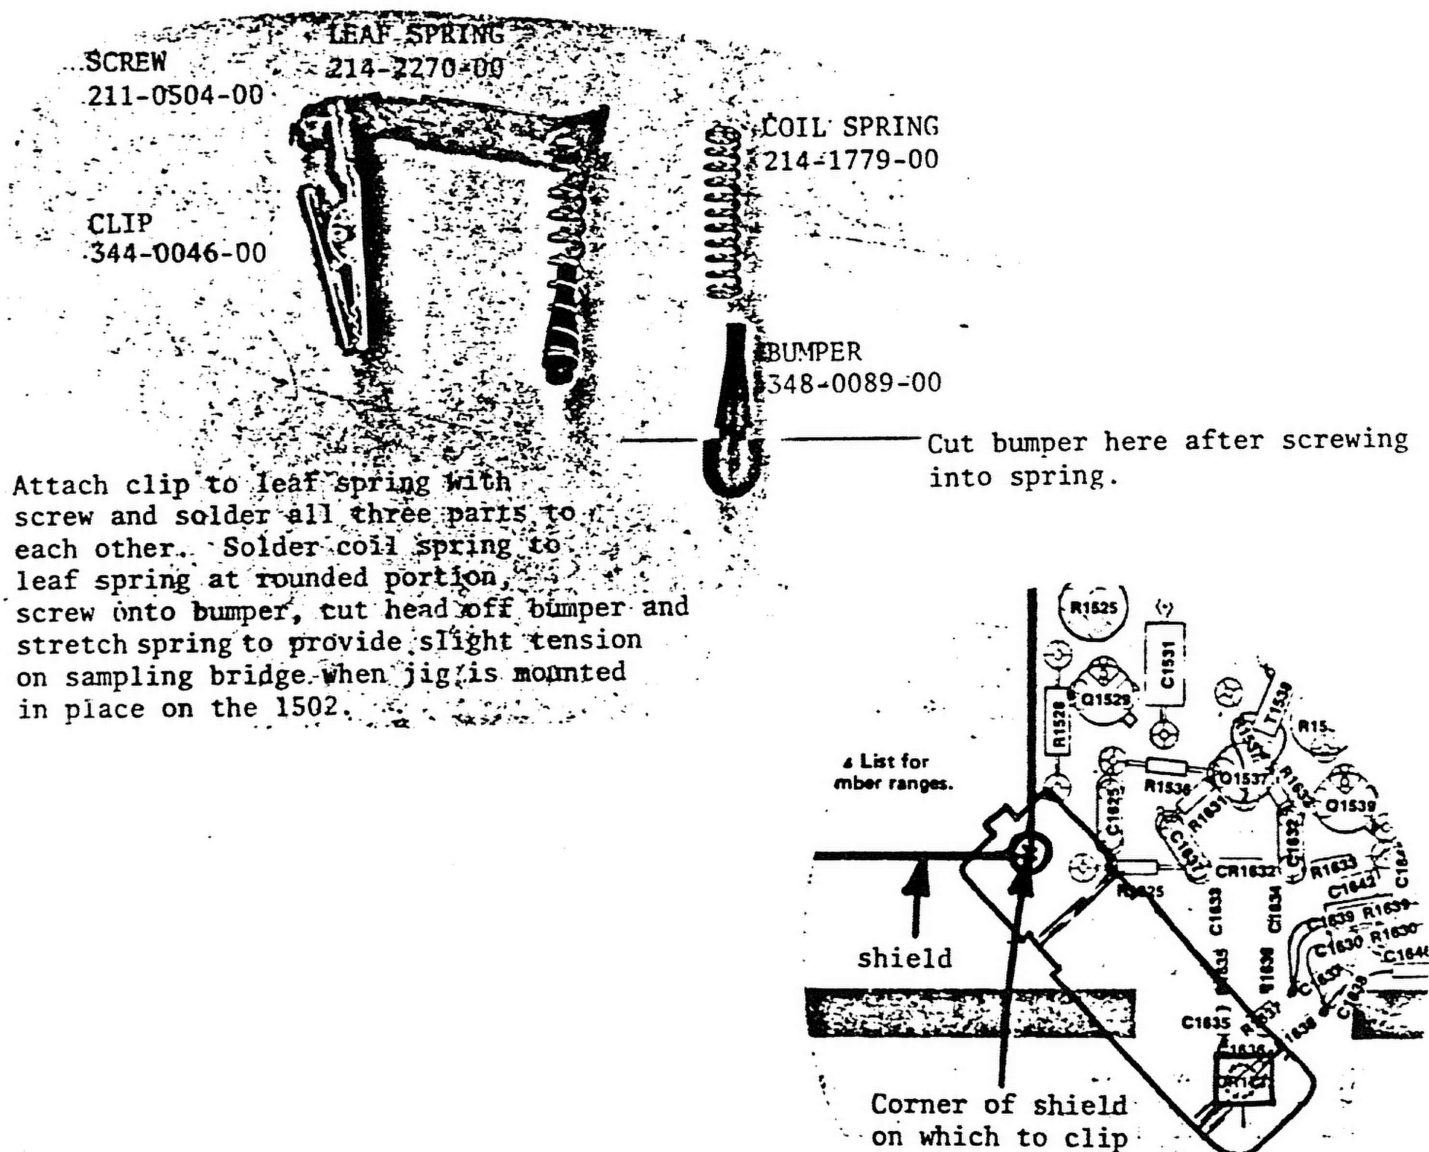
When constructed, this little jig looks to be straight out of a five-year-old's Tinker Toy box, but it works; and it saves a lot of aggravation and heat damaged sampling bridges (CR1732).

This is a "hold-down" device, and the clip mounts right at the corner of the plated brass shield near the bridge. The bridge is set into place and held there with the corner of a screwdriver tip or a scribe as the jig is placed over it. The jig will hold the bridge in place while it is being soldered; the bridge is so small and light that the steel leads are attracted to a magnetic soldering iron tip, making it nearly impossible to work with without this "third hand." In fact, even the surface tension of the solder has sufficient grip to move an unanchored bridge along with the iron.
