# SERVICETEKNOTES

TABLE OF CONTENTS

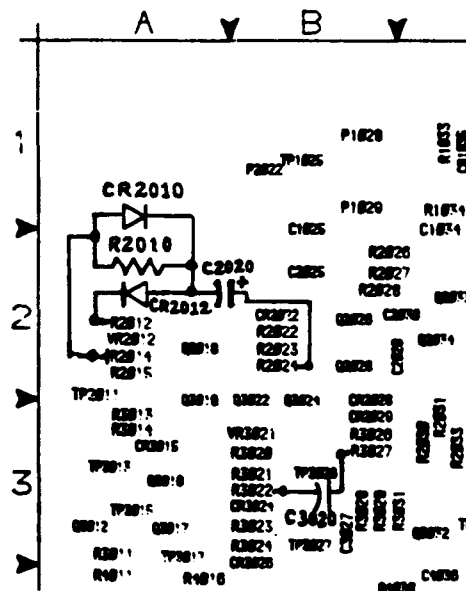
A38 —Optical Pulse Generator circuit board.

Because of an excessive failure rate of Laser Diodes in the Coupler Assemblies of early OF150's, it is imperative that all instruments within the serial number range of B010100 to B010200 entering the Service Center have the installation of the following mod physically verified.

1. To top of Optical Pulse Generator Circuit Board Assy 670-7153-00, add a 15 uf capacitor (C2020) with the positive lead at the +5V end of a 100K resistor (R2024). Connect the negative lead of C2020 to the anode lead of an added diode (CR2012) and connect cathode lead of diode (CR2012) to junction of 12K resistor (R2012) and the emitter of transistor Q2018.

Connect an added diode (CR2010) and added 100K resistor (R2010) in parallel and connect the cathode end of pair at the junction of the negative lead of 15 uf capacitor (C2020) and anode lead of diode (CR2012).

Connect the anode lead of diode (CR2010), which is paralleled with resistor R2010, to the ground lead of a 100K resistor (R2014).

2. On back of the same circuit board assembly, add a .1 uf capacitor (C3020) between junction of a 360Ω resistor (R3022) and a 1.37K resistor (R3024) and the ground lead of a 20K resistor (R3027).

The above parts are located on the A38 Optical Pulse Generator board and shown on diagram 2 OPTICAL PULSE GENERATOR.

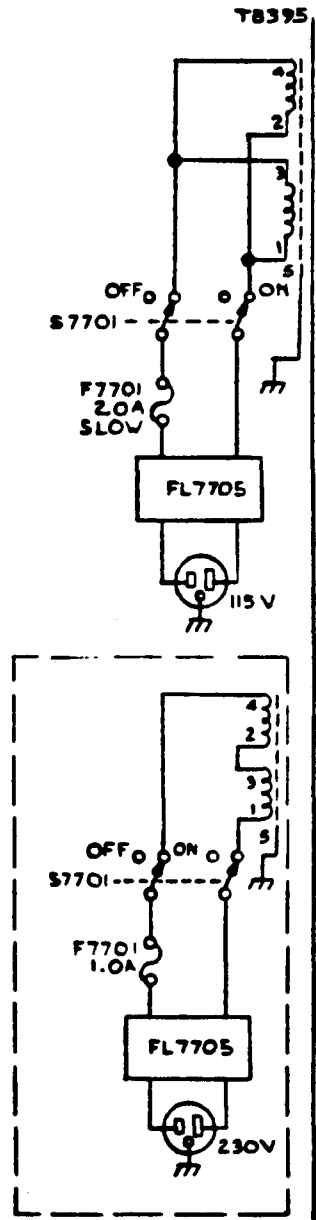
FL7705 is added as shown in partial diagram 18

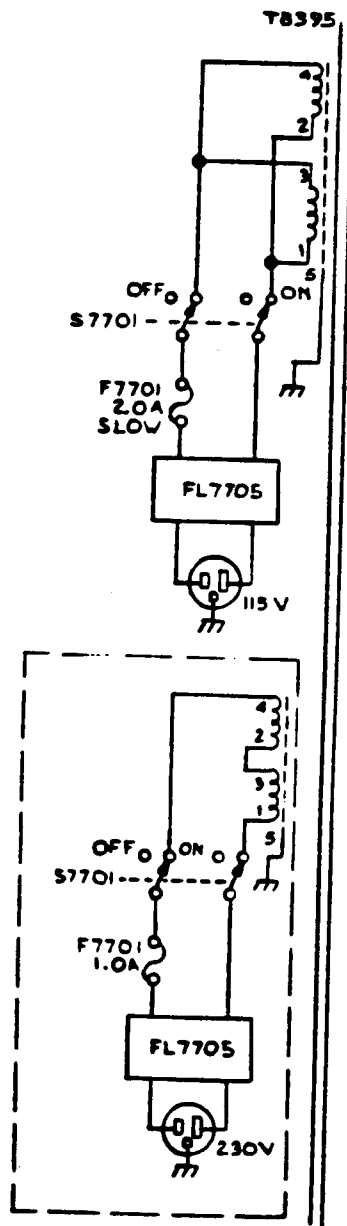
FL7705 is added as shown in partial diagram 16

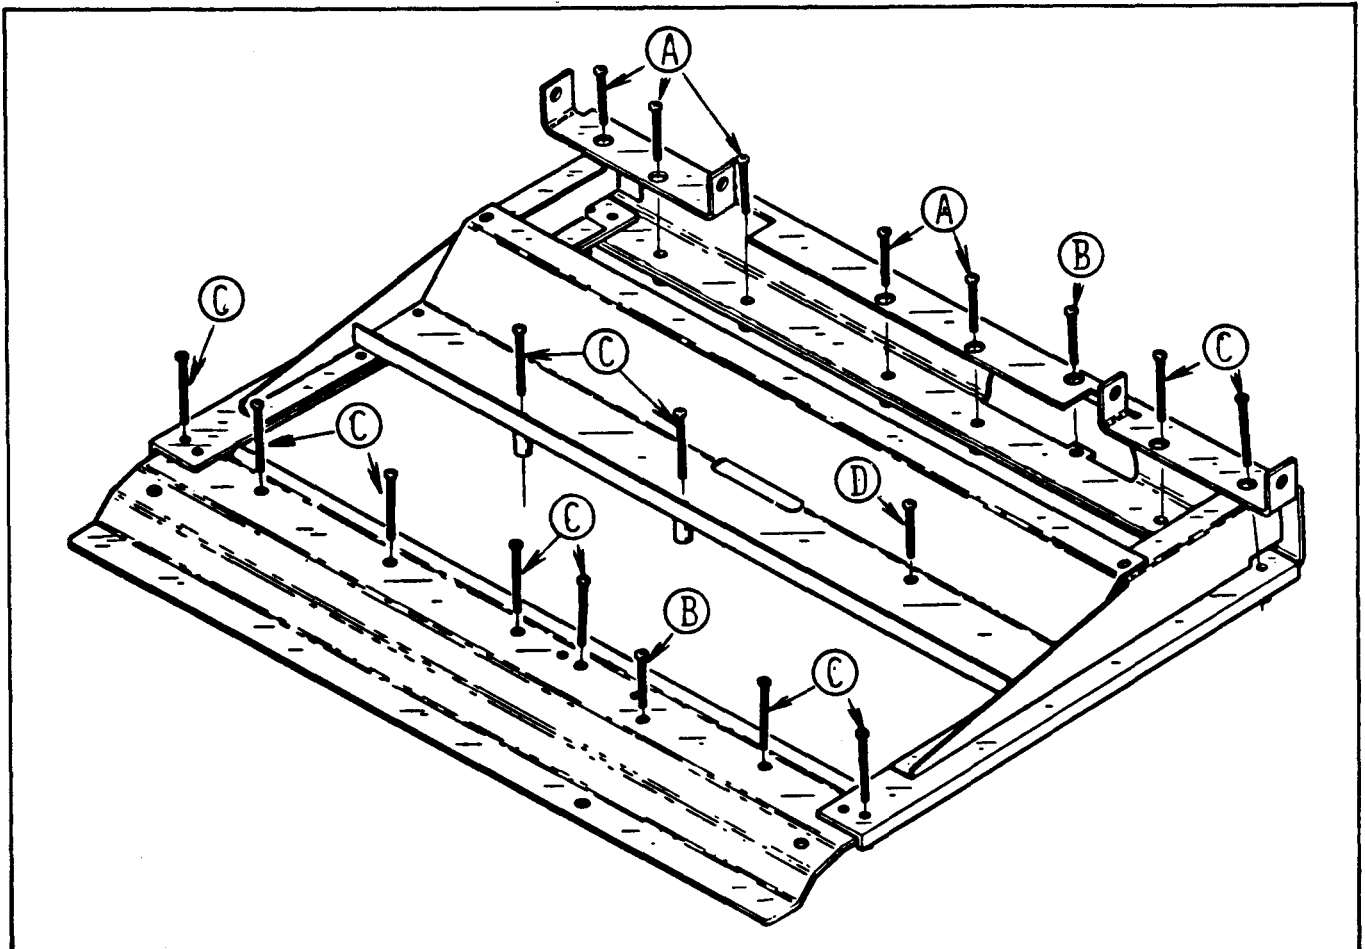
Figure 1

Many 4054 products have been experiencing intermittent start-up malfunctions as well as intermittent "locked busy" failures during operation. These malfunctions are usually caused by failures on the I/O or MAS boards, with RAM failures the most predominant. These failures have been traced to poor or intermittent connection of the cables to Q5001 and Q5002. These transistors are mounted to the CPU frame and are connected to J117 and J118 on the I/O board.

Note that there are two "D" type screws listed. On the 4054A this screw goes through the ALU board and into the I/O board, whereas on the 4054 it only screws to the ALU board.
