SERVICETEKNOTES

Published by Tektronix Service
Administrative Support

TABLE OF CONTENTS

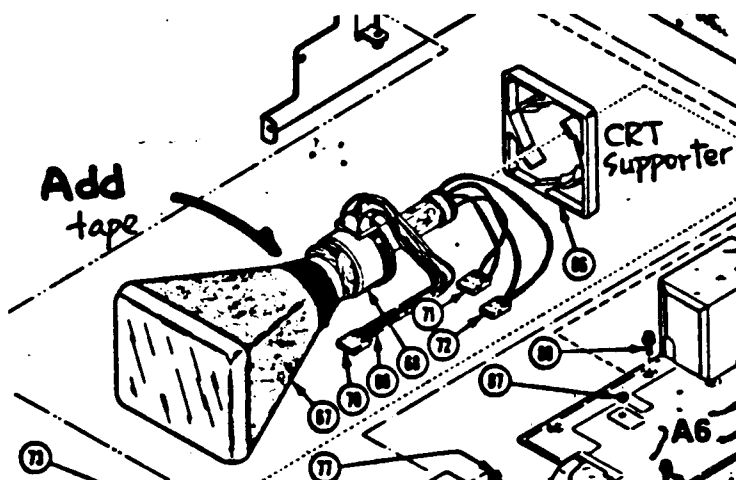
Some CRT's rotate in the vertical axis (tilt) due to shock and vibration. To alleviate this problem a piece of adhesive tape, 10 cm x 2.5 cm, is wrapped around the CRT where it is bracketed by the CRT supporter. (See Illustration). This effectively increases the friction between the CRT and bracket, reducing rotation.

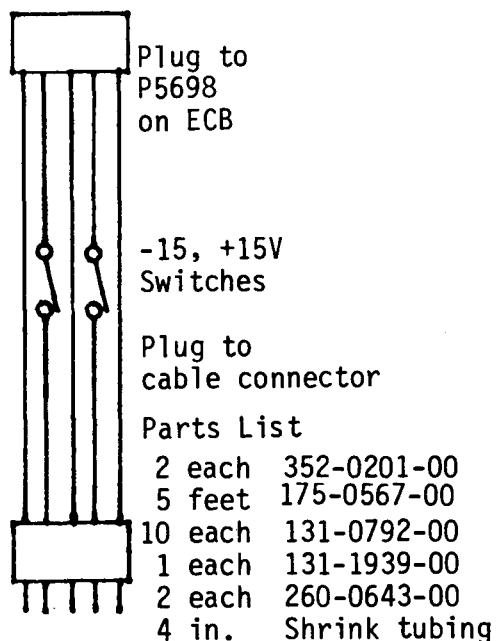
Figure 1
RCU Power Fixture

In later model 1440 Mod instruments, the power that is supplied to the RCU passes through diodes CR5691 and CR5692. In older instruments, there were fuses. The calibration procedure starting at step 18 on page 3-7 talks about removing these fuses as a part of the calibration procedure. Since the fuses have now been replaced by soldered in diodes, removal is not a clean and easy process.

1. Pull P5698 and temporarily remove the wires from slots 2 and 4 on the 5-pin connector as appropriate for the calibration steps.
2. Construct a fixture as shown in Figure 1. This fixture can then be inserted in series with the connection at P5698, and will provide the ability to disable the RCU supplies.

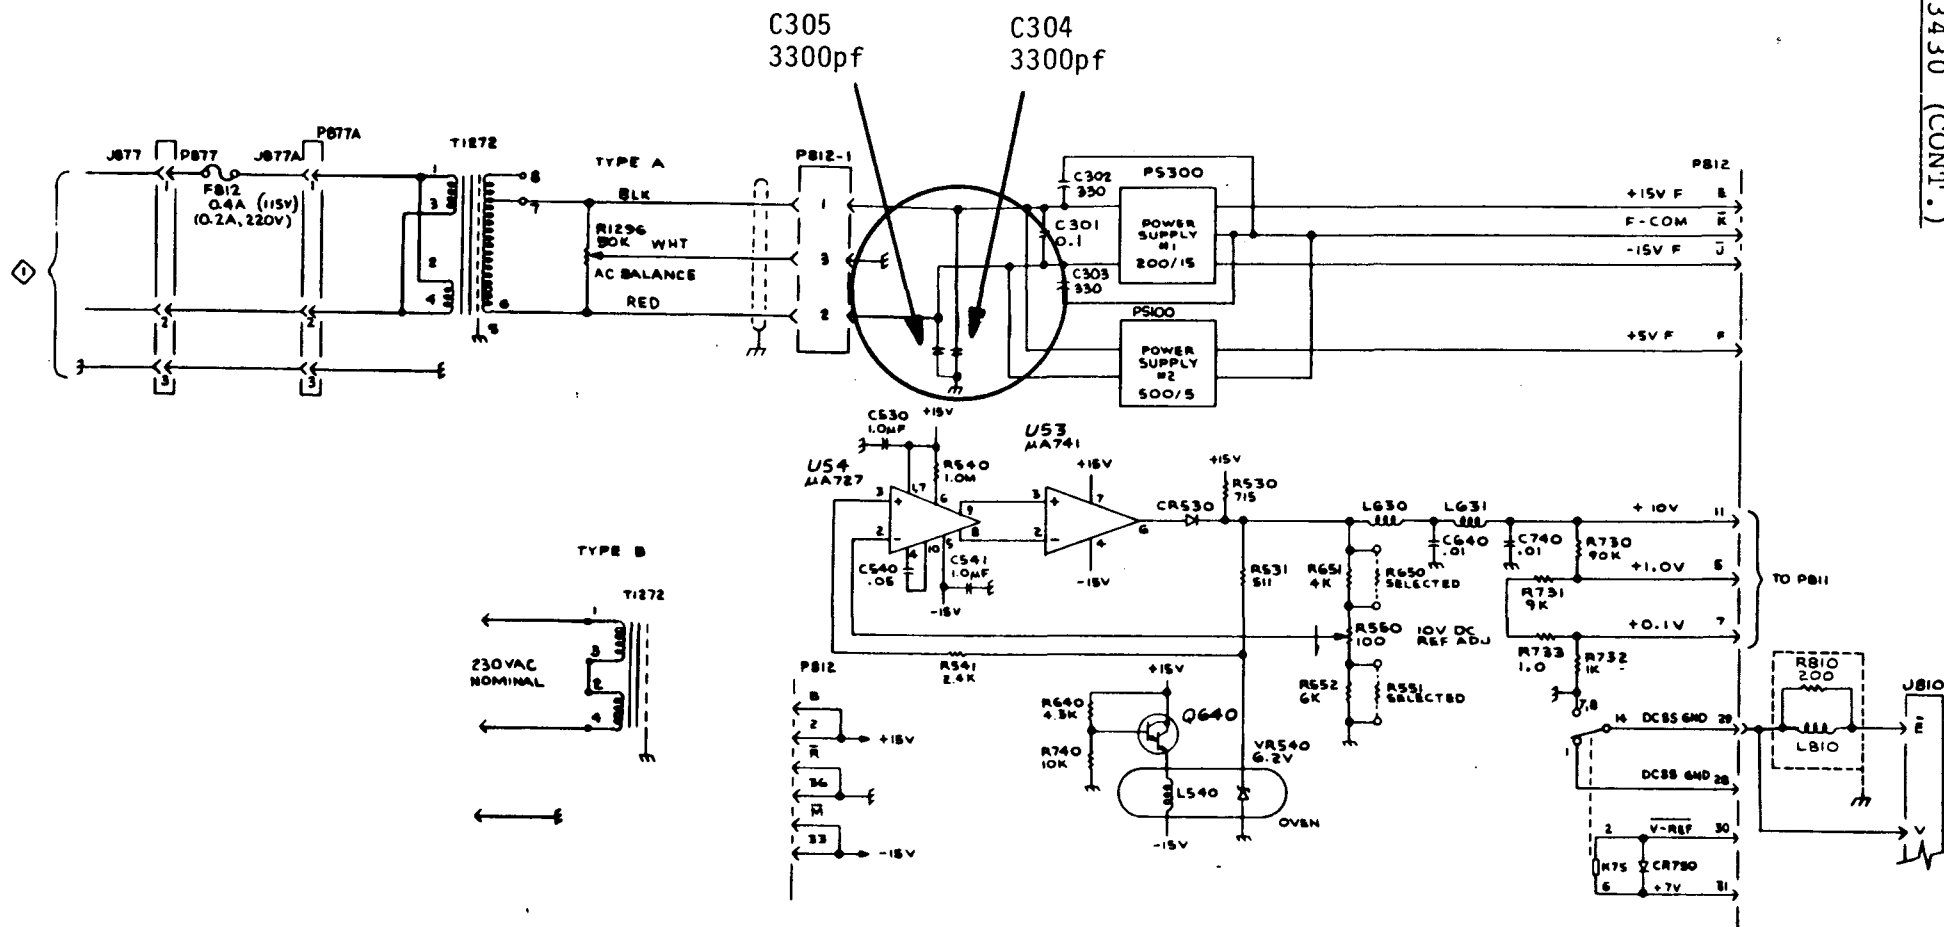
PS 812 DC SUBSYSTEM
FLOATING POWER SUPPLY CARD

Switching noise on the AC line
gets on the floating common of the
DC subsystem and may cause F040
(T1140A.EDT) to fail.

MOD M43430 adds two
.0033uf capacitors
(C304 and C305) as
shown above.

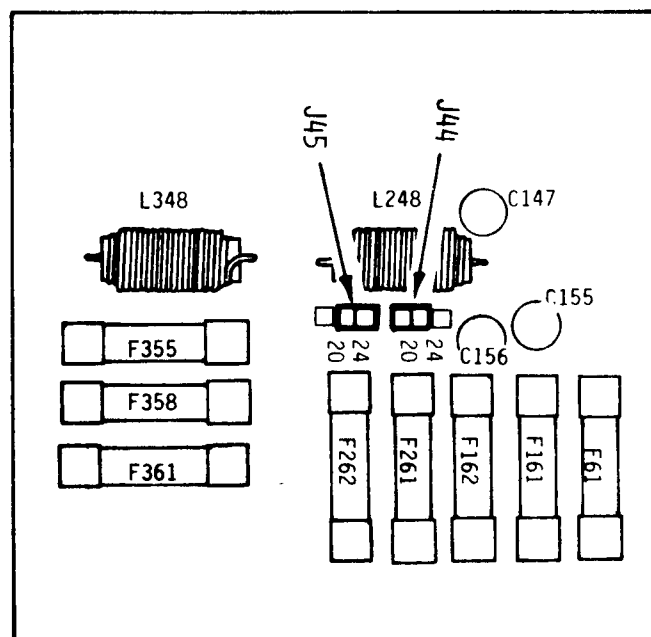
Figure 1.

One possible cause of premature failure of replacement CRTs in 4016 terminals and GMA125 monitors are flood gun heater straps that are not set for optimal performance. When a CRT is replaced, the flood gun heater straps, J44 and J34 on the secondary LVPS board, should be placed in the 44V settings. Leaving the straps in the 48V settings may severely curtail the life of the CRT. The 48V setting is used to extend the life of an old CRT. The 40V setting is not recommended because it may cause early CRT failures. To strap J44 and J45 to the 44V setting, it requires that one be strapped to 20V and the other to 24V. They are strapped to 48V when both J44 and J45 are in the 24V position.

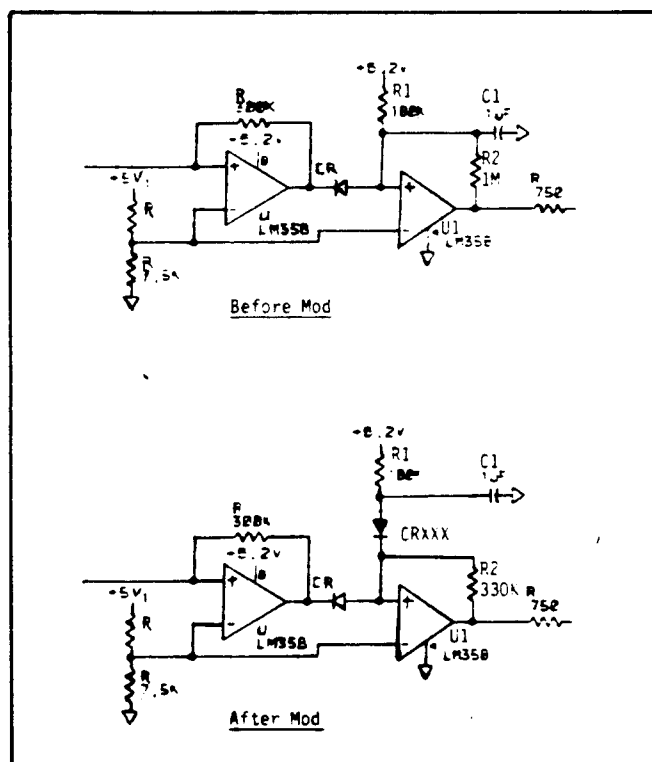
Schematic Changes

Identical power up restart circuits on the 4052/4052A power supply, 4054/4054A I/O boards and the 4050E01 power supply have a design defect which can cause the restart signal to pulse several

times. This can cause the system to hang or for the 4050E01 to power up in the opposite mode than the product to which it is connected. The malfunction can also show up on the 4050E01 as intermittently changing modes.

One end of both a 1 uf cap (C1) and a 180K Ω resistor (R1) are connected to the plus input of the OP AMP (U1) in the circuit involved. Lift this end of both components and "teepee" together. Insert and solder in the cathode end of a 1N4152 diode (CRXXX) into the hole from which the end of the "teepeed" resistor (R1) was removed. Connect the other end of the diode to the "teepeed" resistor and capacitor (R1, C1) and solder together. Last, replace the 1M Ω resistor (R2) with a 330K Ω resistor. Below are part numbers for CRXXX and R2.

Board Name - Input/Output Board
Board P.N. - 670-7630-01 rolls to -02
Ckt. Involved - U265B (+ input = pin 5)
Lift - R265 and C267
Add - CR265
Change - R266
