Wizards Workshop

TEKTRONIX INTERNAL USE ONLY

July 17, 1981
Issue 11-13

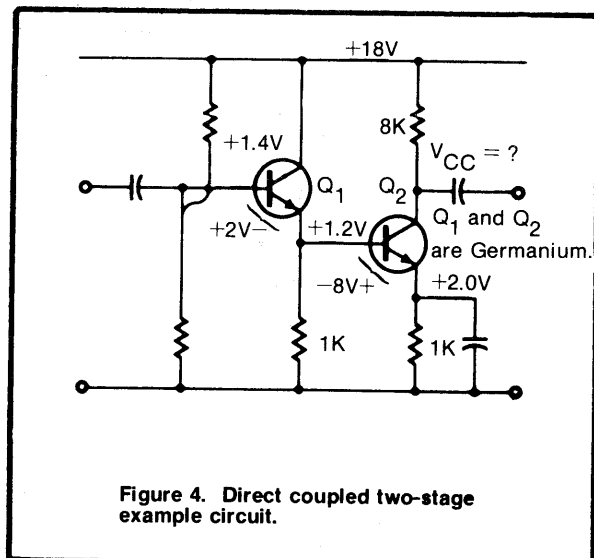
Figure 4. Direct coupled two-stage example circuit.

An interesting problem is illustrated in Figure 4. In this circuit, both transistors are of the NPN type. Note that Q_2 has 0.8 V reverse bias on its emitter-base junction, but the 2.0 volts on the emitter means that there is 2 mA of emitter current. Now, since the emitter-base junction is not shorted, this 2 mA of current also flows through the 8K resistor in the collector of Q_2 . Therefore, the collector voltage, V_{CC} , is:

Thus, it would appear that Q_2 has a short between collector and emitter.

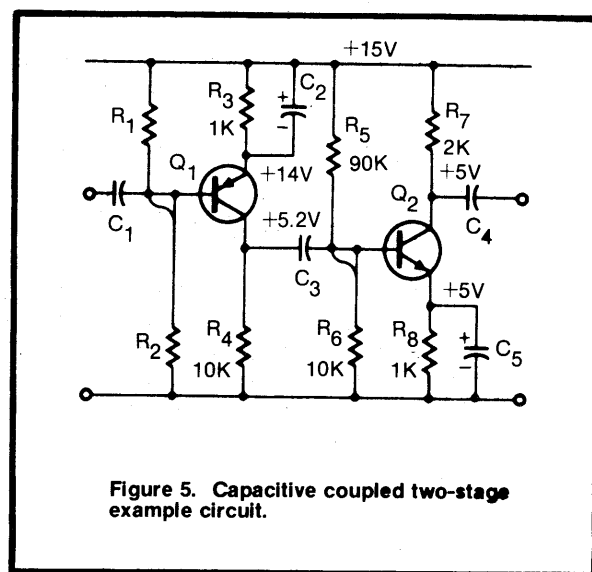
Figure 5. Capacitive coupled two-stage example circuit.

Another interesting problem in troubleshooting is illustrated in Figure 5. Although the emitter current of Q_1 is 1 mA, the collector current is only 0.52 mA (i.e., $5.2V \div 10K$). Stage Q_2 shows 5 mA flowing in both the emitter and collector circuits, so Q_2 is either shorted or saturated. The one voltage that should answer this question is not given; i.e., the voltage on the base of Q_2 . If everything were working correctly, this voltage would be approximately 1.5V.

What appears to have happened is that C_3 is shorted. This would explain why there is only 0.52 mA flowing through resistor R_4 . The other 0.48 mA is flowing through C_3 and resistor R_6 . If C_3 were shorted, it would also explain the voltages on Q_2 . The 5.2 V on the base produces 5.0 volts on the emitter, which, in turn, causes the 5 mA of dc current to flow and Q_2 to saturate.

If capacitor C_3 were replaced, the base voltage of Q_2 would be 1.5 V dc, and the voltage on the emitter would be about 1.3 V dc. This, in turn would cause about 1.3 mA of dc to flow. The resultant collector voltage would be 12.4 V dc.

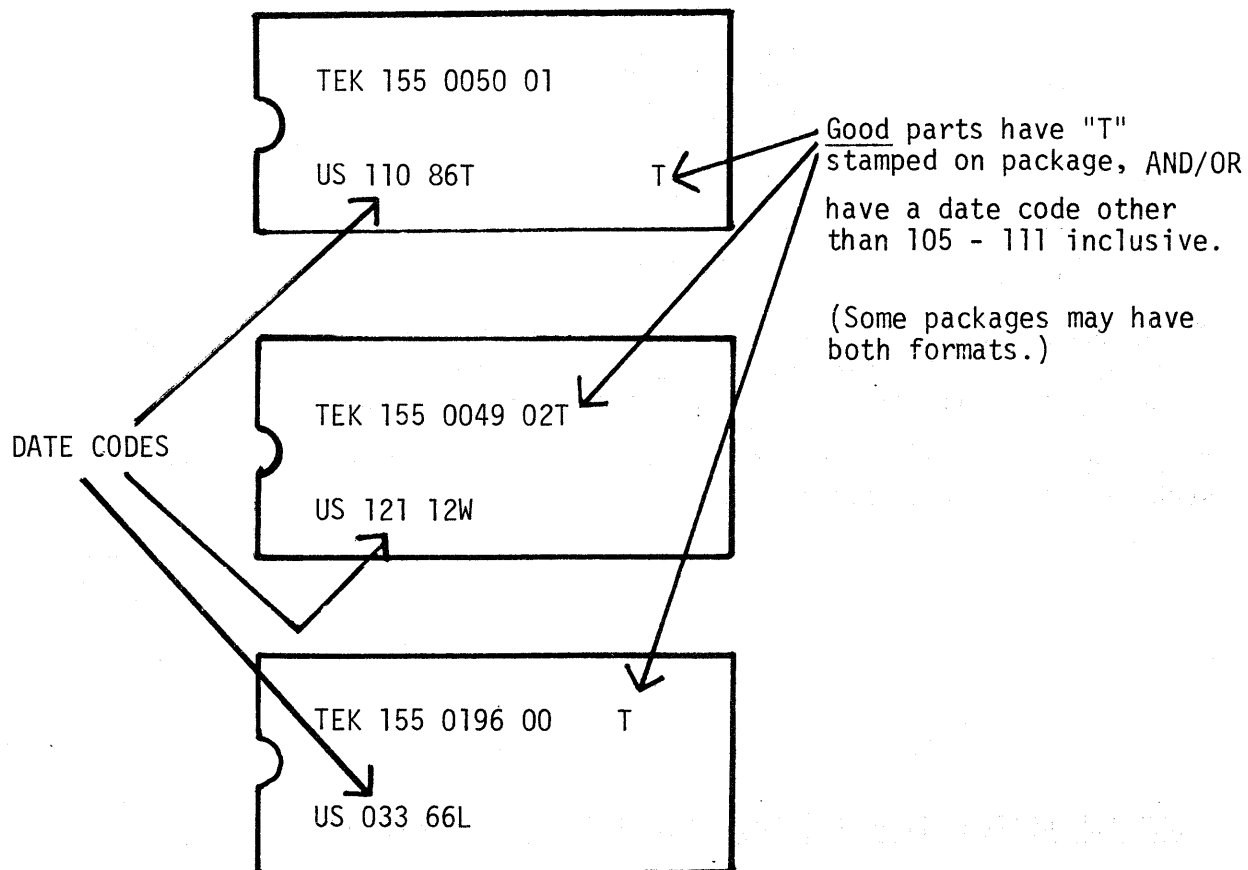
DIAGRAMS OF TYPICAL IC STAMPINGS:

The Integrated Circuits Manufacturing Quality and Reliability Department has detected an integrated circuit assembly problem that is potentially a reliability problem. The problem could be aggravated by temperature change and cause intermittent circuit malfunction. The part numbers that may be affected and the products they're used in are:

Date Codes 105 through 111 inclusive, without a letter "T" following the Part Number or Date Code.

Additional reliability screens have been completed on all finished goods warehouse stock and work-in-process. Each part that passed the additional screens has been stamped with the letter "T" (see the following diagrams).

During a service call or when an instrument is at a Tektronix facility for calibration or repair, replace the part if it is date code 105-111 without a "T". The parts must be replaced with parts that have the letter "T" or with date codes other than 105 through 111 inclusive. Replace the part using failure code "155". Charge the replacement part to Warranty (Activity Code 02) or, Customer Accomodate (Activity Code 03) to Responsibility Number 2328-10. In either case, return the parts to Beaverton using the standard procedure for warranty parts.

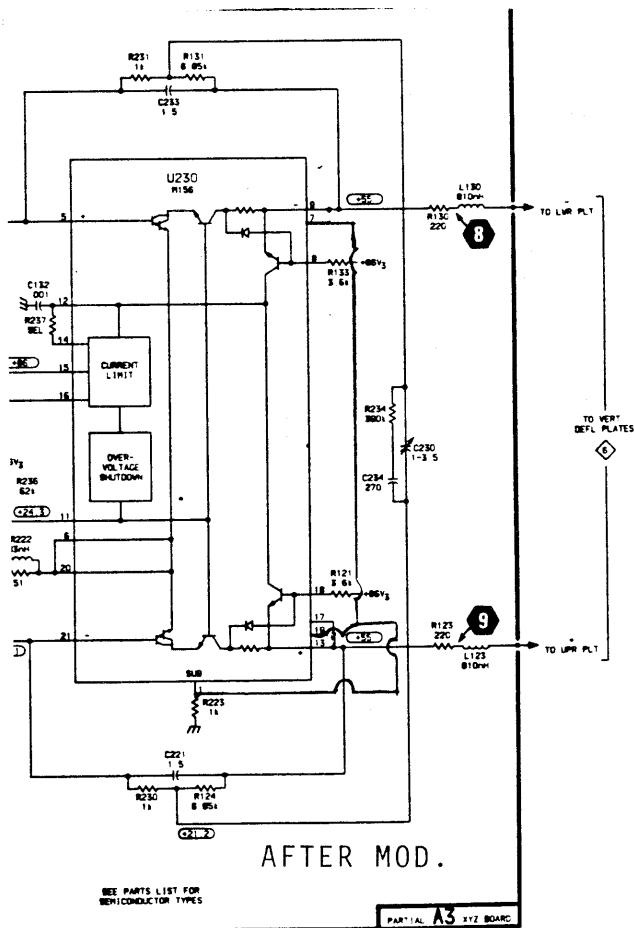
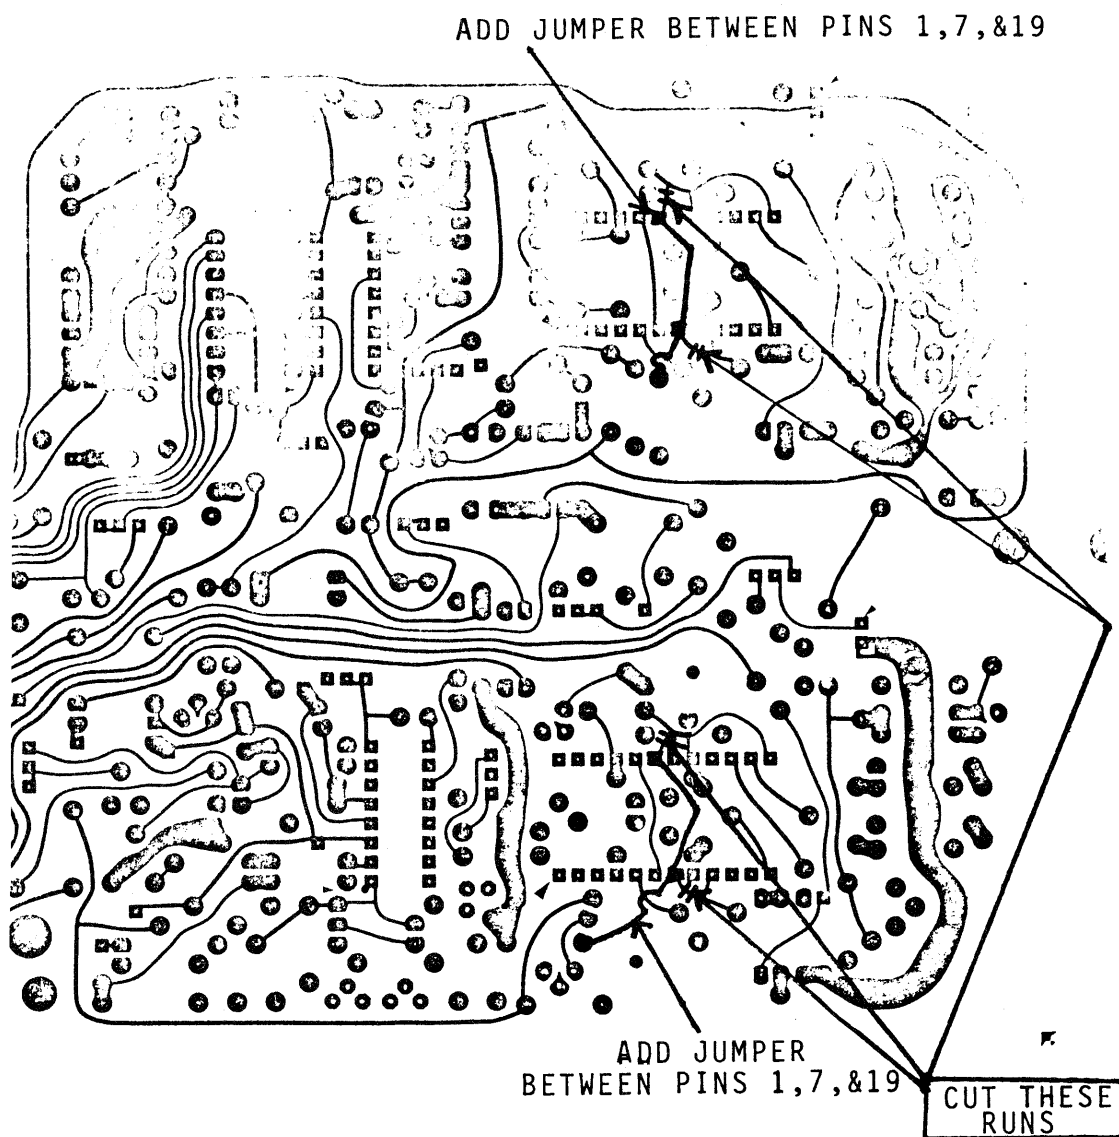
5223, POSSIBLE VERTICAL AND HORIZONTAL OSCILLATIONS

Two modifications have been made to prevent oscillations, one each to the horizontal and vertical amplifiers. Both amplifiers can, especially when cold, exhibit a low level oscillation of about 180 MHz. To cure this, the same change is being done on both output I.C.'s, U200 and U230. First remove the XYZ, A3, circuit board from the instrument. On the back of the board, cut the runs going to pins 7 and 19 of U's 200 and 230. On the back of the board run a jumper, using insulated wire between pins 7 and 19, then to pin 1 on U200, as shown on the following drawings. Perform the same strapping to U230.

AFTER MOD.

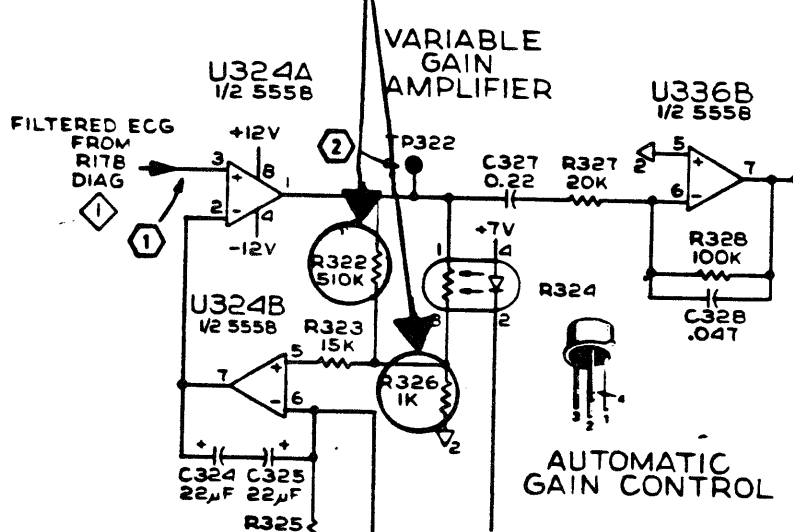
408/412 LEAD FAULT MALFUNCTION

The lead fault lamp may not light on some monitors when patient leads become disconnected because the fault detection current is insufficient to compensate for leakage paths. Also, a vendor process change is producing increasingly sensitive opto-isolators (CR324) which cause the QRS detector AGC loop to overshoot during initialization. The following changes should be made to all monitors listed below as they come in for service.

R322 to 100K ohm P/N 315-0104-00

R326 to 200 ohm P/N 315-0201-00

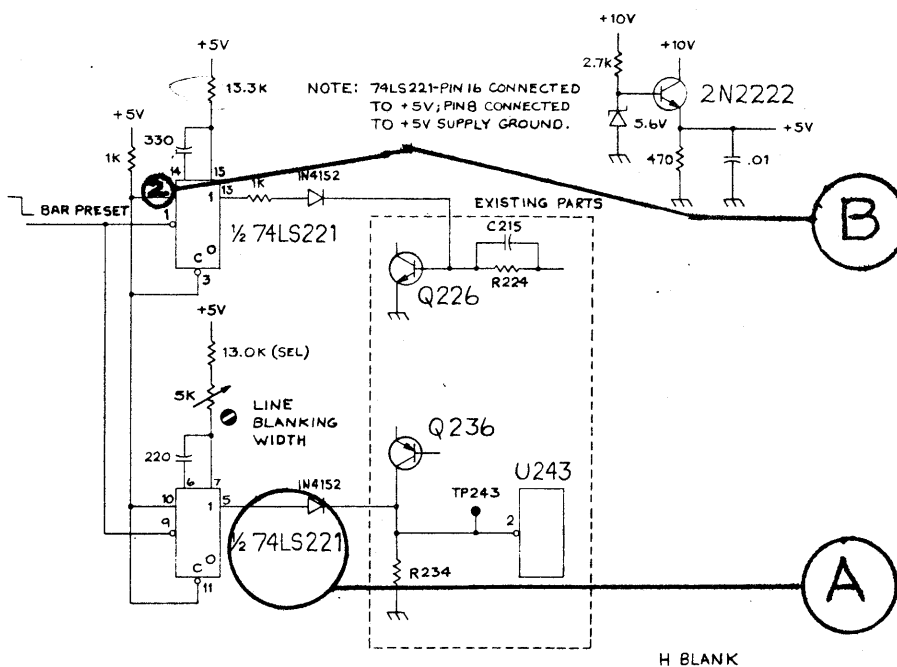
TV APP NOTE #22, 140 SERIES BLANKING INTERVALS

Some minor discrepancies exist in TV App Note #22 that can make it difficult to install properly. The App Note addresses shortening the blanking intervals on the 140-144-146 NTSC generators.

- A. H-Blanking--use only a 74LS221, a 74221 won't function correctly.
- B. The top IC ($\frac{1}{2}$ of 74LS221) has one pin that is not labeled between pins 14 and 1. It should be labeled pin 2.
- C. V-Blanking--the base of the bottom 2N3692 transistor should go through a 1K resistor to U302 pin 5 instead of pin 2.
- D. Figure 5 should be marked U302-5 in accordance with C.

See the following illustrations for the noted changes.

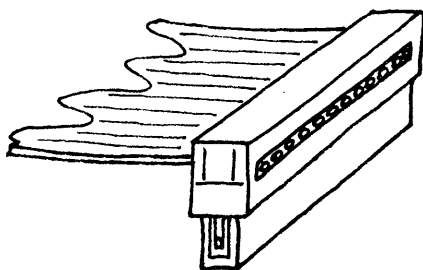
OLD STYLE

It has come to our attention that the cable used to connect the 119-0708-0X tape drive to the 4051, 4052, and 4054 is unreliable. Part numbered 175-1725-00 and 175-2123-00 - these cables should be highly suspect when making a tape drive service call.

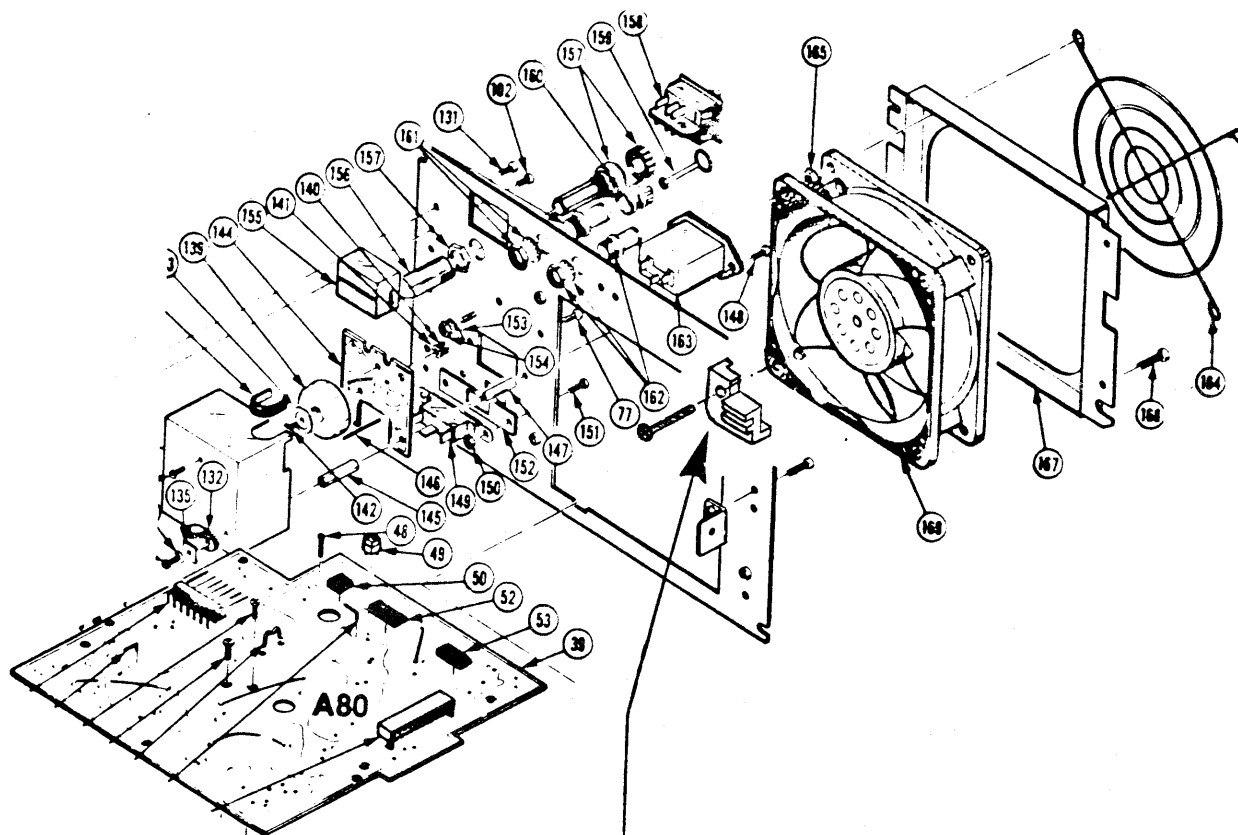
DIAGRAM 'A'

- 1) Power supply shuts down due to failure of CR015, CR016, CR017 and CR018 of the rectifier circuit board (670-5158-00).
- 2) Loose hardware causing shorts or opens in the power supply.
- 3) The rectifier circuit could move and cause structural damage to the board, or short components to the case.
- 4) If the -50V power supply shorts to ground it will destroy Q228 of the regulator circuit board (670-5418-00, -01).

- a) support bracket - PT#386-4641-00
 - b) 1 screw - PT#211-0523-00
 - c) 1 nut - 210-0457-00
- 4) A run is missing going from CR320 to Q228 (A side) on the regulator circuit board (670-5418-01). Strap the anode of CR320 to the base of Q228 as shown in diagram 'B'. This strap changes regulator circuit board 670-5418-01 to a 670-5418-02. There is no change to the schematic diagram 33.

Add rectifier circuit board support bracket (386-4641-00), which is mounted with (1) screw (211-0523-00) and (1) nut (210-0457-00) to the fan as shown.

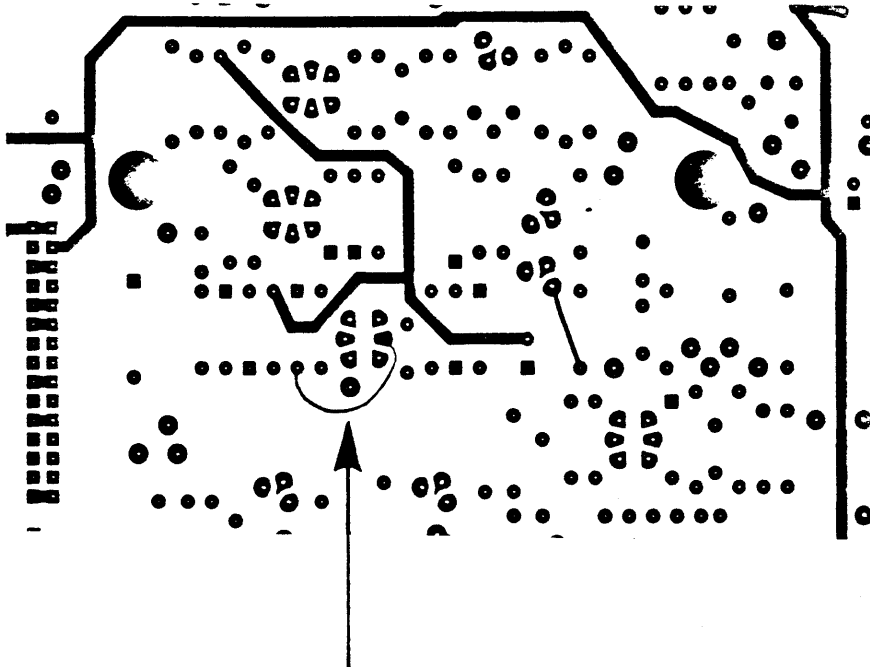
DIAGRAM 'B'

Partial backside view of the regulatory circuit board, 670-5418-01, which changes to 670-5418-02.

Strap the anode of CR320 to the base of Q228 as shown.

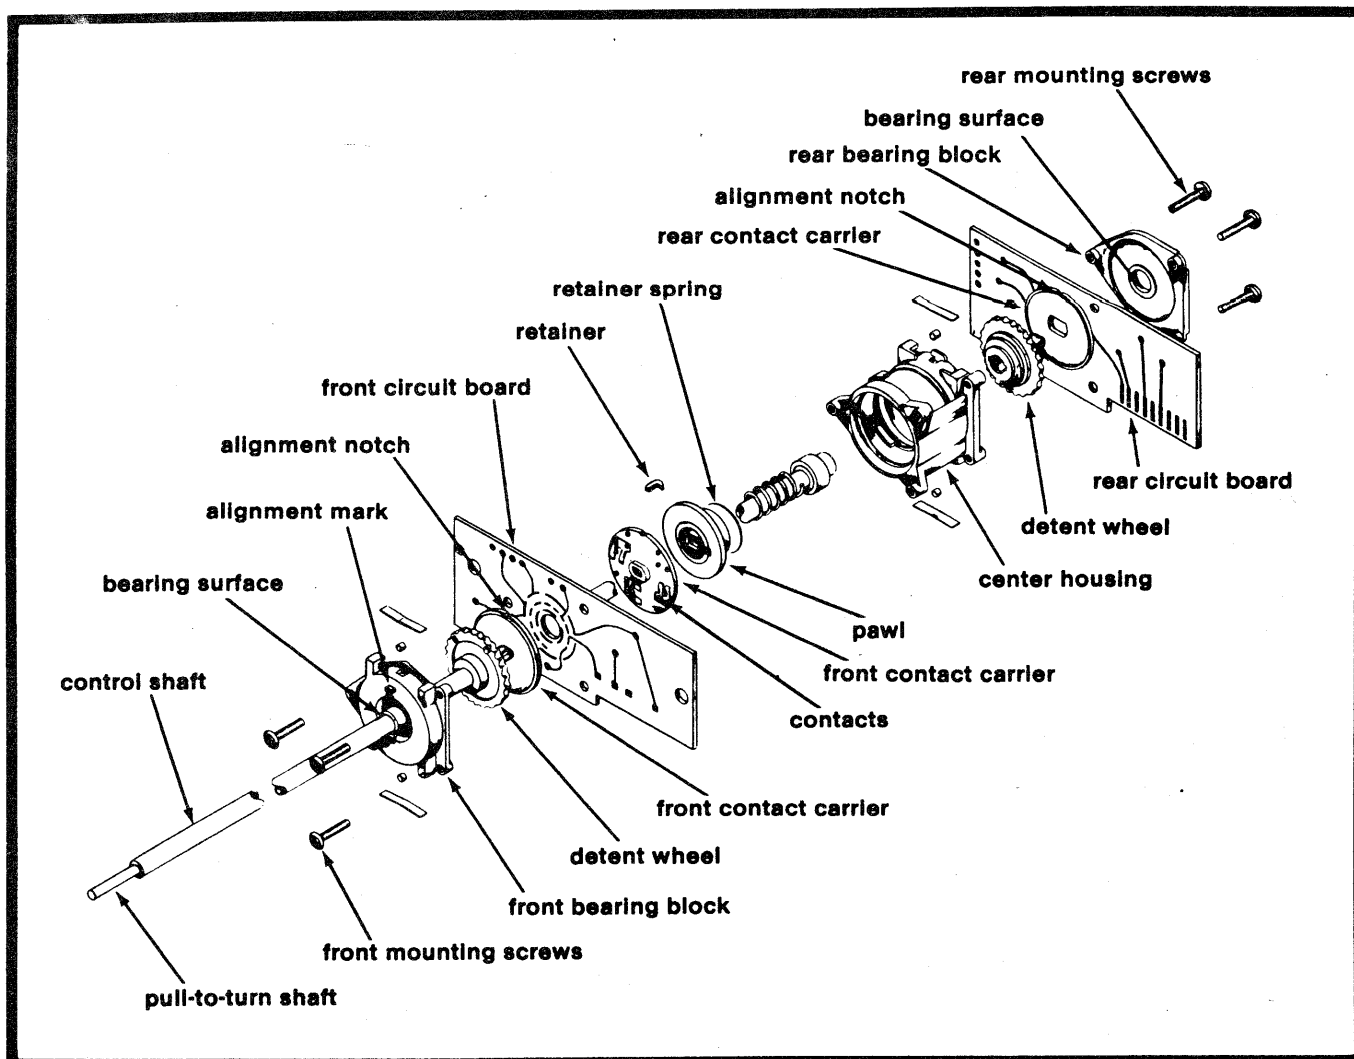
Analysis of failed rotary switches show three primary reasons for failure: (1) contact contamination; (2) contact damage; (3) retainer spring off pawl.

Contact contamination and damage occur most often when cleaning is attempted while the switch is assembled. To avoid damage, remove switch from instrument, disassemble and use the cleaning procedure described on page 3.

Retainer spring off pawl is limited to switches with the "pull-to-turn" feature, and can be repaired by reinstalling the same spring or replacing it with a new spring (P/N 354-0550-00).
