COMBINATION EDITION

Wizards Workshop

TEKTRONIX INTERNAL USE ONLY

November 21, 1980
Issue 10-23

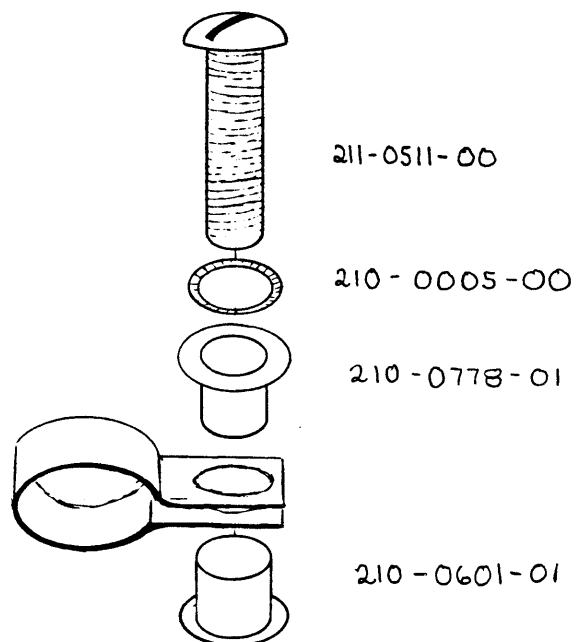
Cable clamps and associated hardware in the 1450 have been showing signs of loosening up after exposure to heat over a long period of time. This is generally caused by the tendency of the plastic, in the cable clamp, to move away from areas of mechanical pressure. Heat makes the plastic a little softer and exaggerates the problem.

Remove--211-0507-00 Screw
210-0863-00 Washer

Replace With--
211-0511-00 Screw
210-0005-00 Lock Washer
210-0778-01 Eyelet
210-0601-01 Eyelet

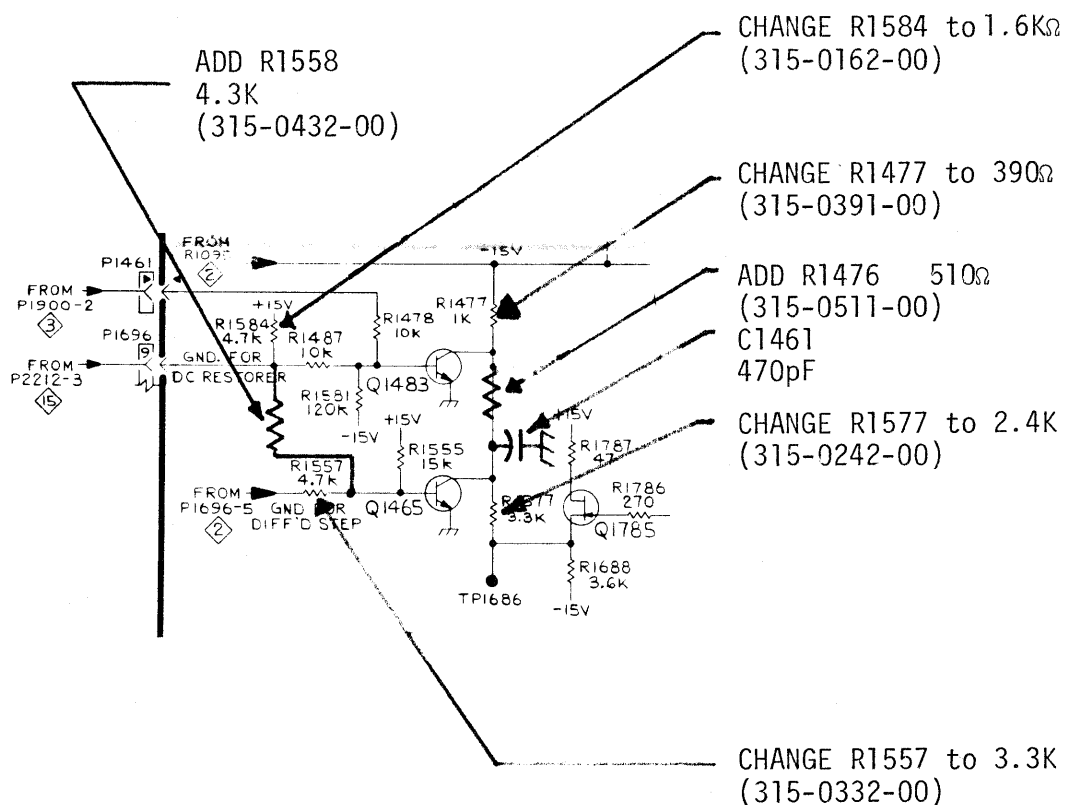
SCHEMATIC 3

The text in the article concerning a modification to improve incomplete D.C. restorer turn-off was correct. The partial schematic that was provided is in error. The proper schematic is illustrated below. The nomenclature is also correct as it is illustrated below:

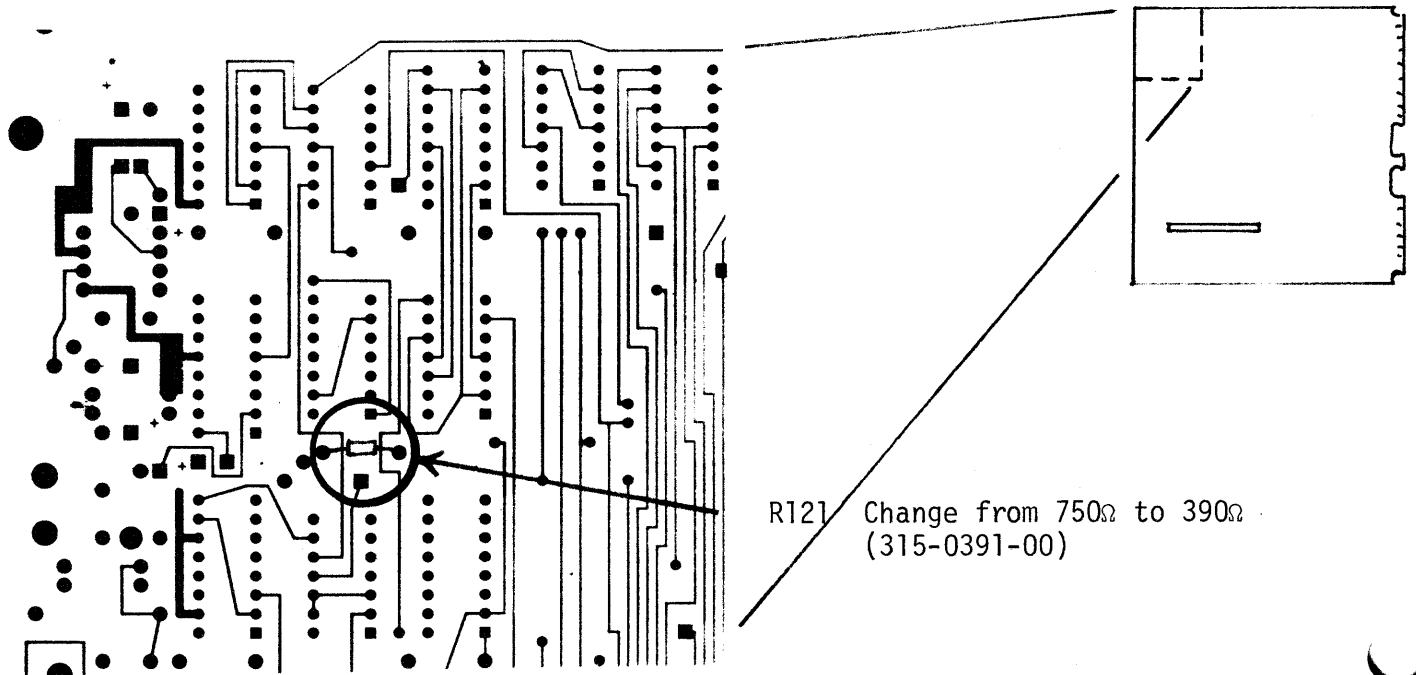
Front of 670-5695-00
(Partial)

The 1980 will show a power-up diagnostic error in the "VID:" section of the diagnostics if a signal is connected to EXT B SYNC. This is due to an error in the circuit board. All video data converters will have the following modification installed before leaving the factory. Units with S/N B010010180 and below should be modified as they are returned for repair service, or they can be modified on-site on an "as needed" basis.

1. Change R121 from 750 Ω to 390 Ω (315-0391-00).

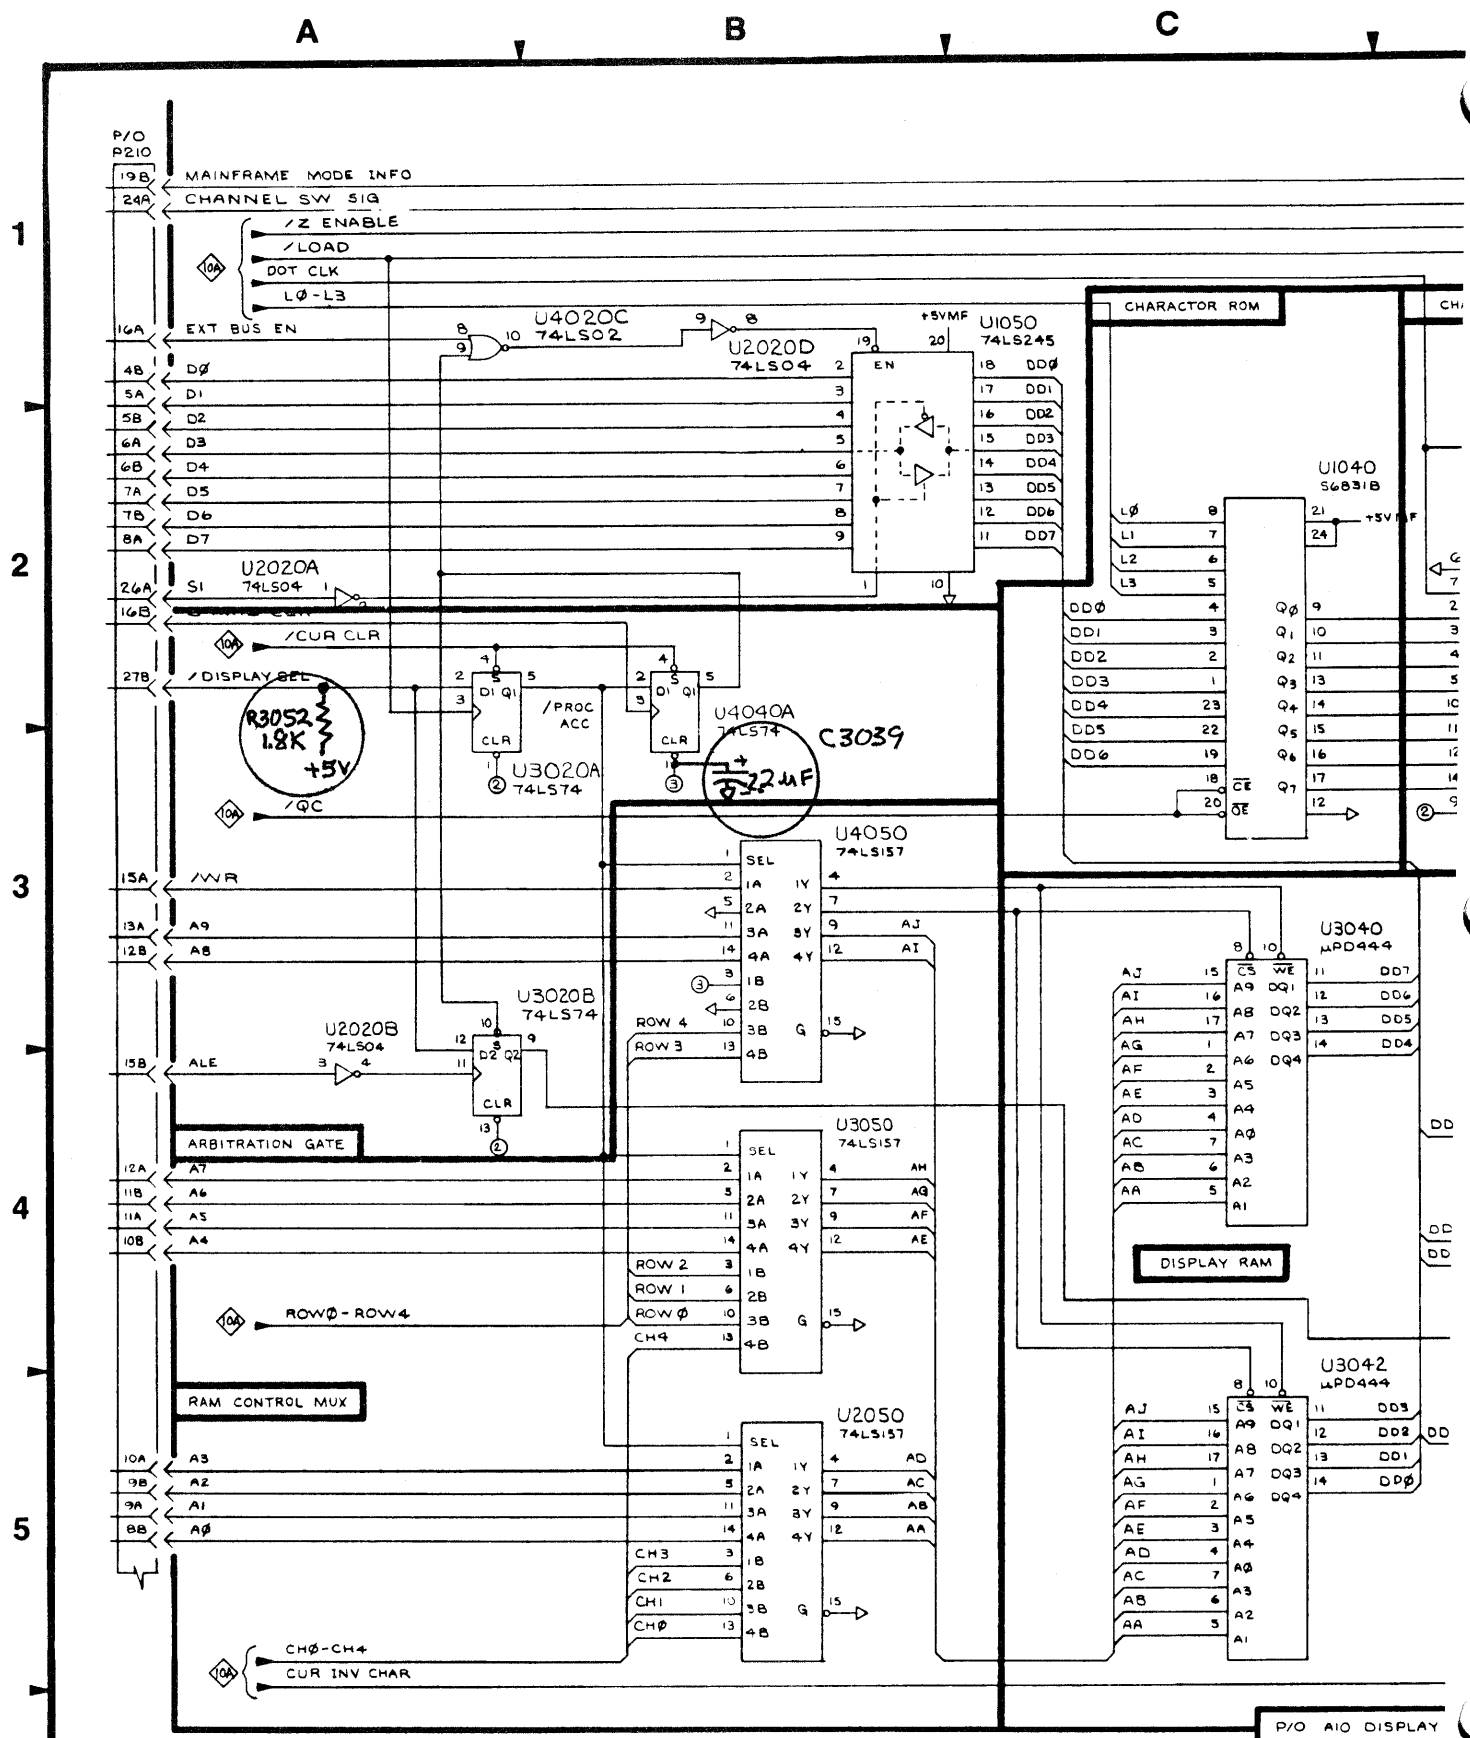
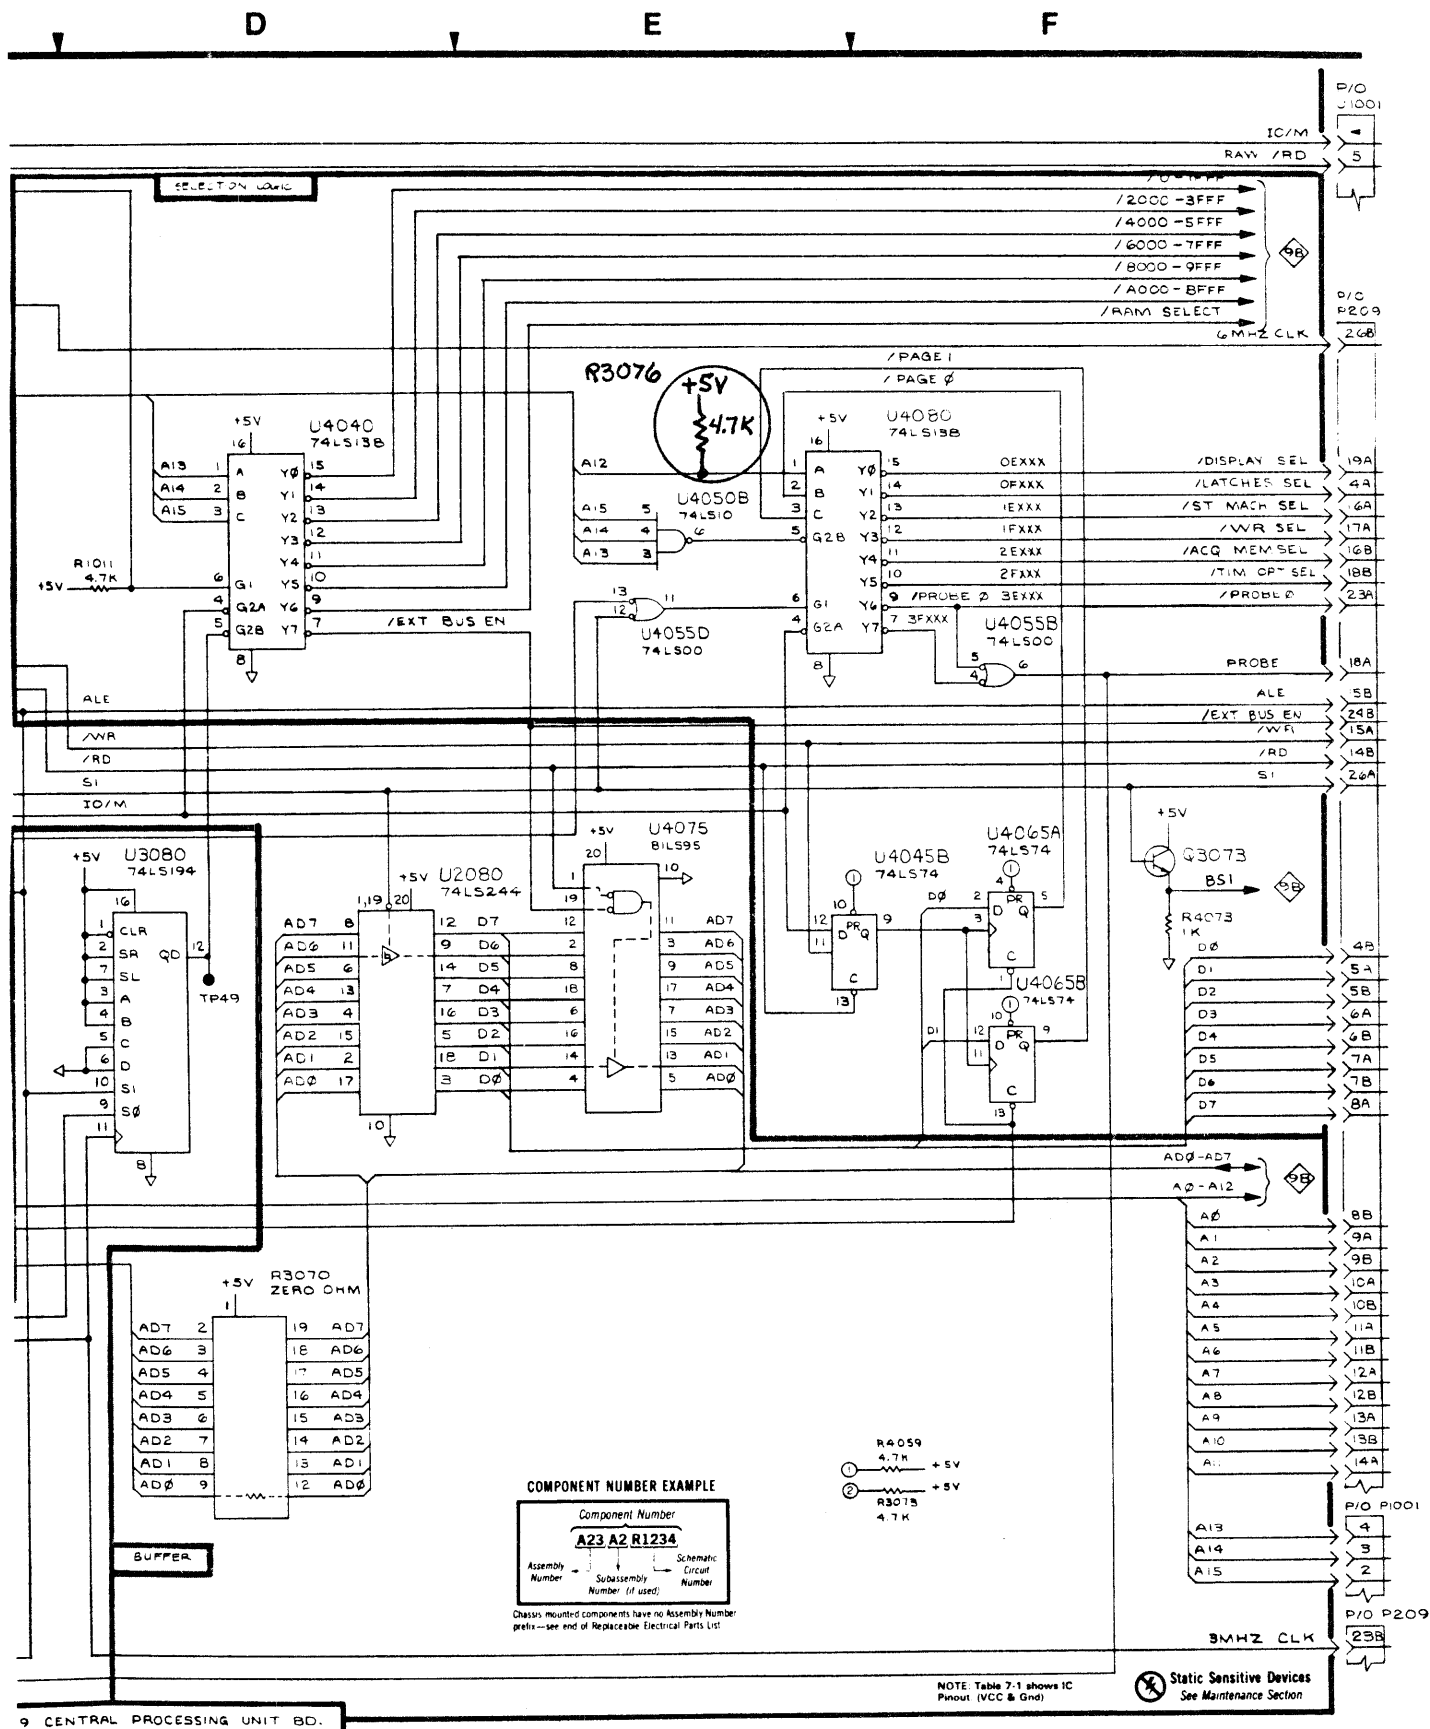
670-5983-00

This condition is caused by the display board +5 Volt supply coming up slightly before the C.P.U. Board +5 Volt Supply. This in turn, sometimes causes the ready line to go low while the C.P.U. is trying to exercise power up routines. A low READY line will inhibit the 8085 from writing to and reading from memory.

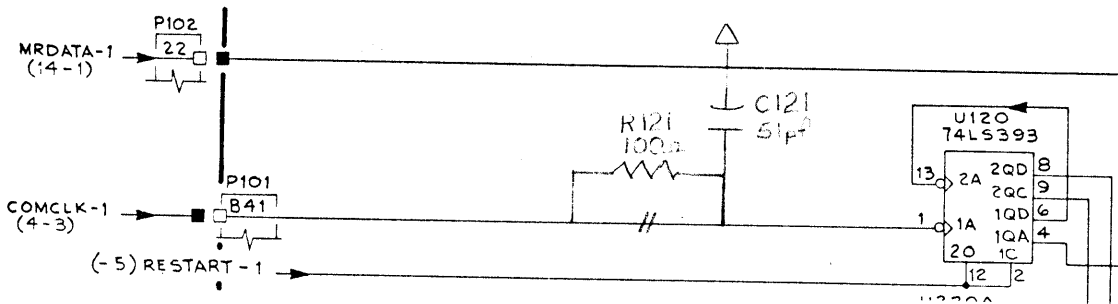
Figure 2 4054 Manual Schematic 5-2

Some 4052's and 4054's have indicated read errors during a read operation of the magnetic tape. The source of these read errors are actually due to a improperly formatted header written on a file or data on the magnetic tape written incorrectly. The result is the magnetic tape cannot be read by the 4052/54. The circuitry that causes the error is on the 4052/54 I/O Boards. Modification #M40828 addresses the write error.

- 1) Clip and lift U120 pin 1
- 2) Add 100 ohm resistor circuit number R121 (317-0101-00), between U120 pin 1 and the pad of where pin 1 of U120 was clipped from.
- 3) Add a 51pf capacitor, circuit number C121 (283-0107-00), between U120 pin 1 and ground.
- 4) The 670-5666-01 rolls to a -02.

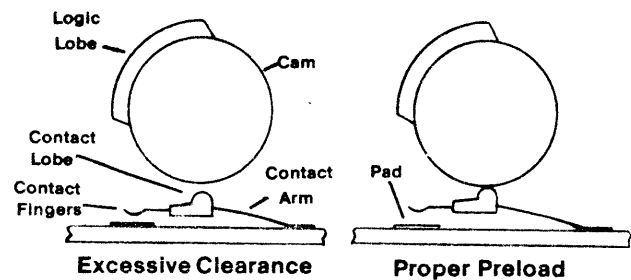
With contacts open:

1. Lobe on contact arm should ride on the cam. A gap means either a defective contact arm or excessive cam clearance.
2. Contact-to-board gap should be even. Variations may indicate defective contacts, actuator problems, or cam cover problems

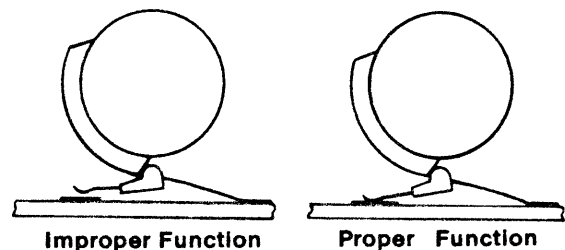
As contacts close:

1. Contact should be made while the contact lobe is still on the cam ramp (before logic lobe is over the contact lobe). Failure means excessive cam clearance or defective contact arm.
2. All fingers on any arm should touch the pad at the same time. Failure means defective contact arm or fingers.

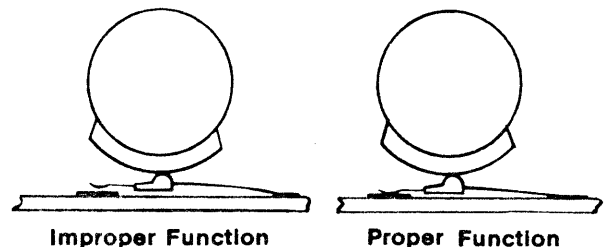
With contacts closed:

1. Contact fingers should be centered squarely on the pad. Failure means defective contact arm or fingers.
2. Contact arm should be deflected toward ECB. Failure of contact arm to deflect means that inadequate pressure is being exerted on the pad. This may mean either a defective contact arm or actuator problems.

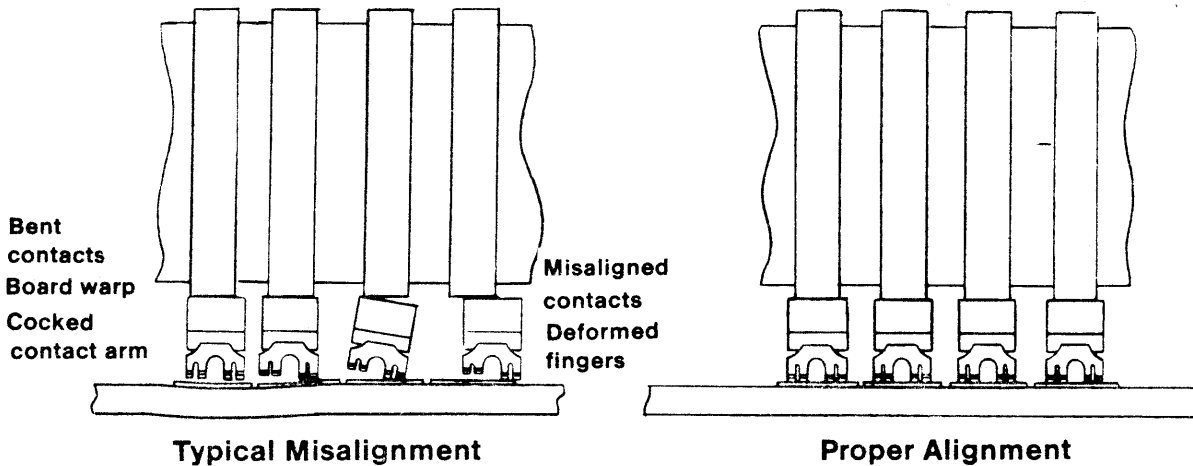
For normally closed attenuator contacts: Sight along board. All contacts should be in line and set squarely on their pads. Failure means defective contacts, which must be replaced.

All defective contacts should be replaced. Do not attempt to adjust or repair defective contacts because optimum realignment is not possible.

For standard contacts use replacement kit 040-0541-00. For high-frequency (attenuator) contacts use kit 003-0708-00, and for T900 Series instruments install a whole new contact strip.
