SERVICETEKNOTES

TABLE OF CONTENTS

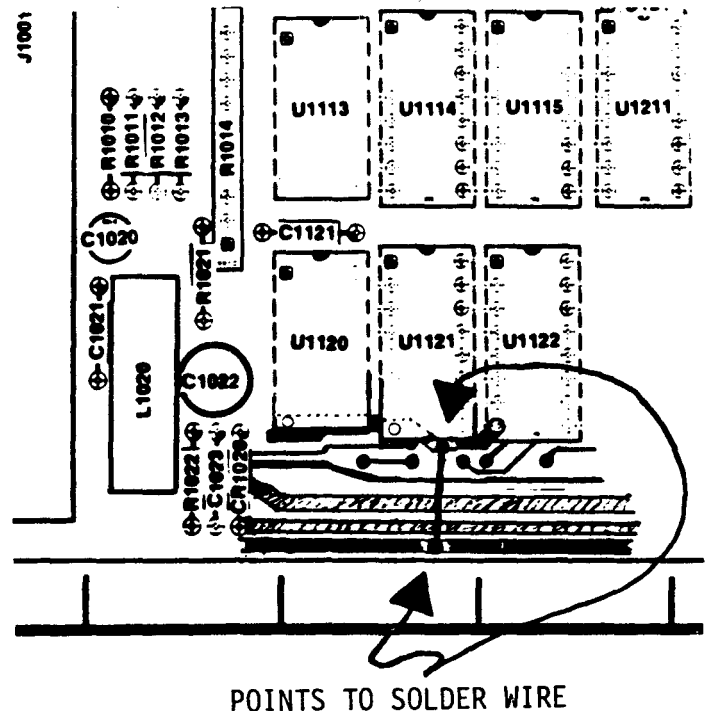
Fluctuation of >10kHz on the last four to five L.S.D.'s may occur when measuring frequencies between 100MHz to 350MHz (the symptom normally shows at 350MHz). First, verify the signal source to ensure it is not the cause of the erratic display. If the source is stable,

In some extreme cases U1120 may be part of the noise and will have to be replaced.

1) One end of an insulated wire is soldered to the ground plane run located on the bottom front of the A16 Digital Board. See the diagram for the exact location.

(Scrape the solder mask from the run at the point of soldering, being careful not to damage the run. Too much heat on the run can separate it from the board, so use care when soldering.)

2) Solder the other end of the wire to the ground plane which attaches together Pin 7 of U1120 and Pin 8 of U1121 and U1122. (Follow the soldering procedure in Step 1.)

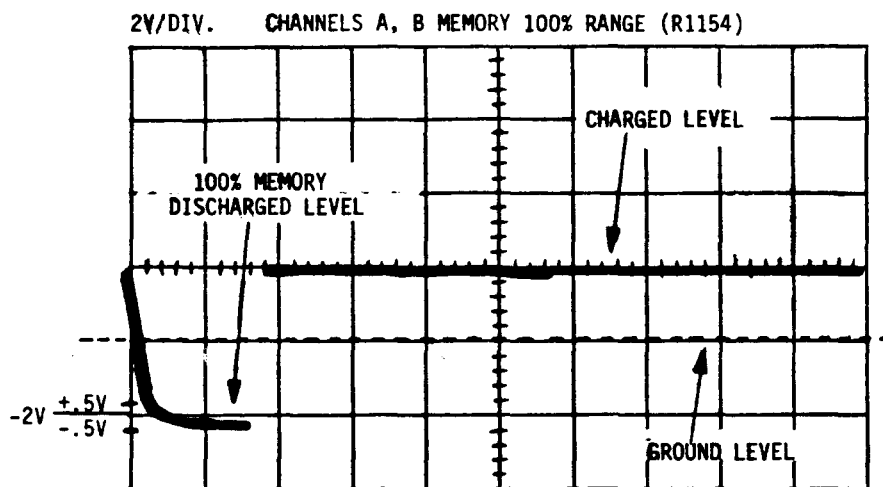
070-1976-00 FIG. 7-4 (B)
 OLD ADJUSTMENT RANGE LIMITS -2V ($\pm .5V$)

The 100% memory range test and adjustment section of the 070-1976-00 manual includes a check procedure for the 100% memory discharge voltage level. Section 9 on pages 7-6 and 7-7 checks and adjusts R1154 for a -2 volt level (with a ± 0.5 volts tolerance) below ground reference.

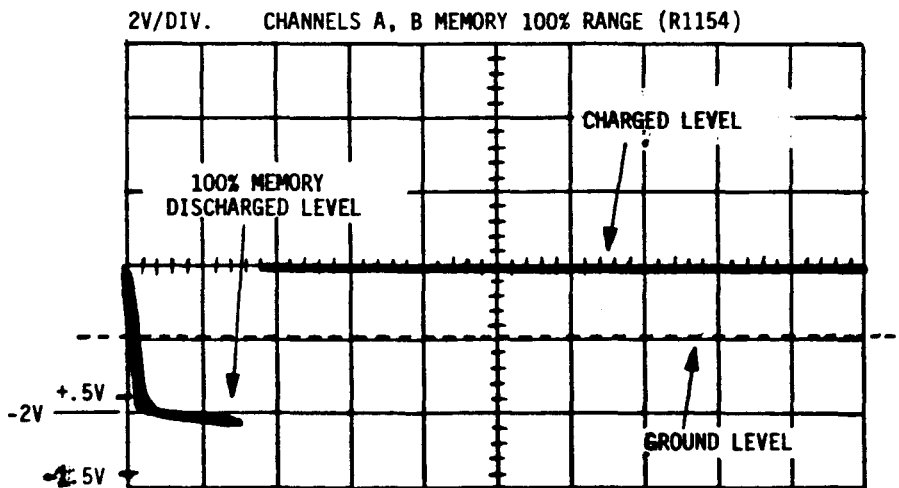
070-1976-00 FIG. 7-4 (B)
 NEW ADJUSTMENT RANGE LIMITS -2V (+.5V, AND -1.5V)

The tolerance range for the -2 volt (R1154) adjustment has been changed from ± 0.5 volts to to + 0.5V through -1.5V from the -2 Volt level. From Ground reference, the R1154 Adjustment range is -1.5 Volts to -3.5 Volts.

In some instances when Q1155 (151-1002-00) is a Motorola part, the wider tolerance range is necessary. The increased tolerance window will not affect memory operation or operating specifications.

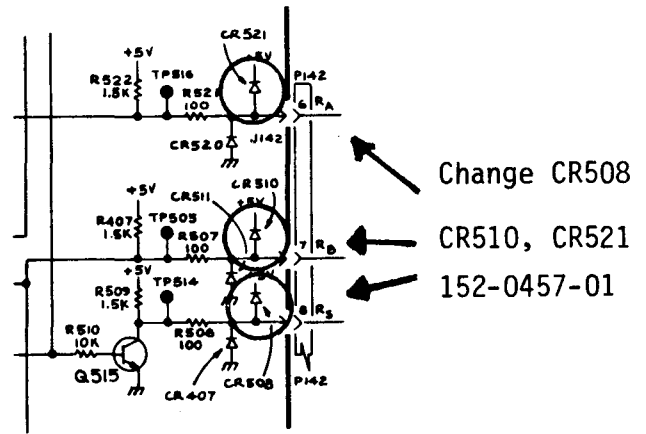
Starting at S/N B011080 on the 6942 and B010410 on the 690SR, a mod was implemented to take care of three problems in the instrument. These changes all occur on the H Delay board, A11 A2.

Change CR508
 CR510, CR521
 152-0457-01

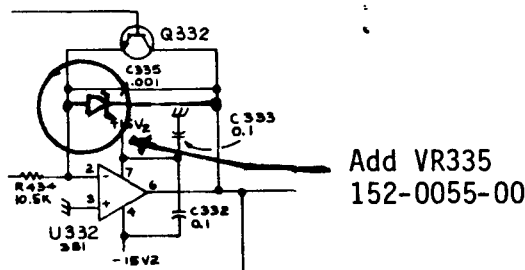
1. At high scan rates (37.5 kHz) the unit would not always function properly since U332 was in voltage limit prior to the retrace command occurring. To correct this, VR335, an 11 volt Zener diode was added in parallel with C335, cathode to the U332-pin 6 end of C335 (see diagram).
2. To improve reliability, CR508, CR510 and CR521 were changed to burned-in parts (see diagram).
3. With the monitor set for a high scan rate mode, it occasionally would not free-run with the interface module removed. This was caused by the valley current of Q331, a Programmable-Unjunction Transistor, being too low in some devices. To eliminate the need to select Q331 for proper operation, a kit (050-1675-00) has been established that will add another transistor and a resistor in a "teepee" fashion to the circuit. This will insure high-rate, free-run capabilities. (See diagram.)

Add VR335
 152-0055-00

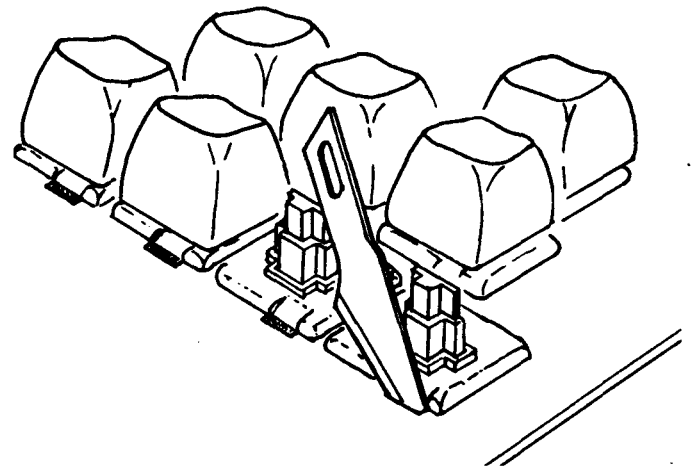
The late style cherry keyswitch, with the expanding mounting tabs, is difficult to remove from the keyboard without first cutting the mounting tabs off.

Older keyswitches have bumps, rather than locking expanding tabs; therefore, do not require cutting.

It has been found that the X-acto blade #11, 002-1040-00, with the long straight edge, works quite well in cutting the cherry keyswitch tabs. Insert blade in keyboard as pictured and cut off tab.
