# SERVICETEKNOTES

## TABLE OF CONTENTS

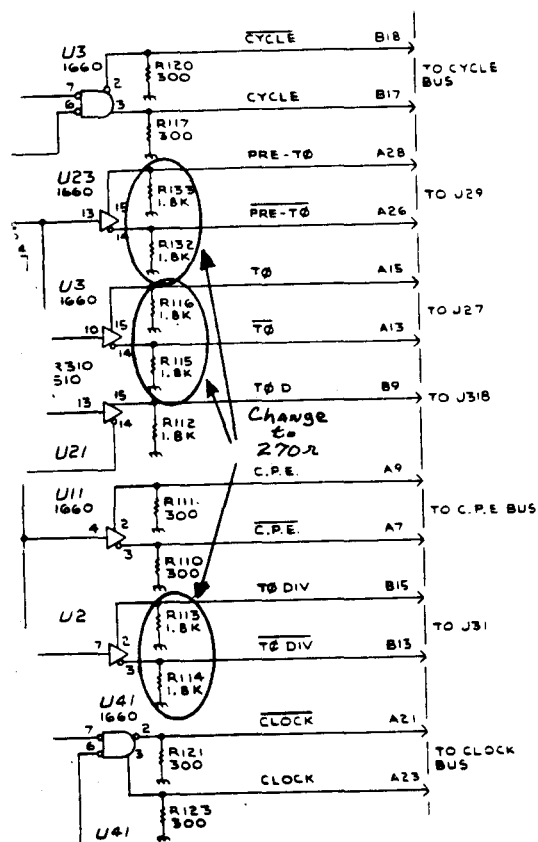
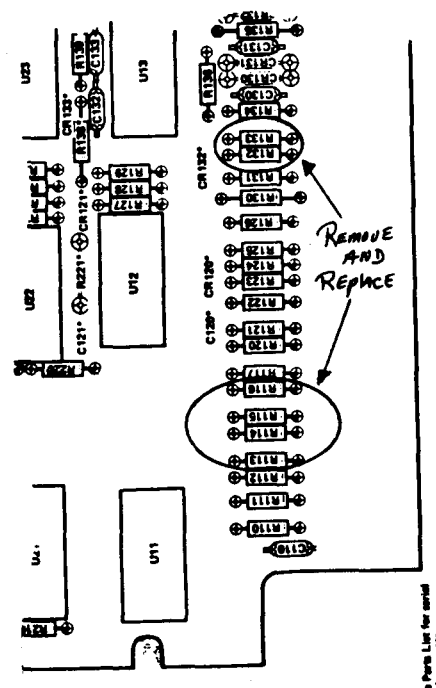
670-5383-06  
P4 Cycle Length

In some 2943/2944 clock generators the clock signal edges may vary (jitter) between 400 ps to 1 ns. The jitter is caused by high signal impedance, signal sources and cross talk to adjacent signals.

On the Cycle Length Board 670-5383-05 change R113, R114, R115, R116, R132, R133 from 1.8K P/N 315-0182-00 to a 270 ohm P/N 315-0271-00. Change board P/N to 670-5383-06. On the Clock Phase Board 670-5425-01 change R300 and R301 from a 1.5K ohm P/N 315-0152-00 to a 270 ohm P/N 315-0271-00, change board P/N to 670-5425-02. On the Programmed Cycle Board 670-5417-01 change R211 and R212 from 1.8K ohm P/N 315-0182-00 to 270 ohm P/N 315-0271-00, change board P/N to 670-5417-02.

The following are locations of the changes on partial drawing of schematic and parts layout:

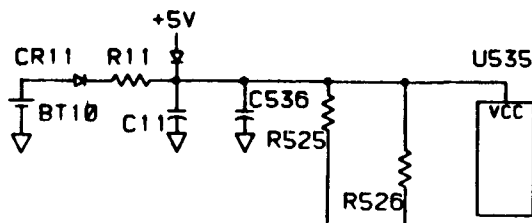
Fig 1. Schematic Diagram

The NiCad battery on the Processor board has had a high rate of failures. This battery, p.n. 146-0040-00, is used to power the CMOS RAM which stores the user selectable operating parameters. If the battery fails, the set up parameter stored will be returned to their default conditions. This is indicated by a message, "Setup Default Reset", displayed on the screen at power-up. The replacement battery is a lithium battery, p.n. 146-0045-00, with a life rating of ten years, and requires no charging circuit. The charging circuit components will be removed with the old NiCad battery.

To implement Mod 51340, refer to Fig. 1 and 2 while doing the following steps:

1. Remove CR9, CR10, CR11, BT10, R11.
2. Add new CR10 (152-0322-00) to replace old CR10.
3. Cut run on surface of board between R11 and CR11.
4. Insert CR11 (152-0322-00) where R11 was removed. Place CR11 in the circuit so the anode is to the battery and the cathode is connected to the run just cut.
5. Move R9 (270 ohms) to bridge the cut run. Attaching one leg to the cathode of CR11 and the second leg to the pad at the other end of the cut run. This 270 ohm resistor will now be referred to as R11.
6. Install the new battery to replace the old battery which was removed. Keep the negative lead short. This battery is slightly longer than the one removed. It will need to be installed at a slight angle for clearance. Use the insulation to cover the positive lead which will need to loop back to the pad labeled with a plus.

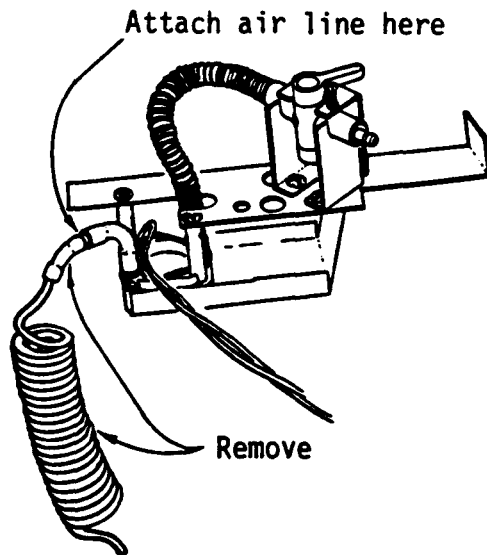
Ink Jet Head Assembly

The 4691 is shipped with spiral hoses hooked up to the air inlet of the ink jet heads. The spiral hoses are only part of the shipping paraphernalia and should be removed when the 4691 is installed. At installation, the spiral hose and its attendant 1" piece of rubber tubing should be removed from each head. The air lines are then hooked up to the remaining short piece of rubber tubing coming from the air inlet on each head. Hooking the air lines up to the end of the spiral hoses and then operating the units in such manner may cause a spurious splatter on the copies.
