SERVICETEKNOTES

TABLE OF CONTENTS

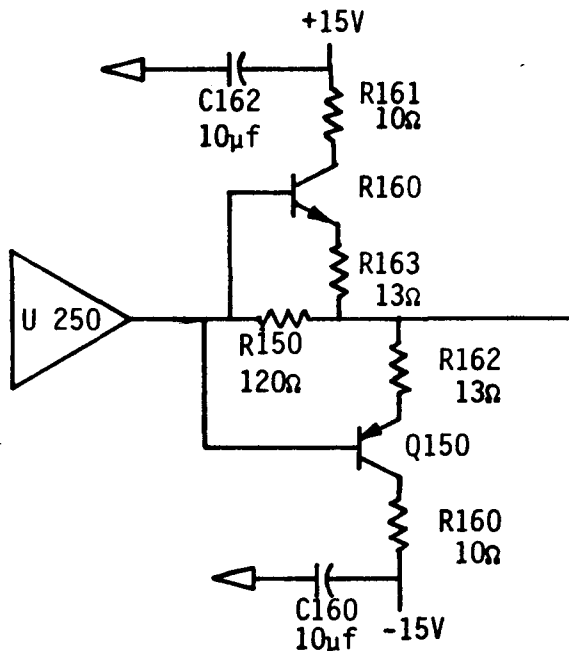
which are caused by the cascaded emitter follower (U250, Q150, and Q160 connections).

Change DC Subsystem amplifier schematic as shown below:

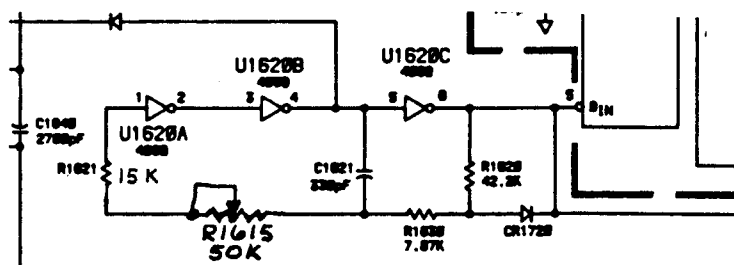
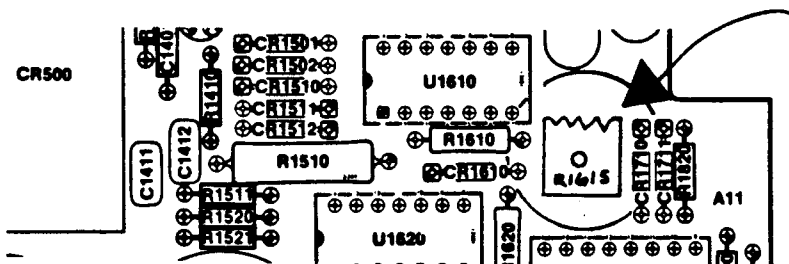
TM 5003

Damage can occur to the switching transistors Q1300 or Q1301, TM5003, (Q1640 or Q1650, TM5006) if the oscillator frequency of the TM5000 mainframe does not meet the 40 kHz to 42 kHz specification as tested at R1510 (R1860). A symptom of an audible high pitch noise indicates

the oscillator is off frequency. Batch variances of the oscillator I.C. U1620 (U1840) P/N 156-0745-00 can cause the oscillator frequency not to meet specification. If it is determined the frequency is not correct or when replacing U1620 (U1840) the following changes should be made.

After the modification is complete the following adjustment procedure for the clock oscillator should be performed:

- a. Connect a probe from the test oscilloscope to Pin 5, U1720 (TM5003) and Pin 5, U1940 (TM5006).
- b. Adjust R1615 (R1855) for a frequency of between 40 kHz and 42 kHz at Pin 5, U1720 (TM5003) and Pin 5, U1940 (TM5006).

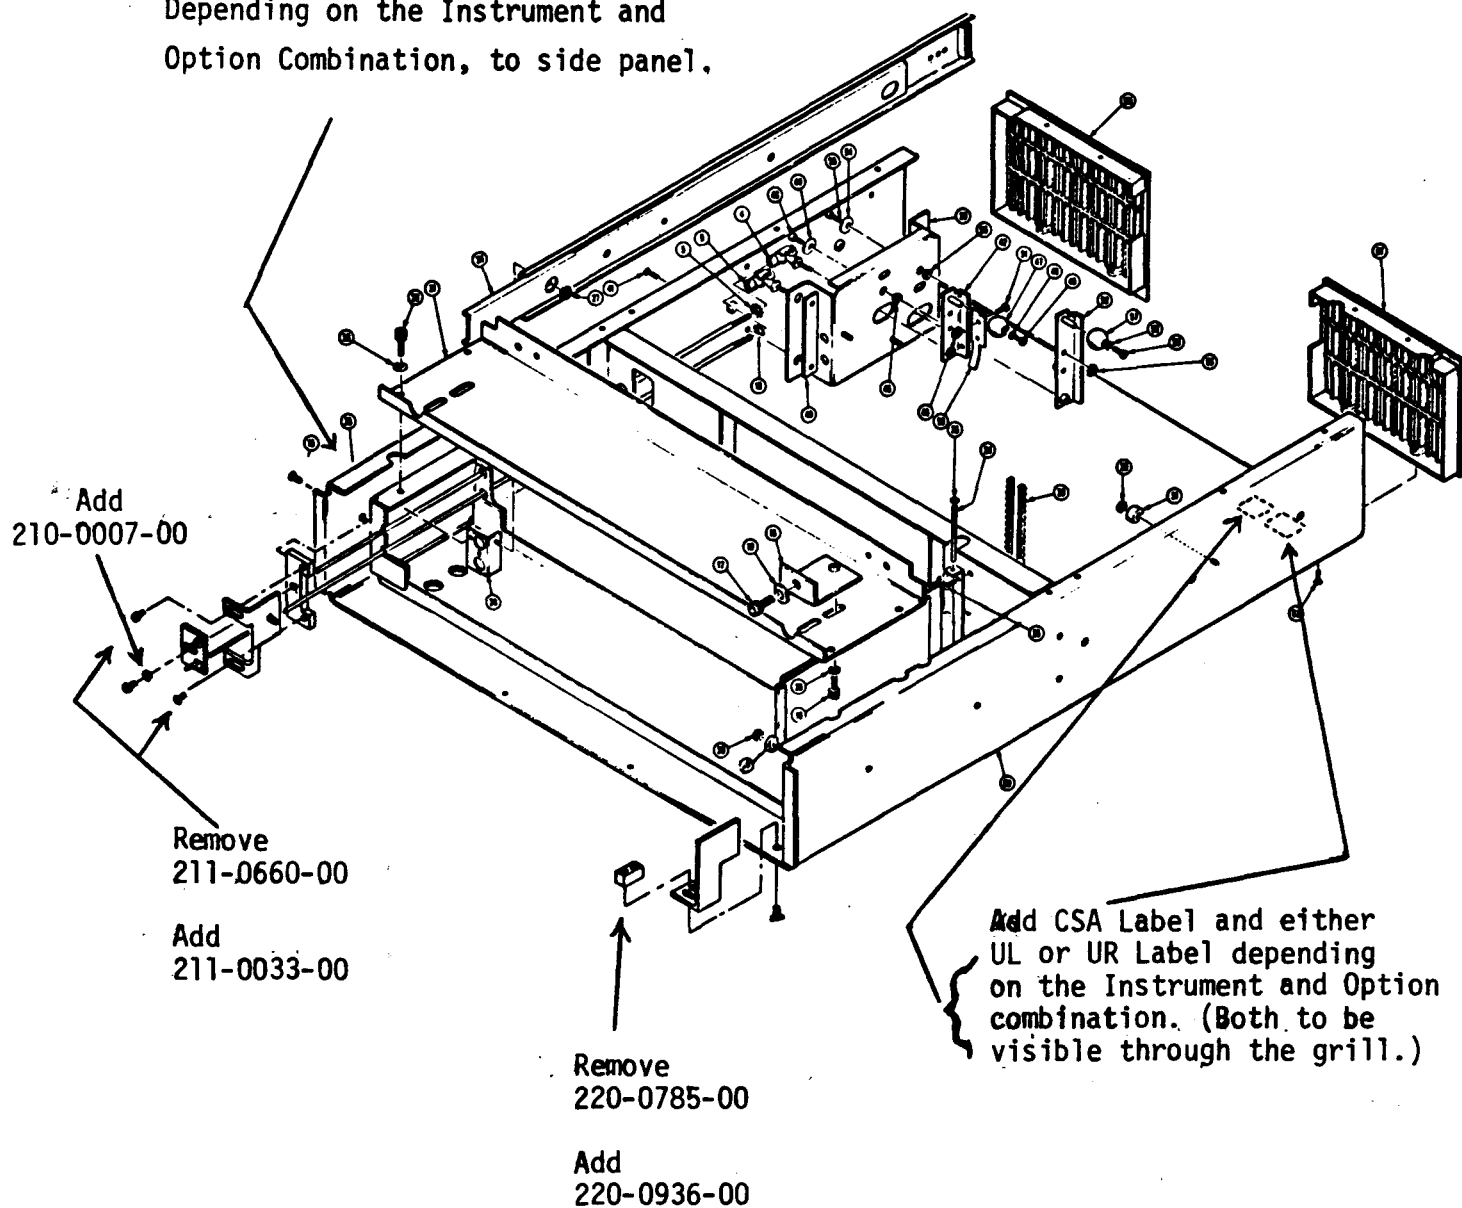
Figure 3

These labels are located at the rear of the bottom chassis as per Figure 3. These labels are not field replaceable. If one of these labels is damaged and must be replaced for customer requirements, the instrument must be returned to the factory. Contact Factory Service and arrange for the instrument to be sent in for recertification on the manufacturing line.

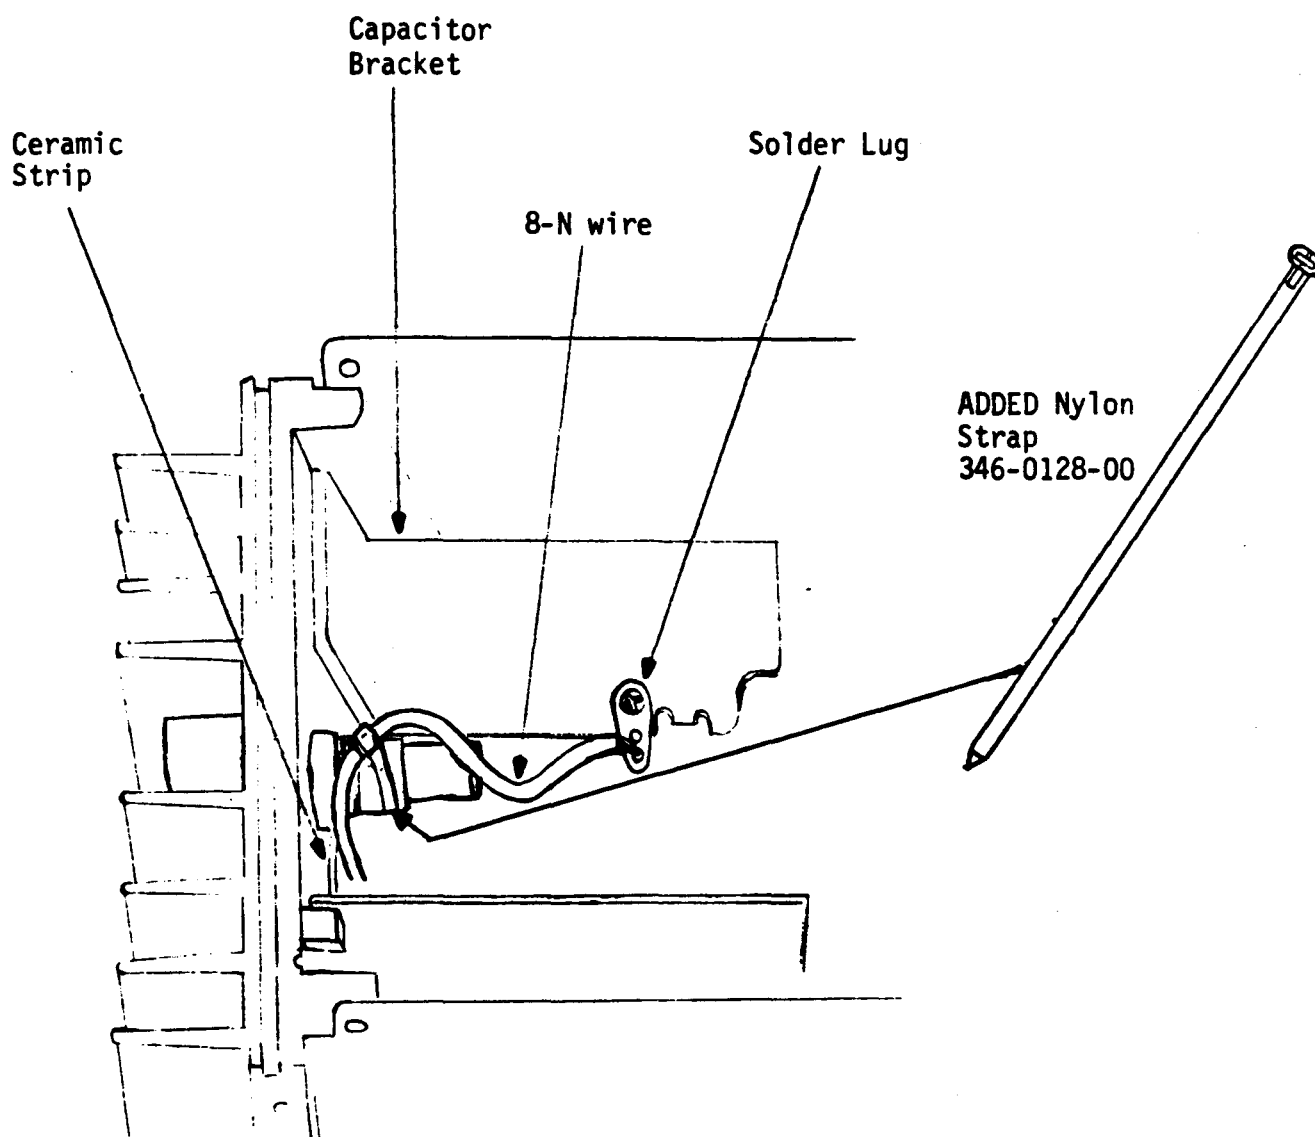
Partial View Low Volts Power Supply assembly 672-0873-02.

One of the requirements for UL recognition of the 690/6942 family was a tie-down strap on a grounding wire, holding it to the fuse holder case. In order to maintain UL integrity, this strap must be in place on any instrument repaired. This applies to those units that were UL

rated from the factory only, but since the power supply assemblies are on Repair and Return, please insure that the strap is also in place on any power supply module that is repaired under R & R. (See attached diagram.) Starting serial numbers for UL rated units are B010987 (6942) and B010361 (690SR).

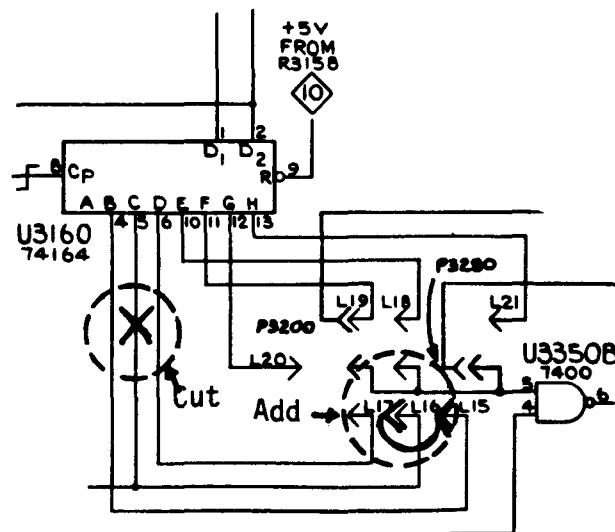
FIGURE A

Note - If you desire to key set up timing to Line 14, a pin is not provided in the VIRS Matrix. You can, however, obtain a Line 14 timing signal from Pin 3 of U3160 (not connected in present diagram).

Vertical insertion width adjustment can be modified to allow passage of lines 15 and 16 by replacing R7200 with an 18.2K ohm resistor, and then

adjusting R7205 for the desired insertion/deletion parameters.

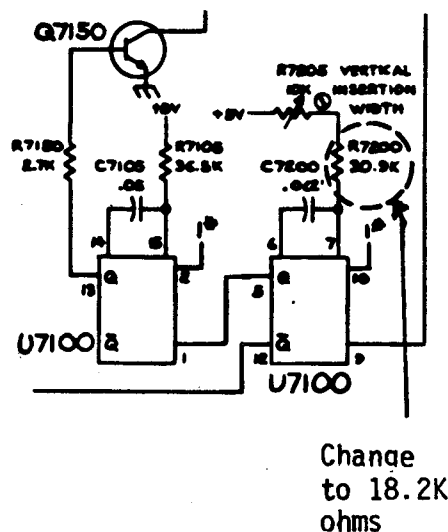
Figure B

Figure A illustrates the modification for setup timing, and figure B illustrates the modification for insertion timing.
