SERVICETEKNOTES

TABLE OF CONTENTS

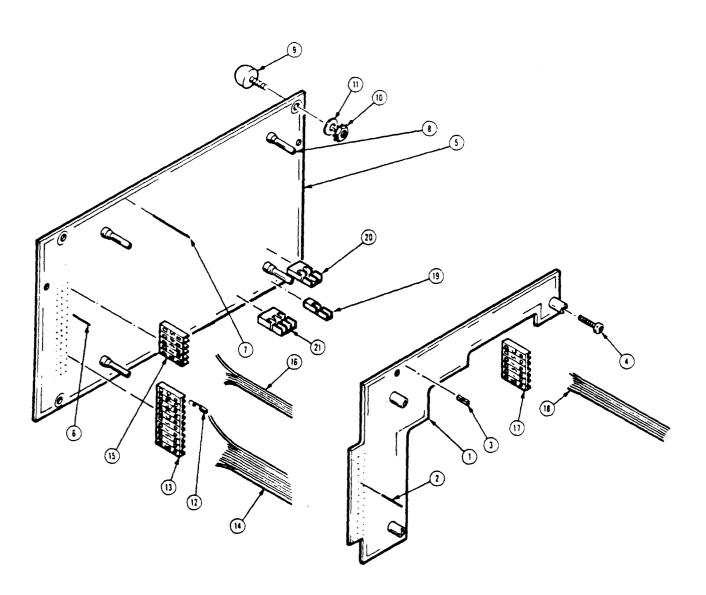
LOGIC BOARD EXTENDER for 7B92A

THIS EXTENDER IS FOR TROUBLESHOOTING ONLY, NOT ADJUSTMENTS.

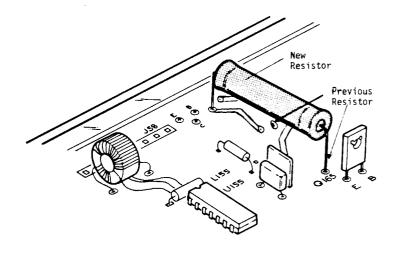
Figure 1

The display board in the 4006-1, 4051/52/52A products is experiencing a high failure rate due to high AC line voltages causing the failure of R64, R339, and Q165. The failure of R64 can generate enough heat to scorch, or even burn, the board.

Corporate modification #54922 fixes this failure mode by changing the value, wattage and placement of R64, and changing the source voltage of the CE1/CE2 circuit from +320 volts to +185 volts. To accomplish this, R64 is physically repositioned. It now connects between the +185-volt source (R39) and the collector of Q165. Physically, it will be positioned as shown in Figure 1.

R64 changes from 68K 2W resistor, P/N 305-0683-00, to a 30K 8W resistor, P/N 308-0105-00. The Display board for the 4006-1 changes from a 672-0537-11 to a 672-0537-12 and the Display board for the 4051/52/52A changes from a 672-0546-11 to a 672-0546-12.

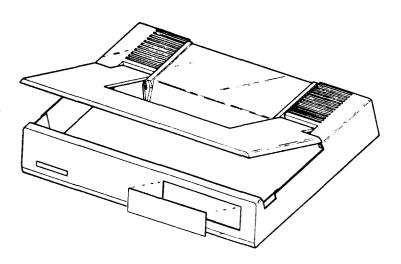
Figure 1
Front Panel Overlay; 118-3624-00

The front panel overlay on the 4695 is replaceable in the event of damage and can be ordered under the part number 118-3624-00. Please make this correction to your existing documentation.
