# Wizards Workshop

Published by Service Admin Support  
56-037

April 24, 1981  
Issue 11-7

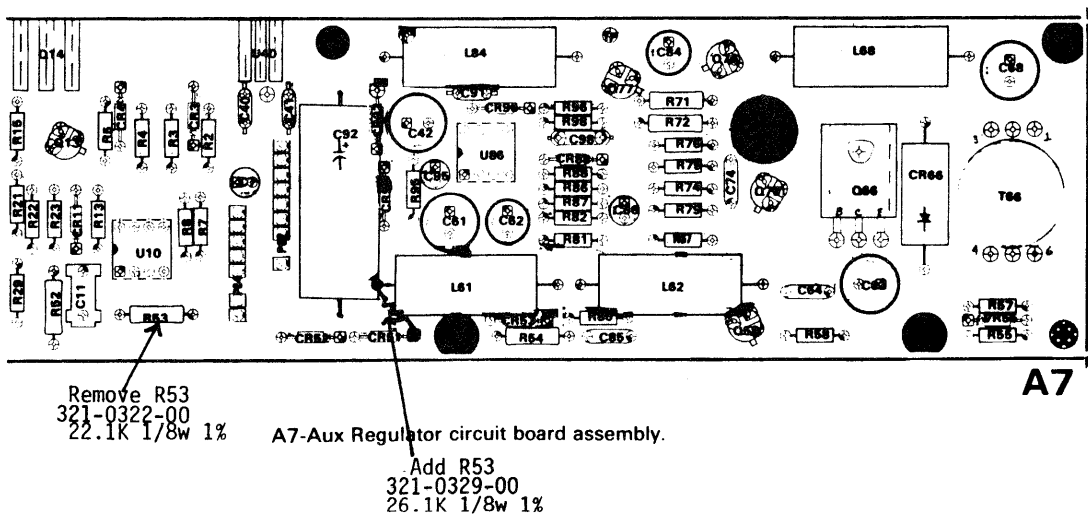
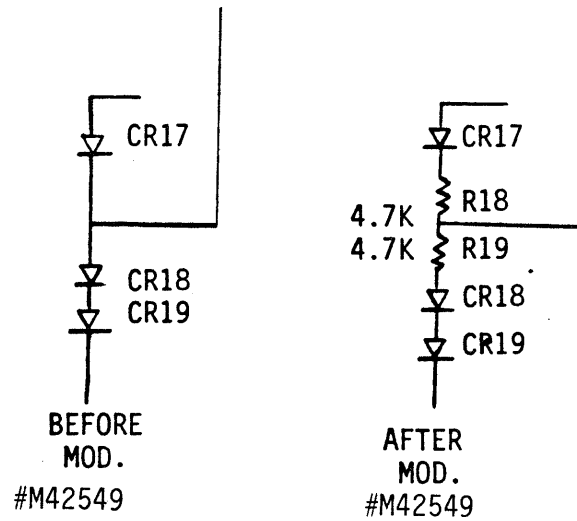
### 7854, PREVENTION OF POSSIBLE CRT BURNS

Mod #M42549 was first installed at Serial Number B010420 and consisted of removing CR17 and replacing it with P/N 152-0242-00, which is teeped with R18, 4.7K ohm, P/N 315-0472-00, which is a new part. Add R19, 4.7K ohm, P/N 315-0472-00, which is teeped in series with existing CR18. Mod #M42913 is being installed with serial numbers of B010600 and greater. This mod removes A7R53, 22.1K ohm, P/N 321-0322-00, resistor. The value is increased to 26.1K ohm, P/N 321-0329-00, and connected to the -17 volt supply. On the schematic this will show as R53 in the same position, but connected to -17 volts instead of -15 volts. See the following remove/add sketches and schematics for further info.

*NOTE: Both mods should be installed in instruments B010420 and below, and Mod #M42913 installed in instruments with serial numbers from B010421 to B010599.*

To assure performance and reliability Mod's #42549 and #M42913 should be installed as follows:

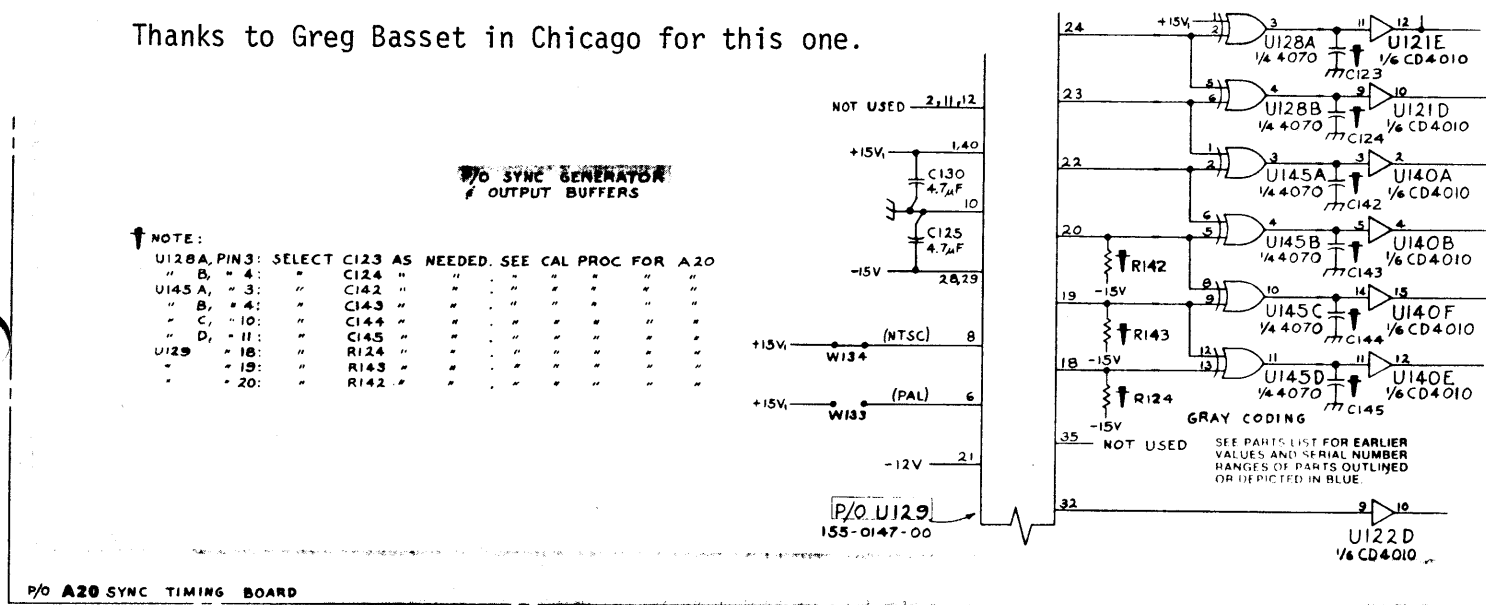
SPG 1 &amp; 2

During a recent update of portions of the SPG1/SPG2 Instruction Manual, some circuit details were inadvertently left out. The diagram below shows the circuit in question (Sync Timing

a). This circuit applies up to S/N B019999. After B020000 the manual schematic is basically correct in this area. Manual correction requests have been submitted.

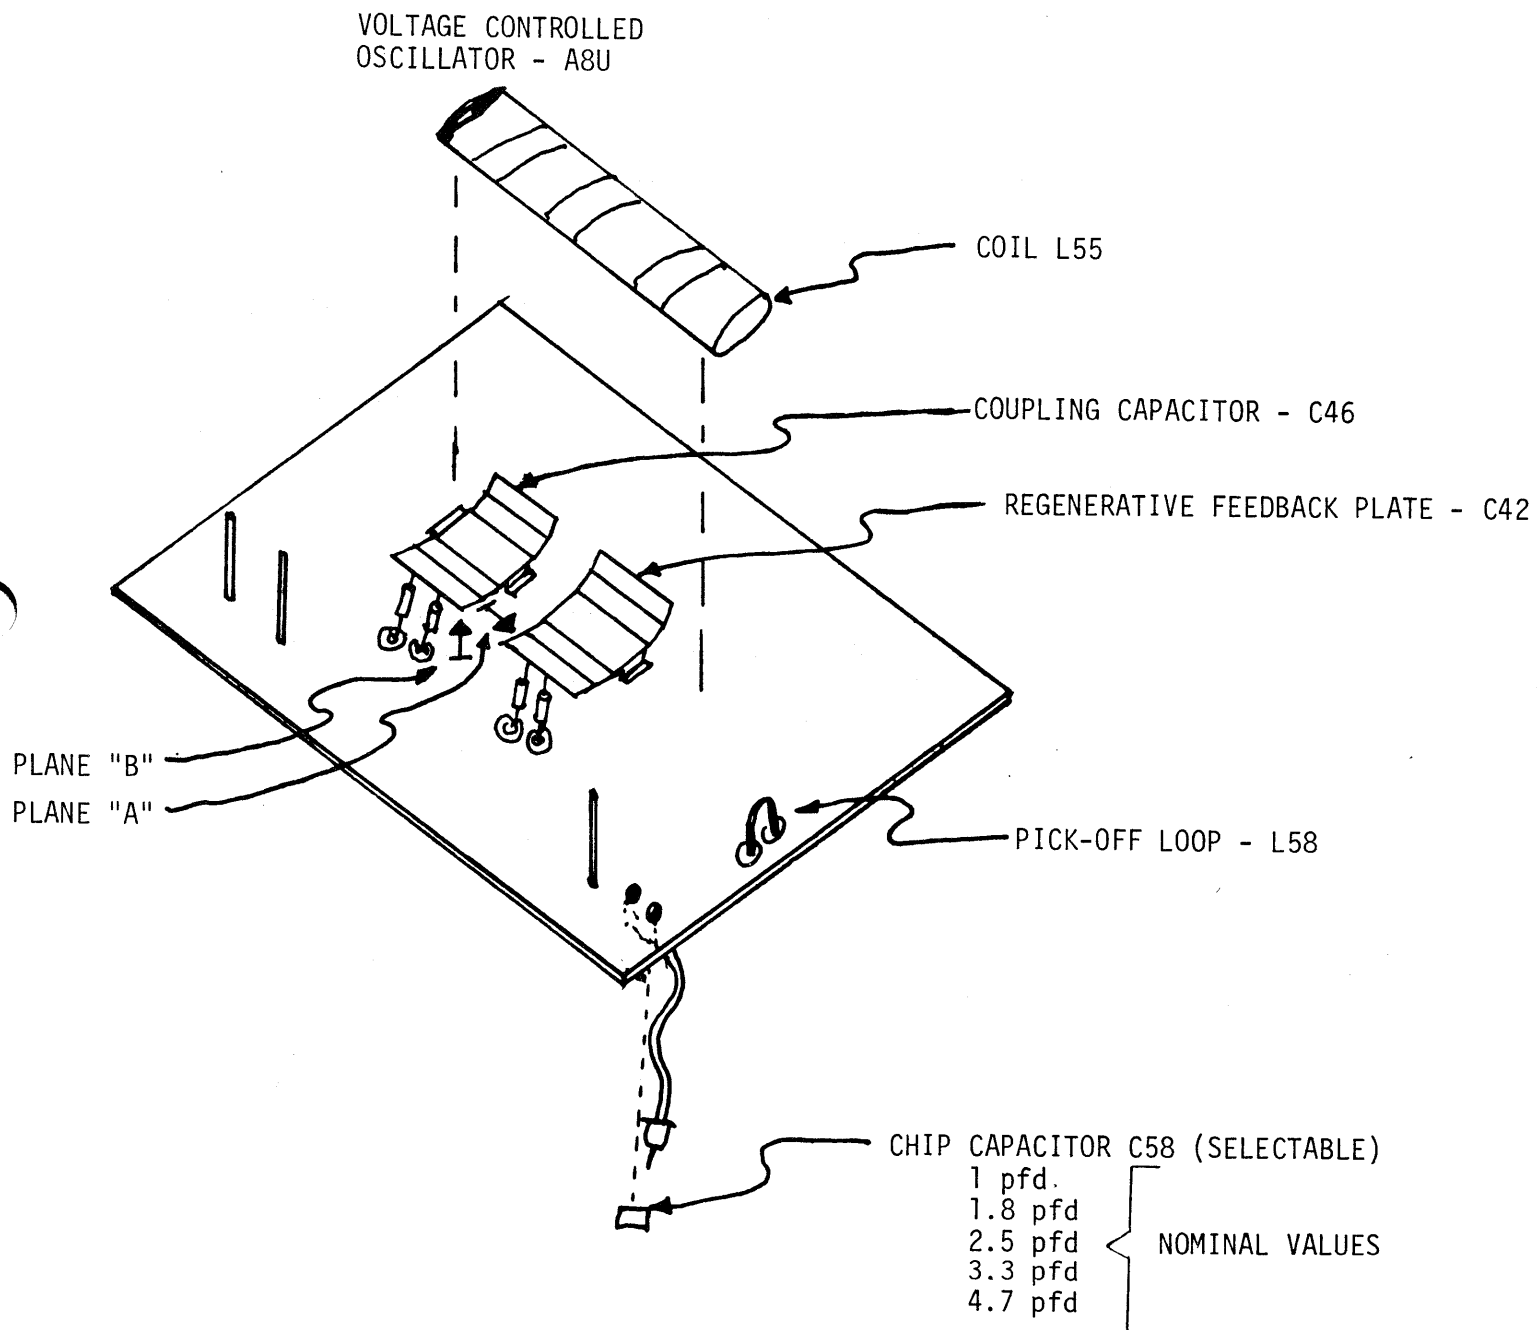
The coupling of power between the ceramic coil (L55) and the coupling plate (L46) is directly related to the metallic surface areas of the two parts. This becomes critical at higher frequencies where the 2 and 3.8 turn coils' metal strip is cut to short lengths to provide resonance at these wavelengths. The problem arises when only a small surface area of metal is available to place in close proximity with coupling plate C46. At this point, it is advisable to use the "barberpole" effect to position as much area as possible above C46.

Another useful method is to actually move C46 along plane "A" (see diagram) towards C42, being careful not to break the metal support tab or the standoff resistors in the process. If it is possible to also move C46 in plane "B" towards the coil, this is also helpful.

If, at any time, the oscillations disappear entirely, the coupling plate (C42) may also have to be moved or bent to facilitate regenerative feedback for Q33.

If the coil is suspected of having a hairline fracture on its ceramic form, a felt-tip pen ran around the inside of either end will reveal the crack as the ink seeps through.

When installing, the best way to avoid cracking the ceramic VCO coil is to use a pair of pliers wrapped with electrical tape. These will enable the coil to be held in place while the end plug and assembly washers are screwed into place. Standing the hog-out (aluminum frame) on the inside corner of a test bench will free both hands to position and insert the coil, along with its associated parts, together and center it.

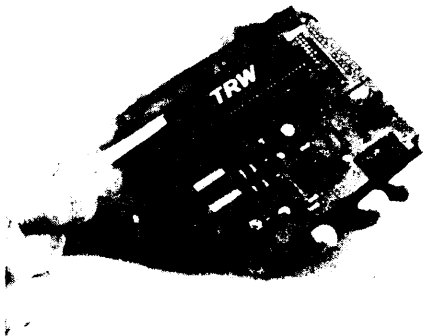
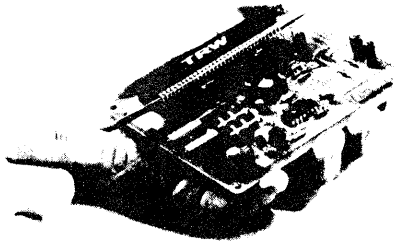
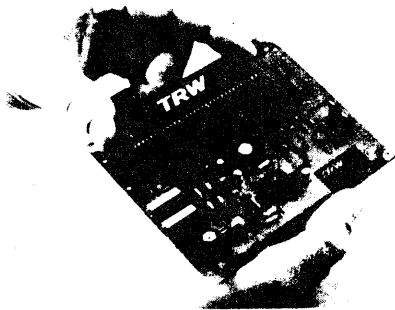
#### **PROCEDURE FOR REMOVAL OF 64 PIN PACKAGE**

Inserting or removing U456, a 64 pin package, incorrectly will result in damage to the chip. Damage occurs when applying uneven pressure by inserting or prying on one end of the chip and then moving to the other end to complete the insertion or removal. Small cracks in the I.C. results from uneven pressure which will show up as missing waveforms or complete failure.

To accomplish insertion, use a piece of flat metal placed over the entire chip and apply pressure evenly until the chip sets properly. To remove the chip use the following procedure recommended by TRW.

Slide a letter opener or similar device under the package and against one row of pins. (DO NOT USE A SCREWDRIVER).

Slowly rotate the opener to push the row of pins upward.

Repeat the procedure for the other row of pins.

Lift the package from its socket. If there is resistance, repeat the procedure.

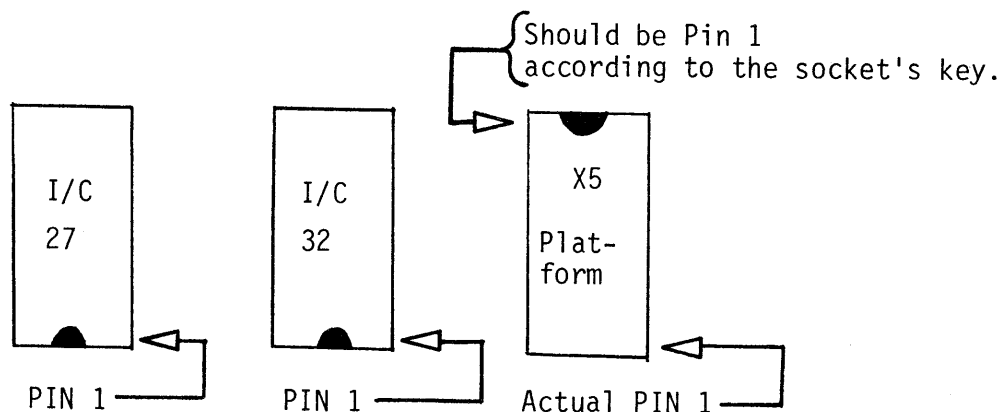
The jumper platforms are frequently mounted on the logic board reversed. When installing jumper networks into these sockets use the rest of the logic board's integrated circuits for a correct reference to the correct location of pin one. Note in the following example how pin one is the lower right pin, instead of the upper left pin, as the socket would indicate.
