COMBINATION EDITION

Wizards Workshop

TEKTRONIX INTERNAL USE ONLY

May 2, 1980
Issue 10-9

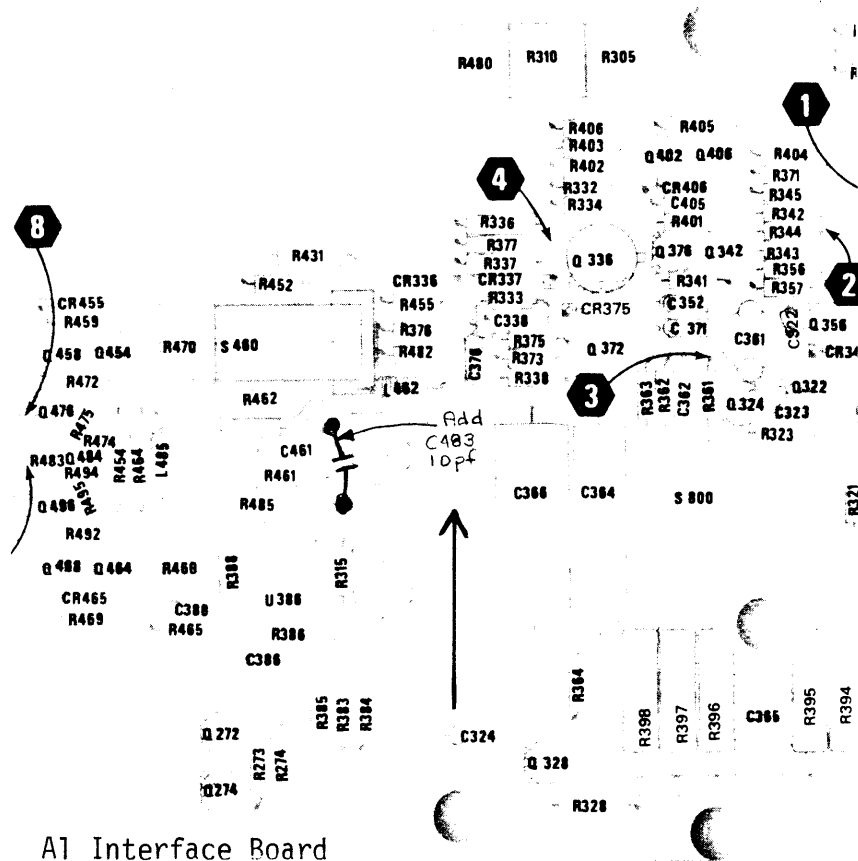
A1 Interface Board

There is a chance that the sweep will oscillate at random time/division settings. To eliminate the oscillations, add C483, a 10pf cap, P/N 281-0811-00, from the junction of R482 (68K) and R483 (10K) to the -15 volt power supply. See the attached drawing for part location.

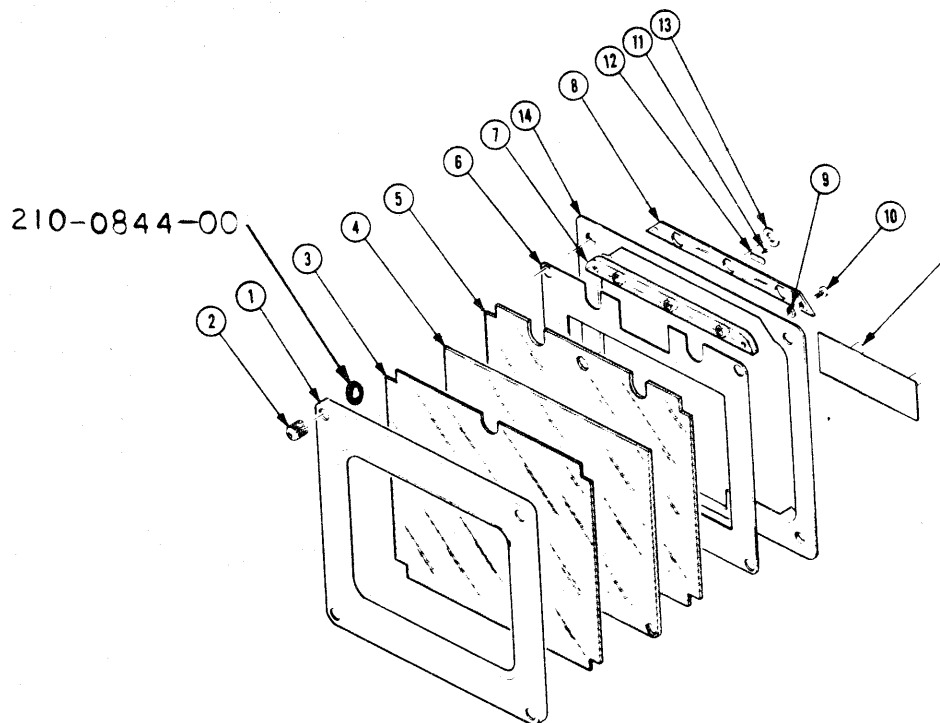
1480 SERIES

The part number for the rubber washer underneath the CRT Bezel is 210-0844-00. See the following drawing for the location.

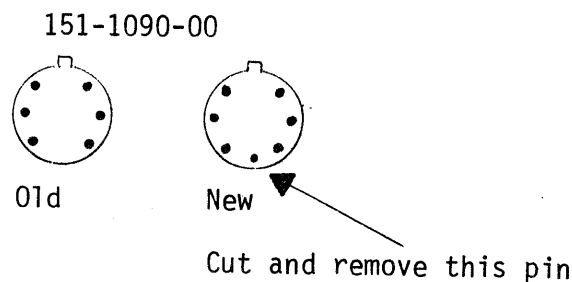
Fig. 1

A dual N-Channel Fet, P/N 151-1090-00, used in the CH1 (Q1297) & CH2 (Q1698) vertical input circuit, now has 7 legs instead of 6. (The new leg will have to be removed to fit in the socket, see Fig. 1.) This is due to a change with internal bonding.

The change in bonding effects the capacitance of the FET, which in turn effects the H.F. response of the preamps. To compensate for this change in capacitance R1299, (CH1) and R1798 (CH2) are now selectable with a nominal value of 510Ω , P/N 315-0511-00 and a range of selection from 100Ω to $1K\Omega$. To select the correct value of resistance after replacing Q1297, Q1698:

- 1) Switch the preamp to the 5mv range and input the H.F. square wave. Use 6 div of display.
- 2) Adjust for a flat top within specs.
- 3) Switch to 20mv, and adjust the generator for 6 div.
- 4) If the first 10NS of display is rolled down, select a lower value resistor. If the first 10NS is rolled up, select a higher value resistor.
- 5) Due to interaction, check the 5mv range and readjust as necessary. If an adjustment is made, recheck and adjust the 20mv range. Re-check L.F. compensation.

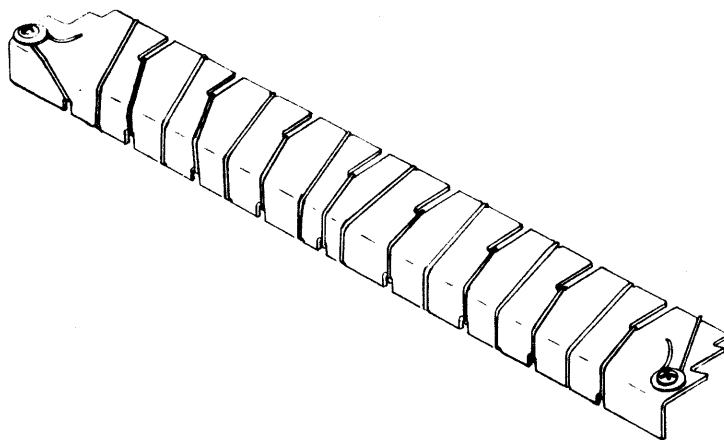
Figure 1. Front View

The fishline-wrapped processor entrance guide is not available in assembled form. It must be assembled from two parts: the "frame" and the fishline. The frame is orderable from Tektronix under part number 351-0378-01 (for the 4631 and 4632) or 351-0582-00 (for the 4633A and 4634). The fishline is 25 pound test monofilament line available in a 4 ounce spool under part number 253-0200-00. Assembly is not difficult provided a sample is at hand (see figure 1).

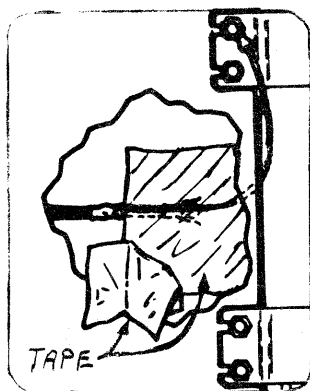
Incorrect Method

Recently reports from the field have indicated a common failure with the 4014/15 Storage boards on new terminals. The symptoms are; no storage, will not page, collimation okay, OP LEVEL high and can not be adjusted. Troubleshooting will probably show that Q85, Q154, Q183, and Q1023 are all shorted. Q1021 and Q1022 may also be shorted and in addition R589 will be burned and R185 and R187 may be burned.

The cause of these multiple failures has been traced to incorrect dressing of the ground cable on the CRT. Below is a illustration showing the location of the cable on one side of the CRT (newer CRTs have a cable on both sides), and two (2) exploded drawings showing the correct and incorrect methods of dressing the cable. What happens is with the cable incorrectly dressed directly over the anode button (target voltage), there is a tendency to short the anode (approx. 250 volts) to the grounding cable.

To remedy this problem the CRT must be removed from the terminal and the CRT Shield Assembly must be removed as per the Service Manual (070-2302-00) on pages 3-4 thru 3-6. With the shield removed notice that there are two (2) pieces of surgical tape holding the wire against the CRT. Be very careful when removing this tape, the silver paint from the anode buttons to the tabs comes off easily. If this paint is removed, the CRT will have to be replaced. As per the illustration, only the top layer of tape needs to be removed. Position the ground wire as shown and cover it back up with the tape. Note that there is an orange wire connecting to another button under these tapes. This is CE-2 and has not been a part of the problem.

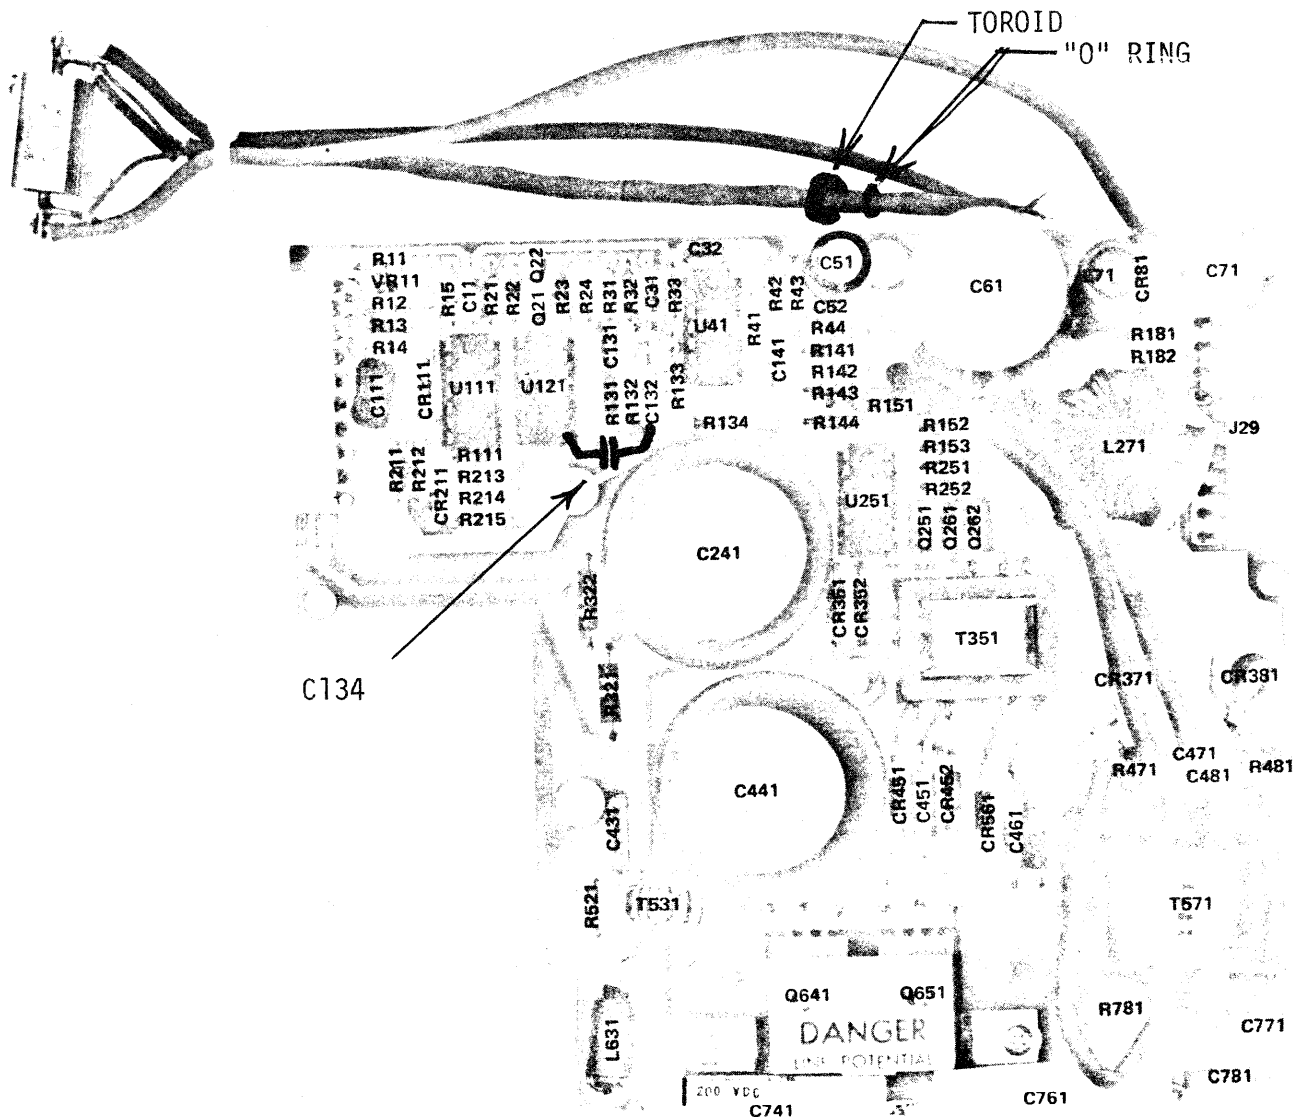
(FIGURE 1)

It has been found that power supply noise from the +5 volt output board in 4052's and 4054's has been degrading hard copy quality. A mod has been generated to reduce the noise from the +5 volt supply, thus increasing hard copy quality.

+5 Volt Output Component Location (067-5622-00).

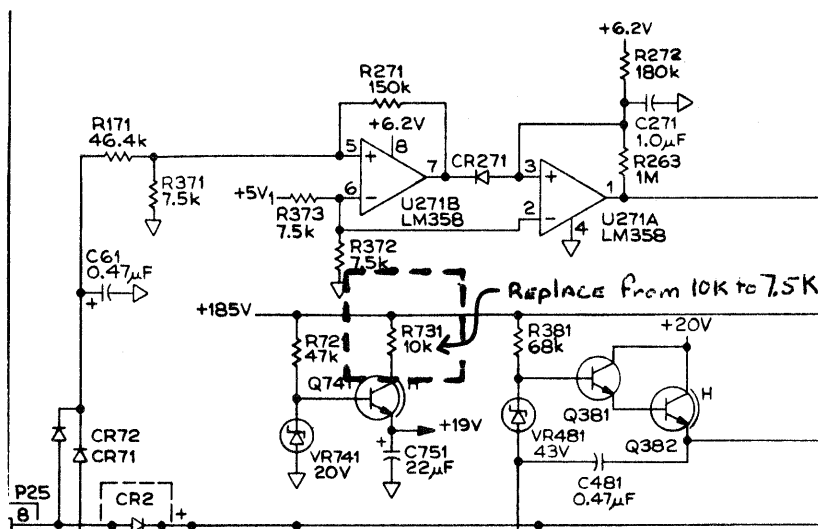
Figure 1 Schematic 1-1 Power Supply
4052 Service Manual

The +15 supply goes out of regulation at low line. The problem is caused by insufficient current capability of the +19V supply used to supply the +15V regulator circuit. This problem could be causing the 4052/54 to randomly lock-up customers units.

The Mod to solve this problem is as follows: (refer to figure 1)

1. Change R731 of the 670-5623-00 regulator board from a 10K (321-0289-03) resistor to a 7.5K. (321-0277-00)

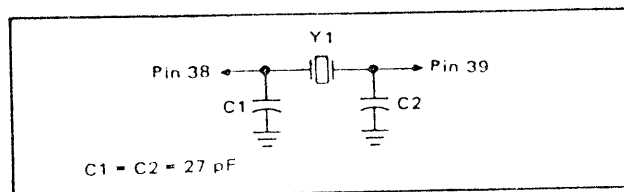
One problem is the type of crystal used. Motorola's advance information sheets (1977) called for a series resonant fundamental crystal (AT cut). Later specification sheets (1979) called for a parallel resonant fundamental crystal (AT cut). At the present time the parallel resonant crystal is the recommended crystal to use with our probe tip and the user's microprocessor.

Crystal Specification — The 4.0 MHz specification case is shown below:

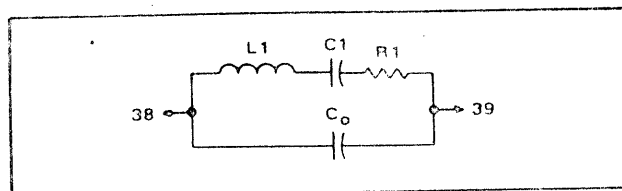
AT — Cut Parallel Resonance Crystal

The following is the figure and parameters to be supplied to the crystal vendor.
