TEKTRONIX INTERNAL USE ONLY

Published by Service Admin Support

September 25, 1981  
Issue 11-18

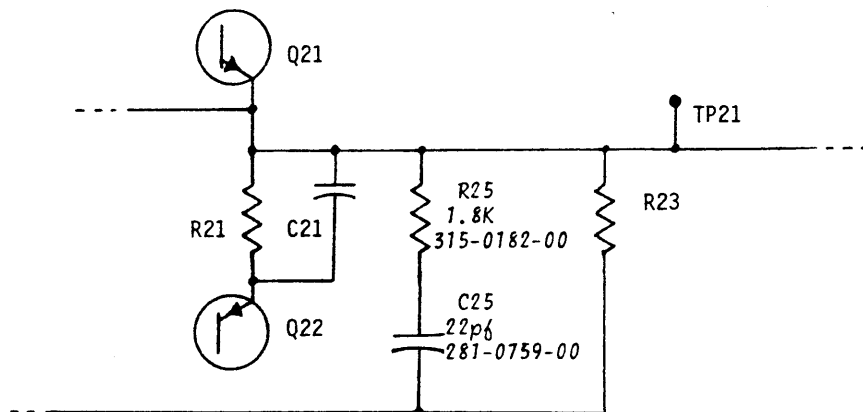
Figure 1. Addition of C25 and R25 to dynamic focus circuitry.

Focus uniformity has been adversely affected by an offset in the dynamic focus waveform. To correct this, a series RC circuit (R25 and C25) is added in parallel to R23. This is depicted in the schematic of figure 1. The addition of these two components changes the standard interface board from 670-5592-03 to -04 and the option 14 board from 670-5965-01 to -02.

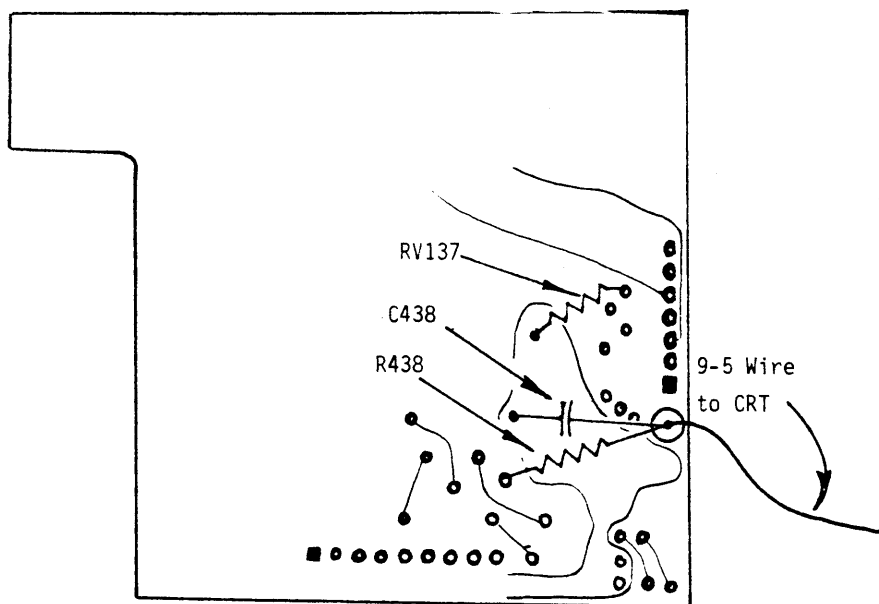
Figure 2. Component layout on back of high voltage board.

Visible noise in the raster has been caused by ripple in the +62 Volt supply. To reduce this ripple (and the noise), C438 and R438 are added to the back side of the high voltage boards. This is not a straight forward "Tee-Pee" and must be done in the following manner.

- Relocate RV137 to the position shown in figures 2 and 3. The functioning and schematic representation of RV137 does not change.
- Install a terminal post (131-0157-00) in the tooling hole near the number 1 lead of T410 (high voltage transformer).
- Add C438 from ground to the terminal. Protect the lead to the terminal with 1/2" of 162-0042-00 sleeving.
- Solder in R438 between the pad shown in figure 2 (junction of C437 and wiper of R435) and the terminal. Cover the whole resistor with a 1" length of 162-0042-00 sleeving to prevent it from shorting to nearby components or the underlying ground run.
- Solder the 9-5 (white background, green stripe) CRT lead to the terminal.

The addition of these components changes the standard high voltage board from 670-5593-02 to 670-5593-03, and the option 15 high voltage board from 670-6403-01 to 670-6403-02.

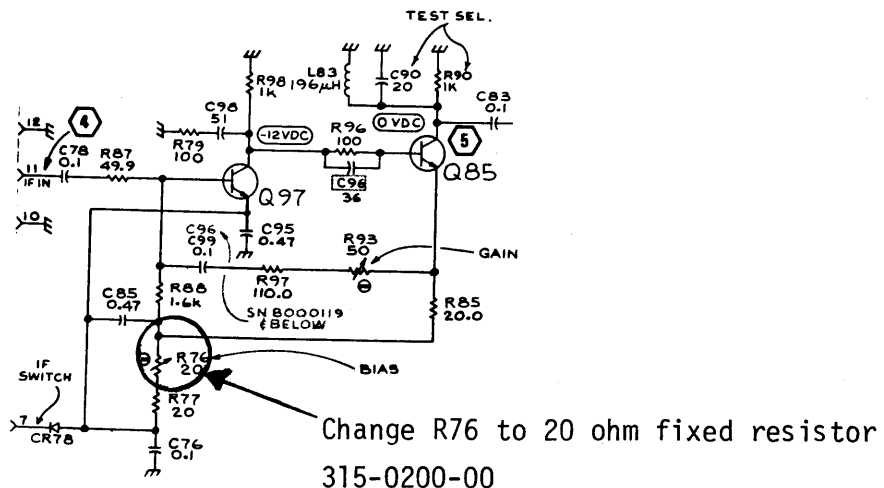
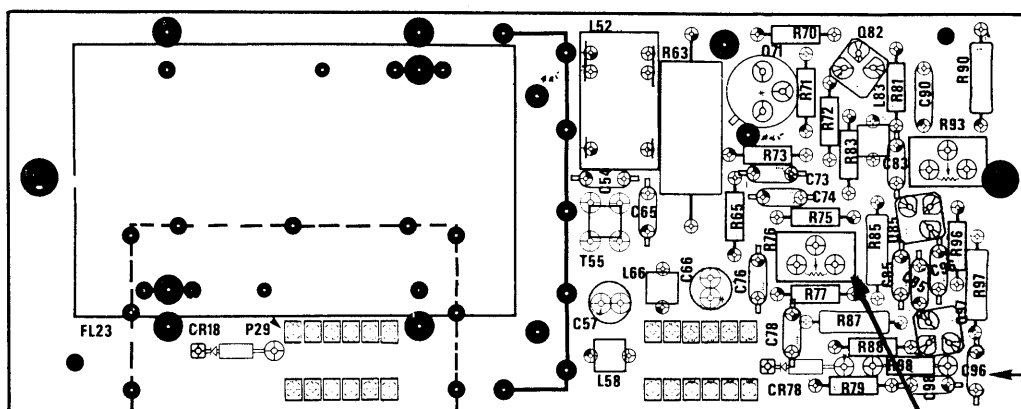
Setting R76 for minimum intermodulation (clockwise), as per the calibration procedure, has caused pre-mature failures of Q85 due to excessive power levels. This adjustment has been found to have very little effect on intermodulation distortion, as was its reason for being. A mod has, therefore, been submitted to implement removal of R76 and replacement of it with a 20 ohm fixed resistor (315-0200-00).

This bulletin is designed to formally request the field service organization to make this change on any 1450 series instrument that comes in for service. Copies of appropriate manual changes are included. Example schematics and parts location charts are below.

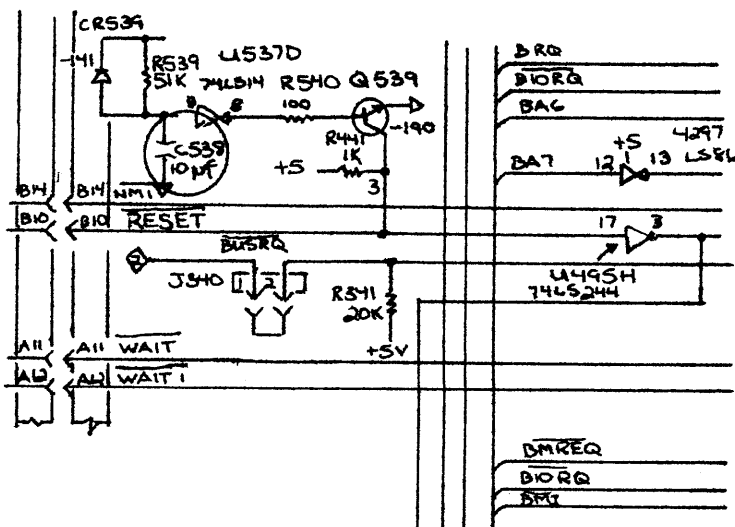
## CONTROLLER BOARD, SCHEMATIC 1

A change has been made to the controller board of the DAS 9109 mainframe which cures intermittent power up failures.

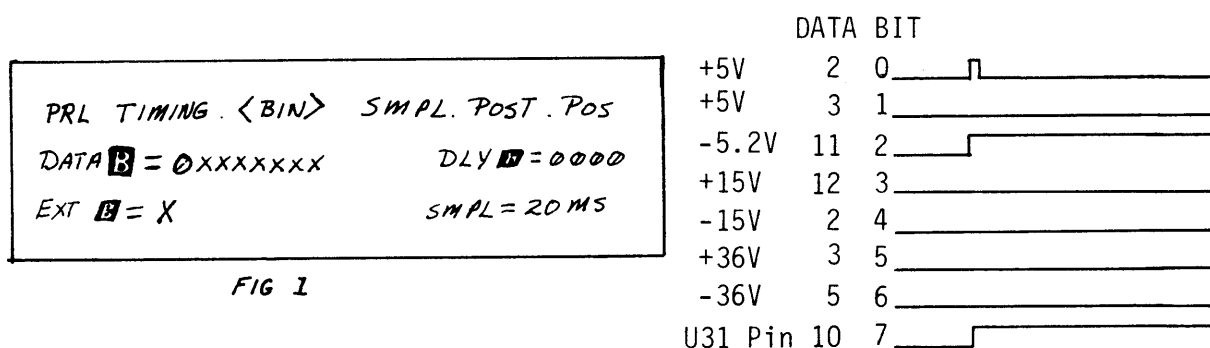
From the example wave form U31 Pin 11 shows the -5.2 volt circuit is at fault. The glitch on U31 Pin 2 occurs because there is no isolation between the +5 volts terminator resistor and transistor driver for each power supply sensing circuits. It should be noted that any fluctuation of the +5 volt supply will show up on the display on all logic analyzer inputs. This is because the +5 is supplied to collector resistors on all signal sense circuits.

Turn the power on the Test Station. As soon as the -15, +36 and -36 LEDs come on, push the 308 START button. If any power supply circuit glitches, the 308 will detect it. By looking at the display of the 308, it can be determined which circuit has problems.
