\*\*\*\*\*  
\* ALL SERVICE QUESTIONS FROM EUROPE, MIDDLE EAST, \*  
\* AND AFRICA SHOULD BE ADDRESSED TO THE EUROPEAN \*  
\* MARKETING CENTER SERVICE GROUP IN THE NETHERLANDS. \*  
\*\*\*\*\*  
TEKTRONIX INTERNAL USE ONLY

June 27, 1980  
Issue 10-13

TABLE OF CONTENTS

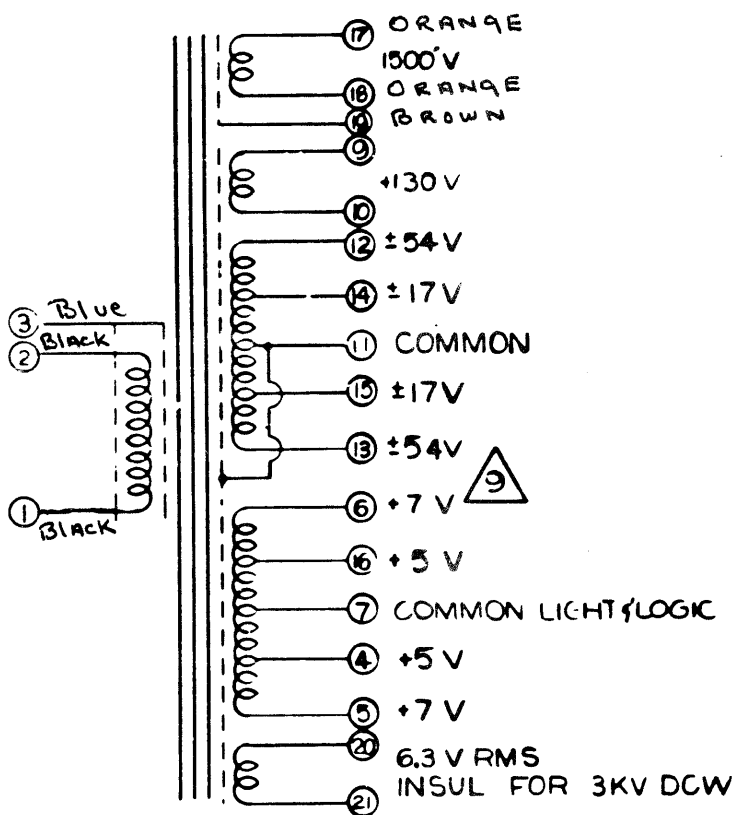
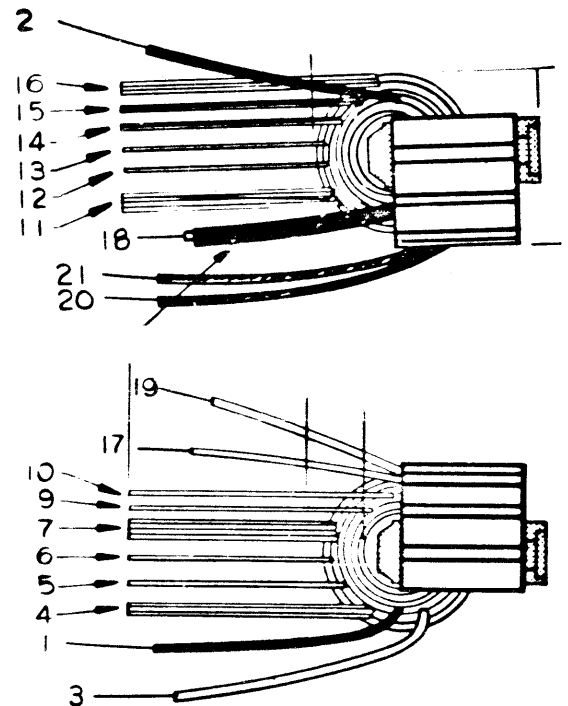
The power transformer, P/N 120-0742-00, previously used in the above instruments, has been replaced by P/N 120-1250-00. The only change is that on the +5 volt light winding, instead of increasing wire size, an extra wire was added. These wires are terminals #4 and #16, and are now 3 large tinned copper wires. It is difficult to connect these wires, as the holes are small, but with care it can be done. Below are drawings which should help in wiring.

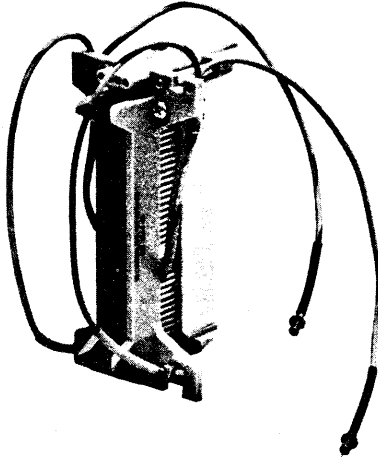
After a period of time the coax cables and connectors on this fixture can become intermittent, or may have broken loose from the connector. The cables are very critical as far as their length is concerned. Do not replace them with just any coax. A cable replacement set is available and contains all four cables. Order P/N 198-2788-00.

Signal Pickoff Connector. Used in conjunction with the 067-0616-00 Flexible Extender in order that the 7000 series horizontal or vertical plug-in unit may be operated outside of the oscilloscope and still be properly terminated.

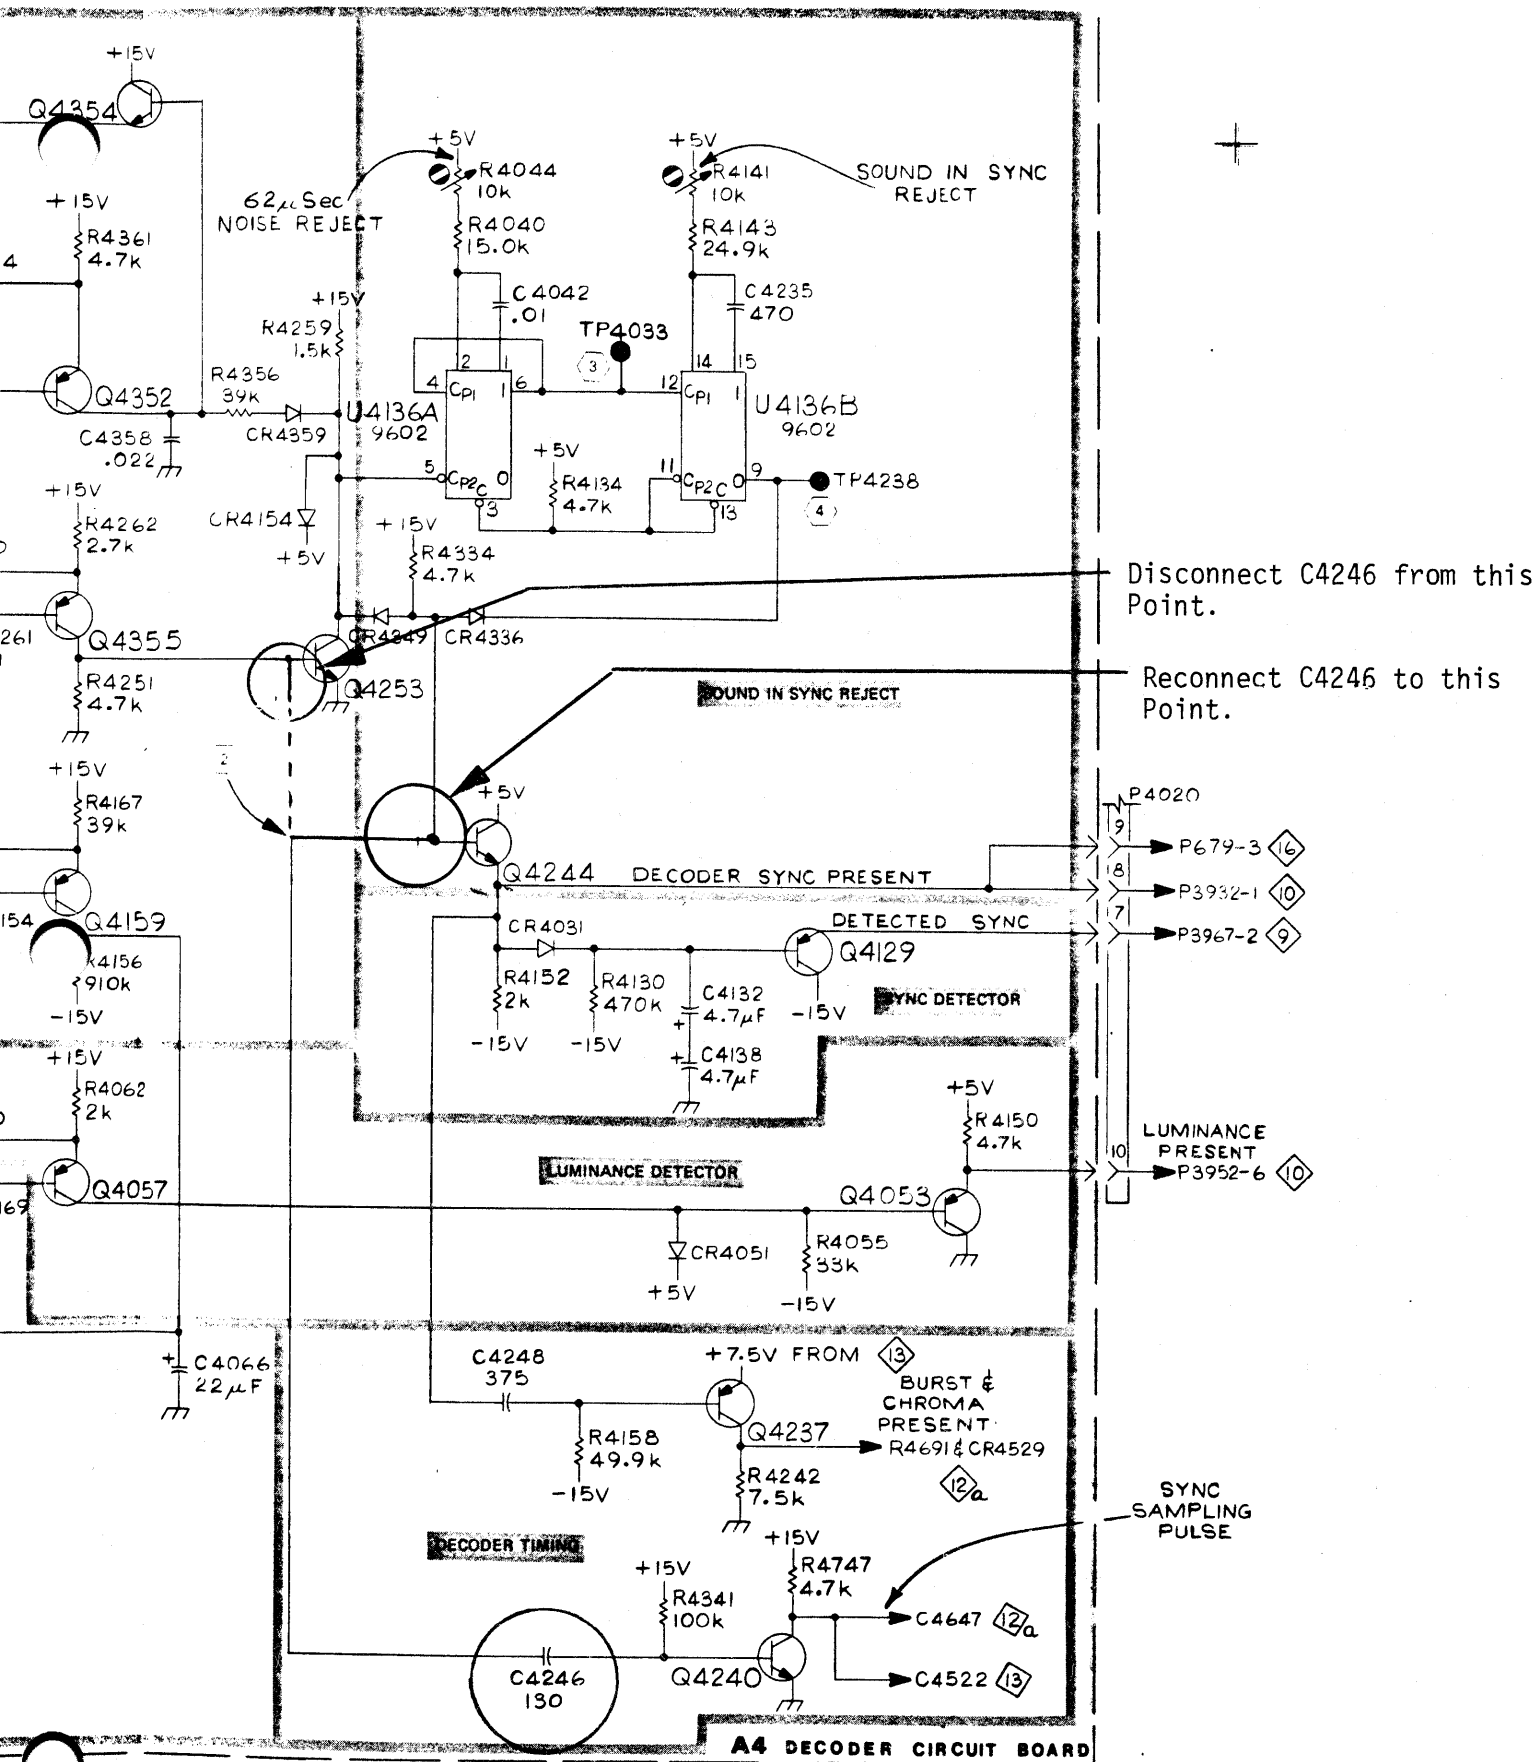
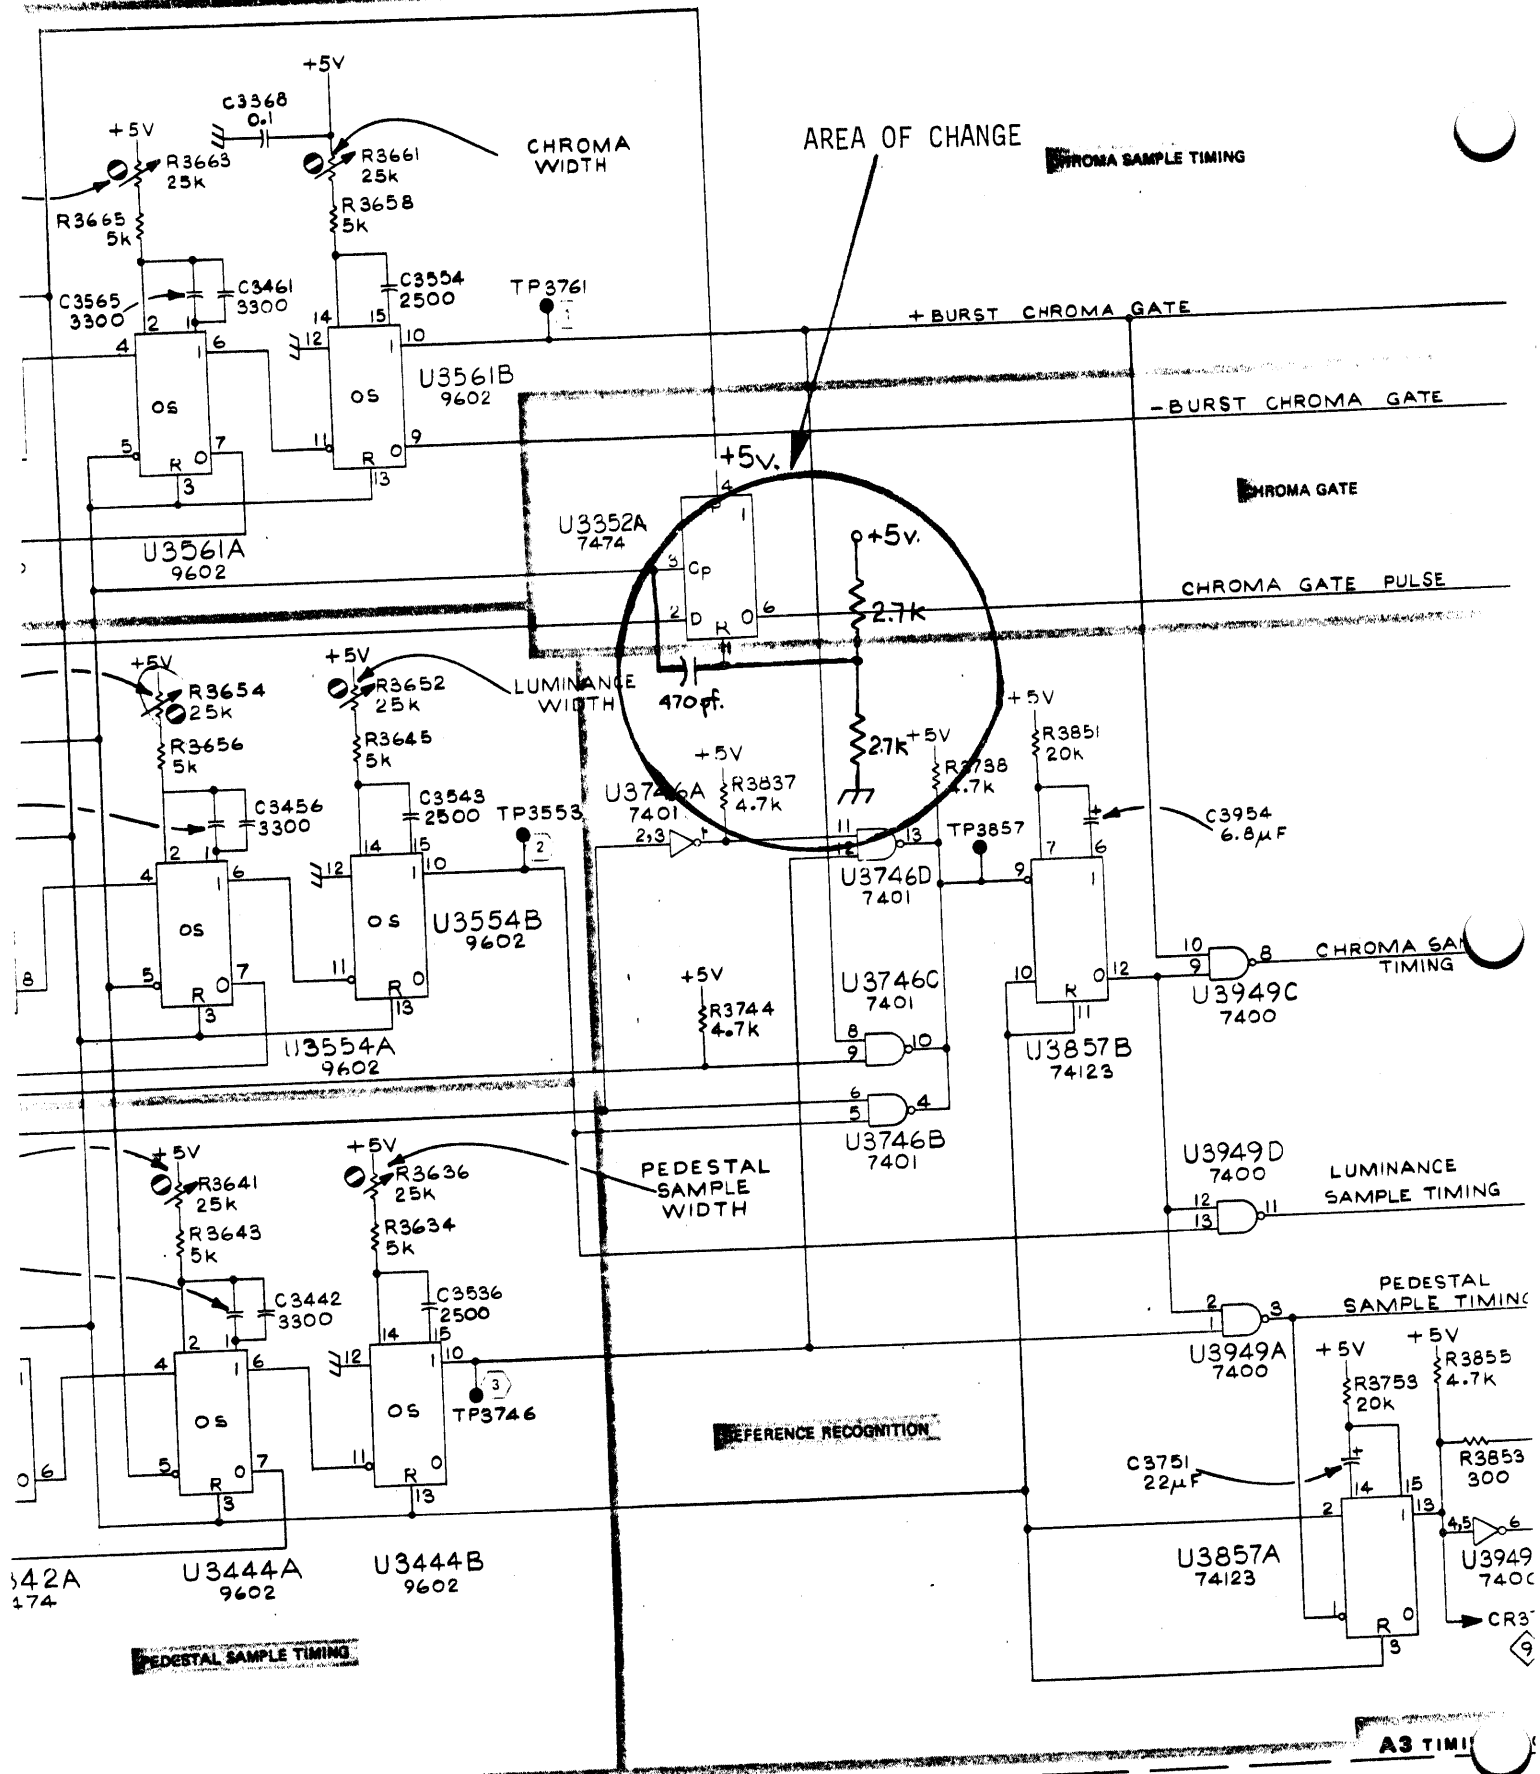
DECODER SYNC STRIPPER 11

1460 instruments used in Sound-in-Sync applications may exhibit Burst and/or Chroma gain "bounce". The sync sampling pulse for decoders (U4651 A & B) has sound-in-sync (S-I-S) present. This causes faulty clamping at TP4351 and TP4721. The end result is varying burst and chroma gain on the output. To correct this malfunction, lift the end of C4346 (A4 decoder circuit board) connected to the collector of Q4253. Reconnect this lead to the base of Q4244. Since the signal present on the base of Q4244 comes from the S-I-S reject circuitry (U4136 A & B), it does not have S-I-S present.

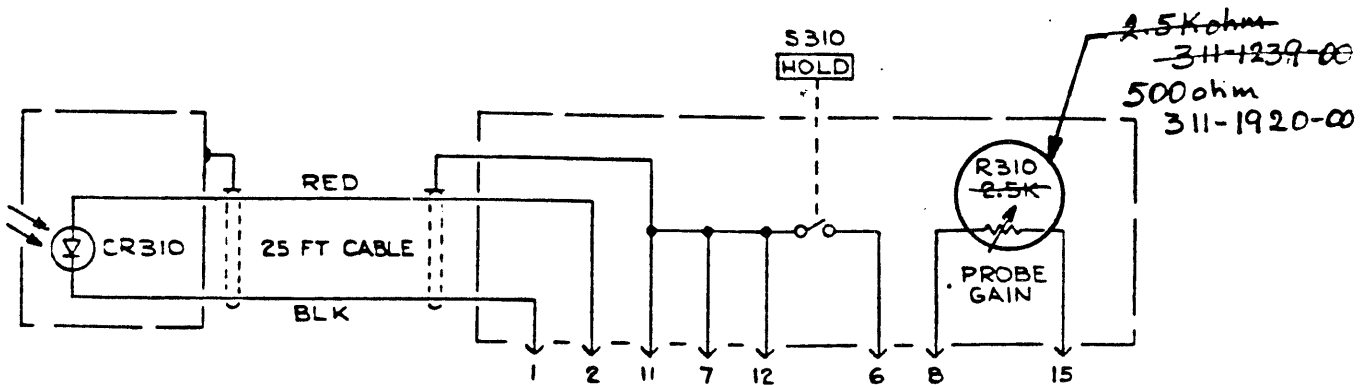
J6511 Schematic

Effective S/N B011133, Resistor R310 will change from a 2.5K ohm P/N 311-1239-00, to a 500 ohm P/N 311-1920-00. See schematic below for location of parts. This is due to the lack of extra sensitive photo diodes, and the increased difficulty of calibration.

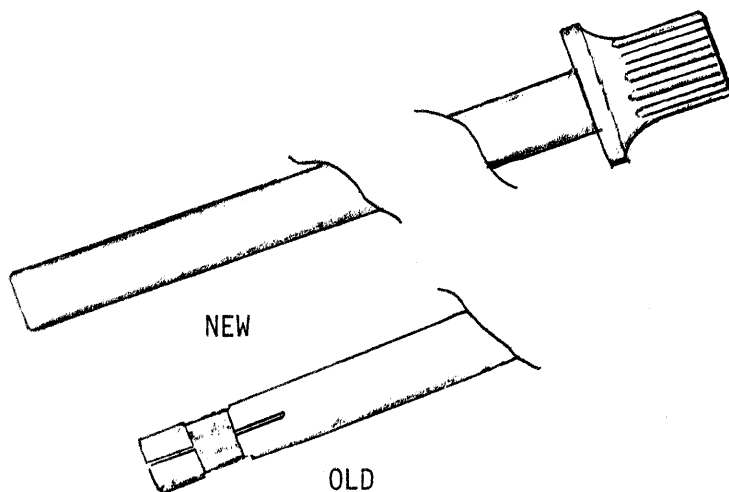
Illustration 1.

To reduce binding of shafts for position controls, CRT controls, etc., the molded knobs with shafts have been redesigned. With the new shaft, the controls will rotate freely and will have a better "feel". The illustration below shows the physical difference between the two shafts. Though the difference is minor, the new shafts will work much better. The new P/N's are a direct replacement.

Old Part Numbers		New Part Numbers
384-1371-00 2.0"L x .280D	- to -	384-1371-05 1.75"L x .280D
384-1371-01 5.265L x "	- to -	384-1371-06 5.015L x "
384-1371-02 6.8L x "	- to -	384-1371-07 6.55L x "
384-1371-03 10.6L x "	- to -	384-1371-08 10.35L x "

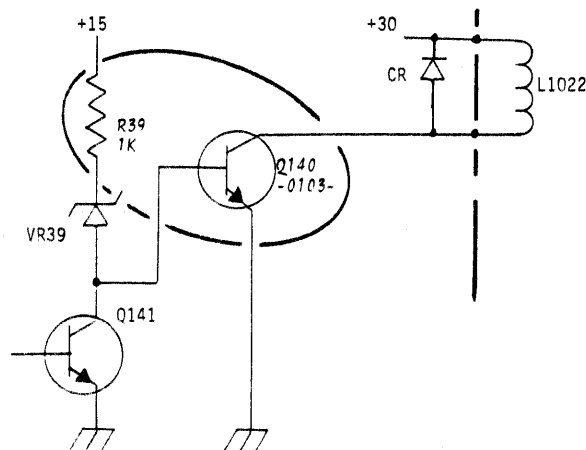
Meanwhile, use of the 105-0520-01 cutter clutch in the 4631, 4632 and 4634 produced the undersirable effect of failure to cut under low line conditions. To correct this, modification 40065 was implemented.

This mod calls for R39 on the 4631, 4632 and 4634 control boards to be changed in value from  $3K\Omega$  to  $1K\Omega$ . The new part number for R39 is 315-0102-00. In addition, transistor Q140 is changed to a higher beta 151-0103-00. These changes cause the 4631 and 4632 control board part number to roll from 670-4104-05 to 670-4104-06. The 4634 control board changes from 670-5770-01 to 670-5770-03.

A field kit, p/n 050-1375-00 has been set up for replacement of the 105-0520-00 cutter clutch by the -01 version in the 4631, 4632, and the 4634.

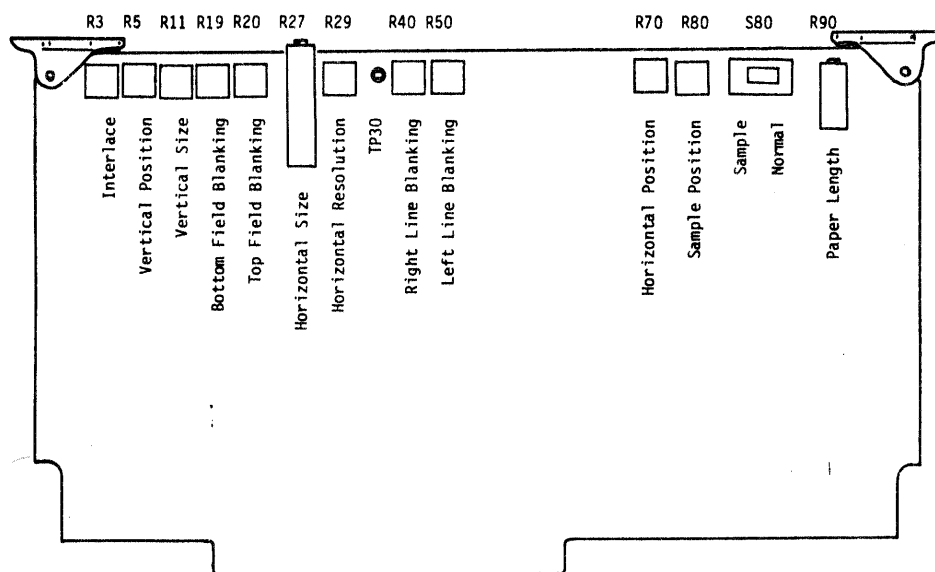
Figure 1: 4634 Timing Board Controls

Figure 1 shows the various controls to be adjusted on the 670-5723-0X timing board used in the 4634. Figure 2 illustrates the approximate effect obtained on a copy by adjusting these controls. Use these figures for reference as you proceed with the calibration. In the event the 4634 requires more extensive calibration, or possibly troubleshooting, please refer to 4634 Instruction Manual, p/n 070-2562-02.

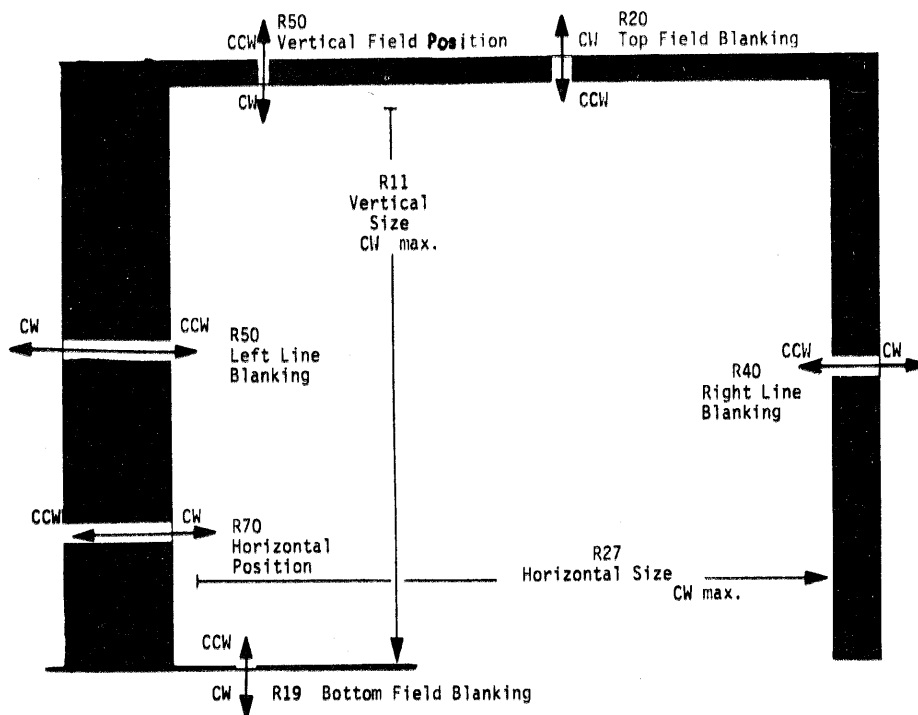
Figure 2: Effects of Controls on Copy

1. Substantial portions of the raster picture are missing on the hard copy,
2. the aspect ratio of the image is incorrect (image appears stretched or compressed).
3. Large portions of the image area are occupied by black (or white) margins, or
4. the raster lines are so evident as to severely detract from the image quality (lack of interlace).

6. If the size is indeed correct, check that the image is centered on the page. If not, adjust R70 (horizontal image position) or R5 (vertical image position) as required. When adjusting R70, be certain to allow at least 1.4 inches of border from the edge of the paper to the beginning of the image. Failure to do so may result in a smeared left-hand side of the image.

8. Now that a properly sized and centered image has been obtained, its time to "pull in the blanking." Adjust R19, R20, R40 and R50 to blank out the horizontal and vertical intervals (those black lines bordering the image). To ensure that slight variations from drift and vibration do not cause the "margins" to reappear, it is necessary to blank out a small portion of the video information. An overlap of one-sixteenth of an inch is usually sufficient.
