SERVICETEKNOTES

TABLE OF CONTENTS

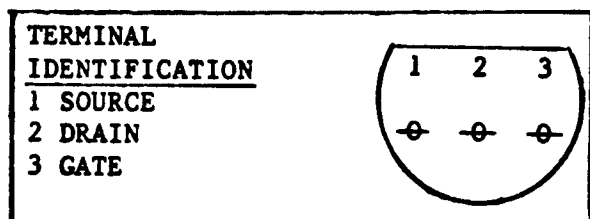
FG502 FET (Q200, Q202) ORIENTATION

The question has been raised about terminal identification on FET's with P/N 151-1042-00. This in turn causes confusion when replacing Q200 and Q202 in the FG502 Triangle Generator circuit. Below is a diagram that identifies the terminals on this particular case style.

Note: Bottom view of component is indicated.

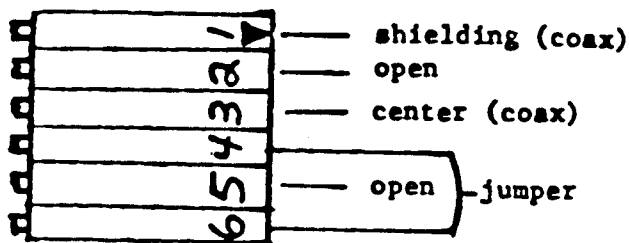
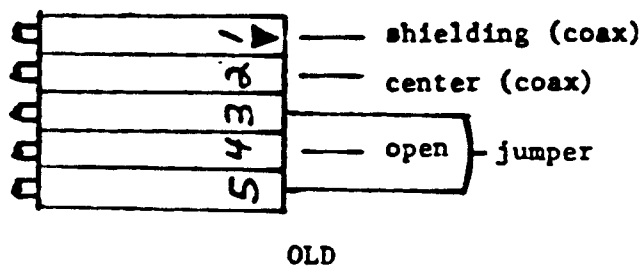
7612D CIRCUIT BOARD DISCREPANCYREF: 7612D Instruction Manual
(070-2387-00)
Parts Location Diagram for the
A26 Deflection Amplifier
Circuit Board

Connector A26 J918 was changed when the circuit board went from a 670-4941-04 to the 670-4941-05 version. The connector on cable P918 will need to be modified to be compatible with the -05 version circuit board. The illustration below reflects these changes. P/N 352-0164-00 (Black plastic connector, 6-pin) is needed to make this change.

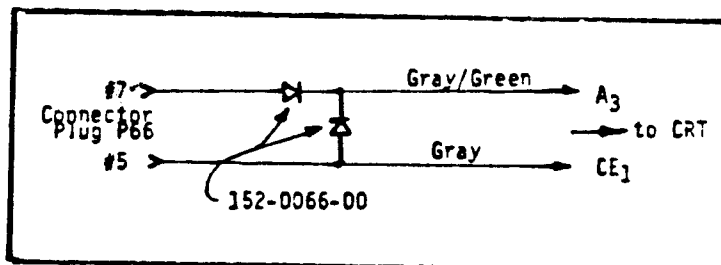
Many 25" DVST CRT's P/N 154-0807-54 built during the past six months contained a defective resistor (1000 ohm, 3 watt) located in the flood gun anode lead on the wiring harness. The defective resistor was caused by overheating during a CRT manufacturing process.

CRT manufacturing has now eliminated the resistor from the flood gun anode lead; and to control hard copy oscillation of the CRT, installed two diodes (152-0066-00) in the A3 and CE1 leads of the wiring harness. See diagram. The diode will pull the CRT A3 wallband to about 238 volts along with CE1 while the tube is in the hard copy mode.

The CRT's using the new wiring harness configuration will carry P/N 154-0807-55 and will be a direct replacement for the older -54 CRT's. This change was effective in week 32, 1985. The older CRT part number will no longer be available. (Note that the new part number represents only a change to the wiring harness; the actual CRT is the same).
