TEKTRONIX INTERNAL USE ONLY

April 10, 1981
Issue 11-6

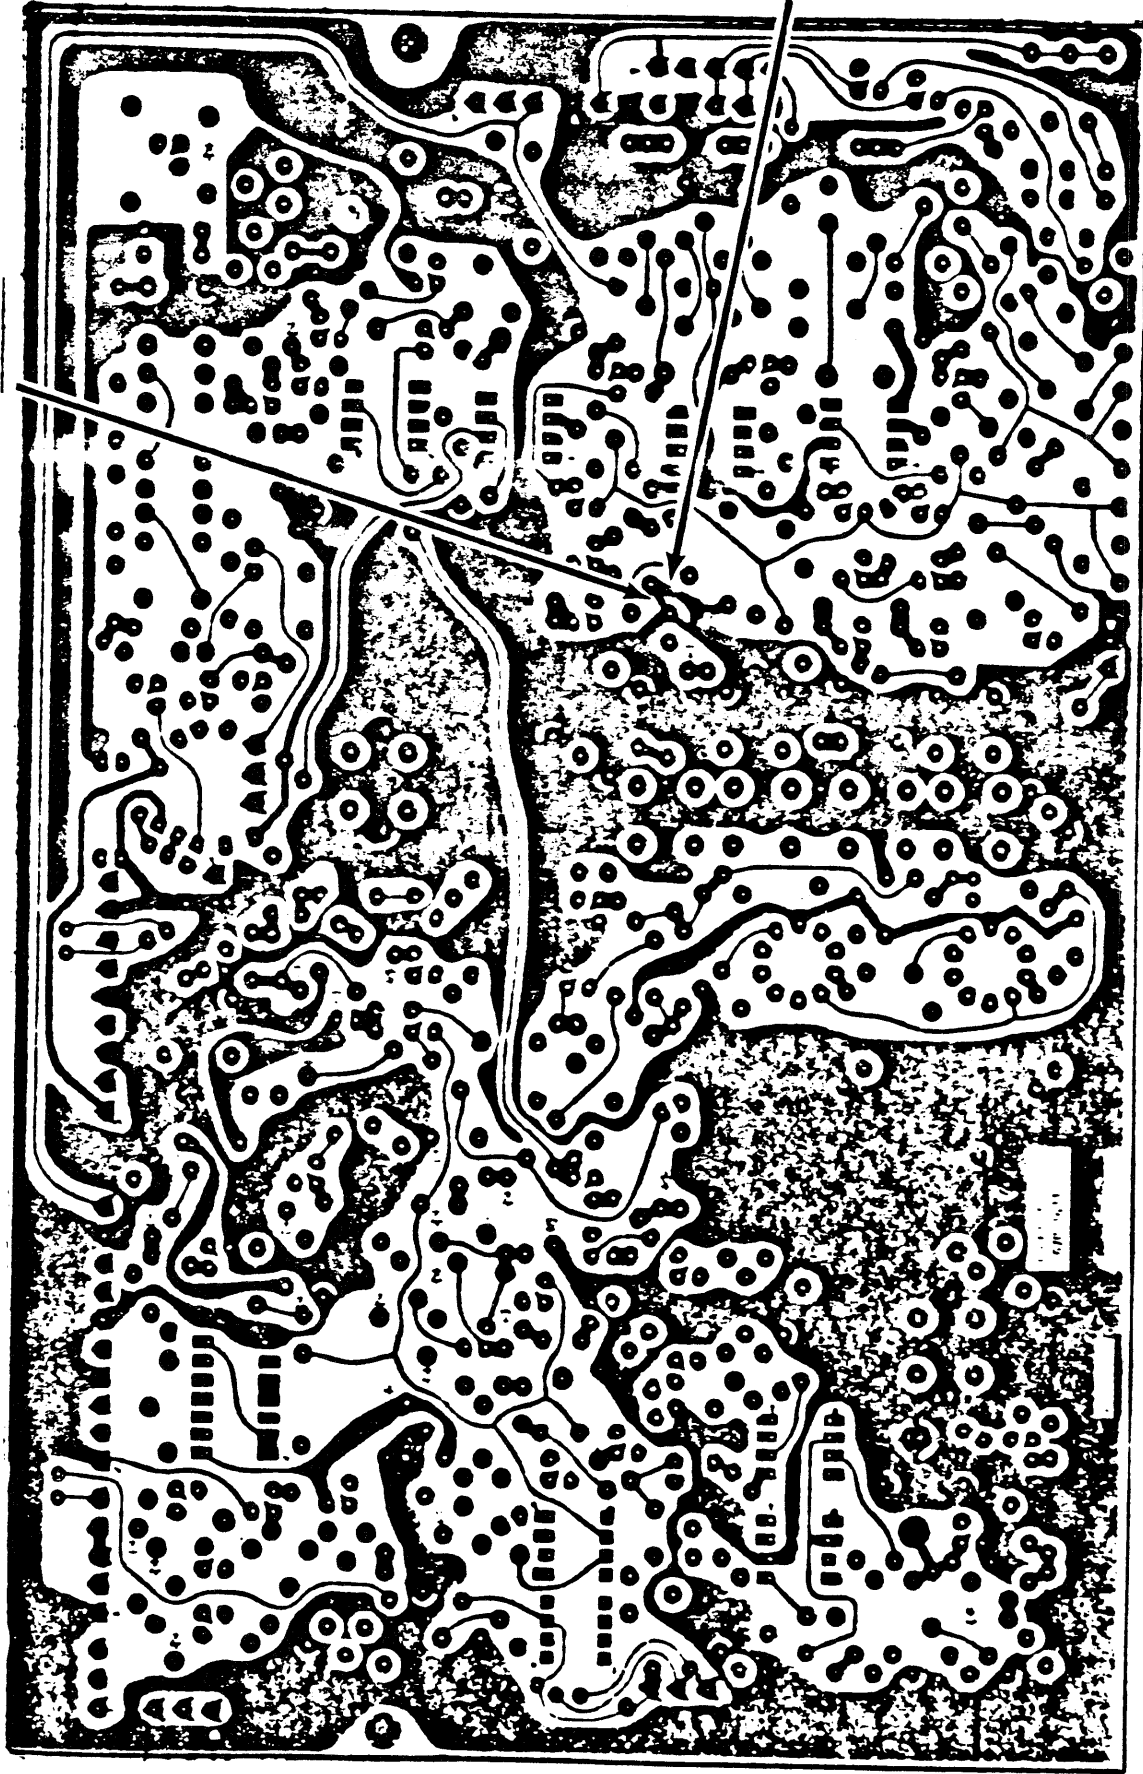
A circuit board error has been found in the listed products. The junction of R2739 and C2641 on the NTSC Decoder Board (670-2611-07) is connected to ground, causing an oscillation or "ringing" in the red clamp circuit. The defect is being corrected in manufacturing by cutting two circuit board paths as shown in the accompanying figure, pending a formal mod and ECB change. If red clamp oscillation is encountered in an instrument being serviced, insure this correction has been implemented prior to proceeding with further troubleshooting.

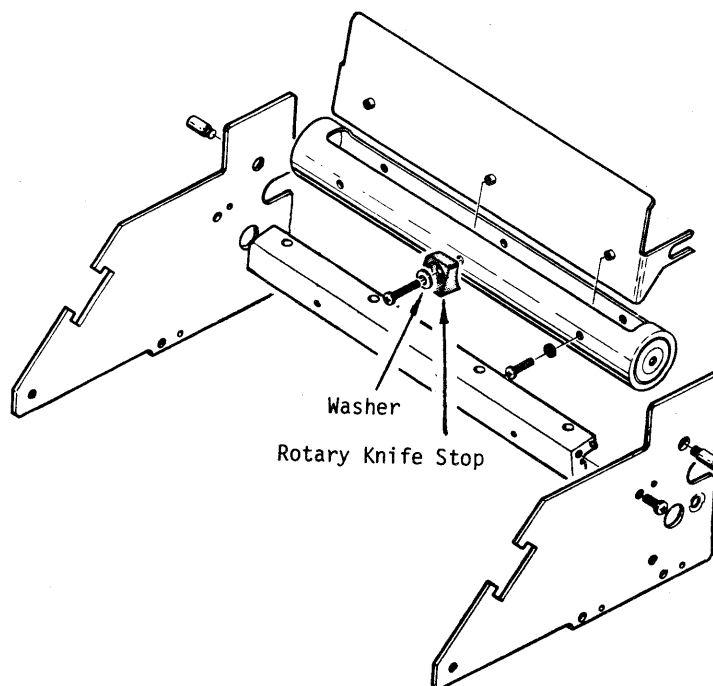
The 463X cutter clutch has been known to "chatter" with the paper cassette holder latched in place. The chatter disappears upon unlatching the holder.

The cause of the chatter is that the rotary knife stop (see figure below) is positioned too low. If the position of the stop is set too low, a constant downward force is put against the pin in the end of the cutter actuator. This in turn causes binding inside the clutch and produces the chatter.

To correct the problem, reposition the knife stop higher on the rotary blade. On earlier instruments where the 214-1932-00 actuator has been replaced by the 105-0781-00, it may be necessary to remove the washer in order to position the stop high enough to prevent chatter. Since the introduction of the new actuator with its greater range of motion, products have been shipped without the washer for just this reason.

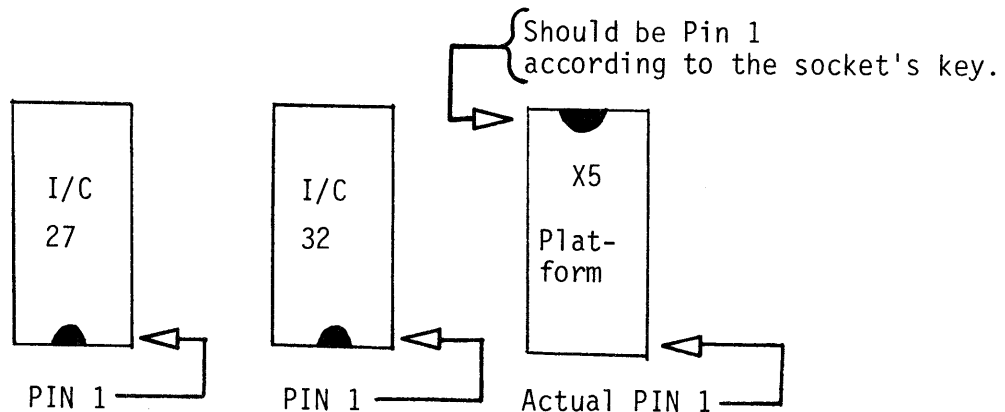
The jumper platforms are frequently mounted on the logic board reversed. When installing jumper networks into these sockets use the rest of the logic board's integrated circuits for a correct reference to the correct location of pin one. Note in the following example how pin one is the lower right pin, instead of the upper left pin, as the socket would indicate.
