Wizards Workshop

TEKTRONIX INTERNAL USE ONLY

April 4, 1980
Issue 10-7

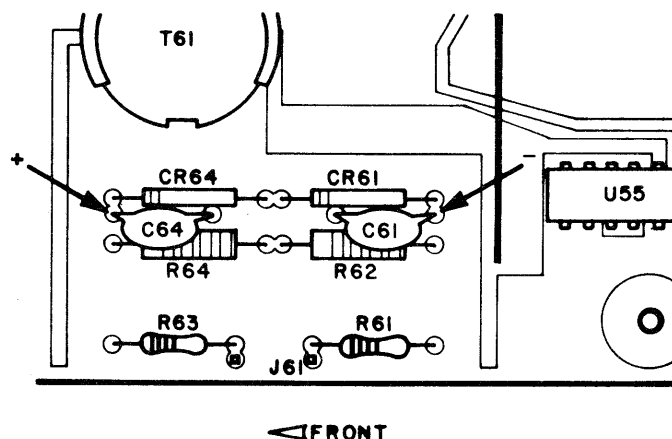
4662 MEASURING THE PLATEN ELECTROSTATIC 880 VDC

When measuring the Electrostatic Platen hold-down voltage of 880 VDC (+ 10%) it is necessary to take into consideration the input impedance of your voltmeter. An example is the DM501 or the DM502. Both have an input impedance of $10M\Omega$ which is low compared to the platen if measured at J61 of the plotter board, hence it places a load on the 880V Electrostatic supply. The resultant reading of a good supply is between the high 600's VDC and the low 700's VDC. To obtain a more accurate reading place the volt meters positive lead on the component lead of C64 as illustrated below (+), and place the negative lead on the component lead of C61 as illustrated below (-). This connects the volt meter before the two load resistors, which helps to remove the previously described loading effect, and allows for a true reading of your 880V supply.

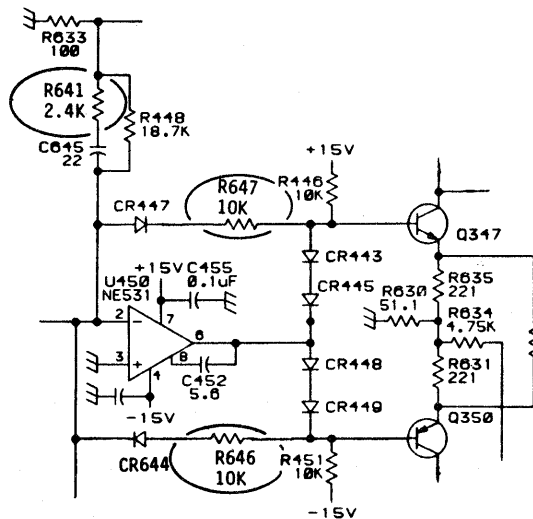
The 4633A Mod JE x-axis deflection amplifier has been known to break into a one megahertz (1 MHz) sawtooth oscillation. The tendency to oscillate has been best displayed when the CRT trace is not centered on the faceplate. The cause of oscillation lies in the fact that during retrace, when either CR447 or CR644 are on, the feedback is unity. U450, however, is not compensated for unity feedback.

To prevent this oscillation, 10K Ω resistors are installed in series with CR447 and CR644 to attenuate feedback during retrace. In addition, R641 is changed in value from 15K Ω to 2.4K Ω (see schematic).

<u>CIRCUIT NUMBER</u>	<u>OLD VALUE</u>	<u>NEW VALUE</u>	<u>NEW PART NUMBER</u>
R641	15K	2.4K	315-0242-00
R646	-	10K	315-0103-00
R647	-	10K	315-0103-00

Installation of this modification causes the mainboard part number to change from CM670-6394-00 to CM670-6394-01.

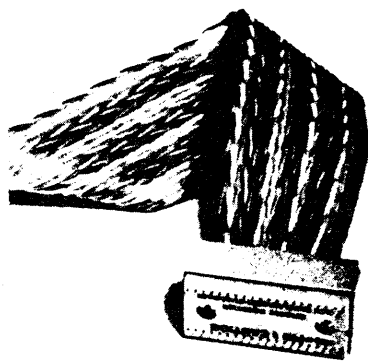
Fig. 1

The following is a list of part numbers for prototype control probe braided cables with the probe tip assemblies (Fig. 1). Each assembly part number is listed by the respective microprocessor it supports. Most of the assemblies were involved in a modification, so part numbers in the appropriate service manuals are incorrect. All of the following part numbers are currently set up in customer service.

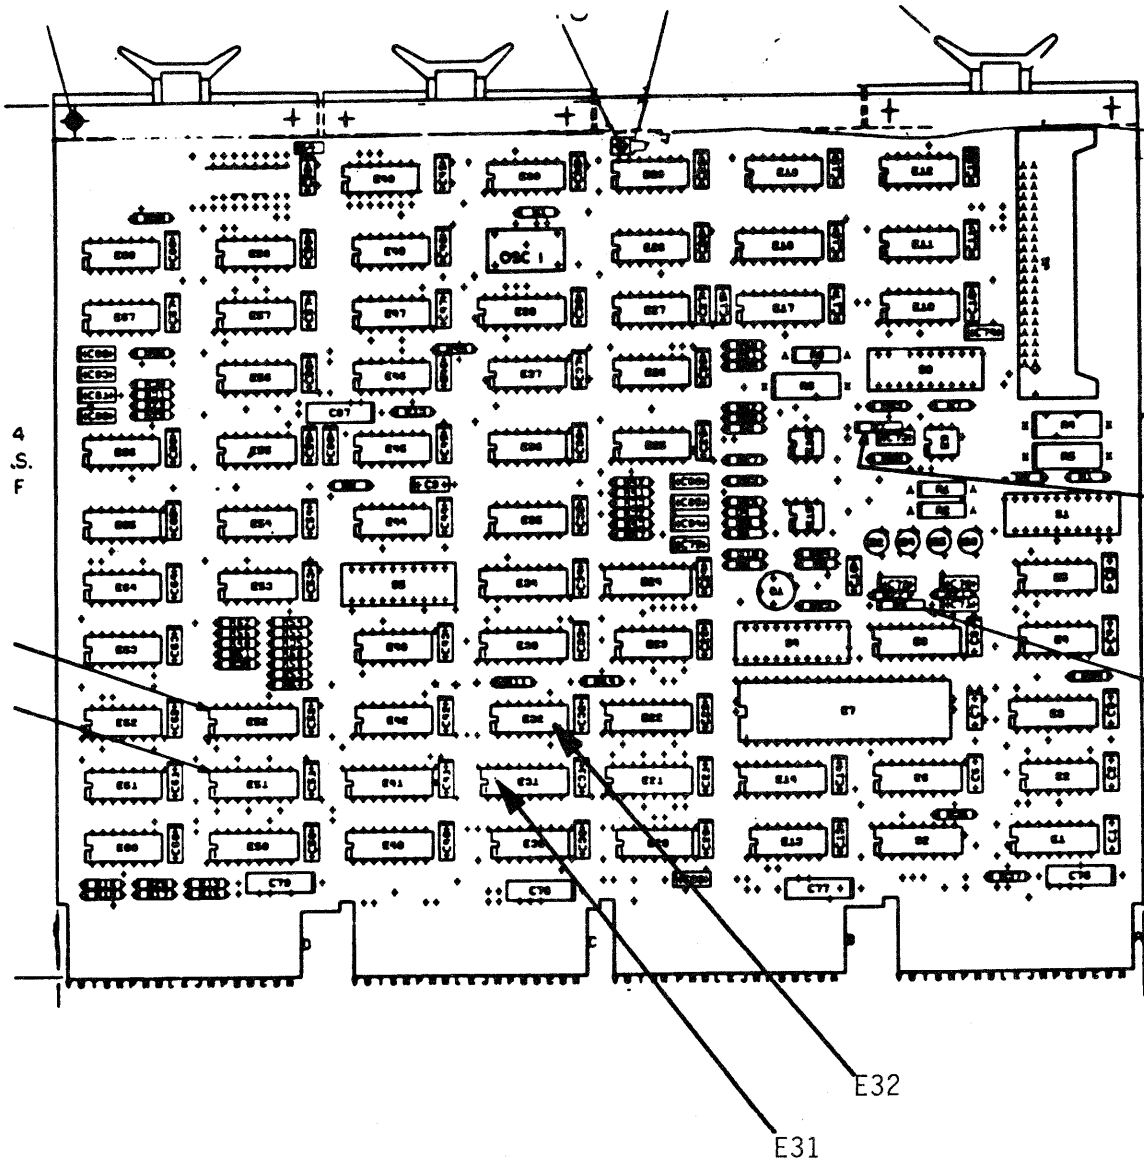
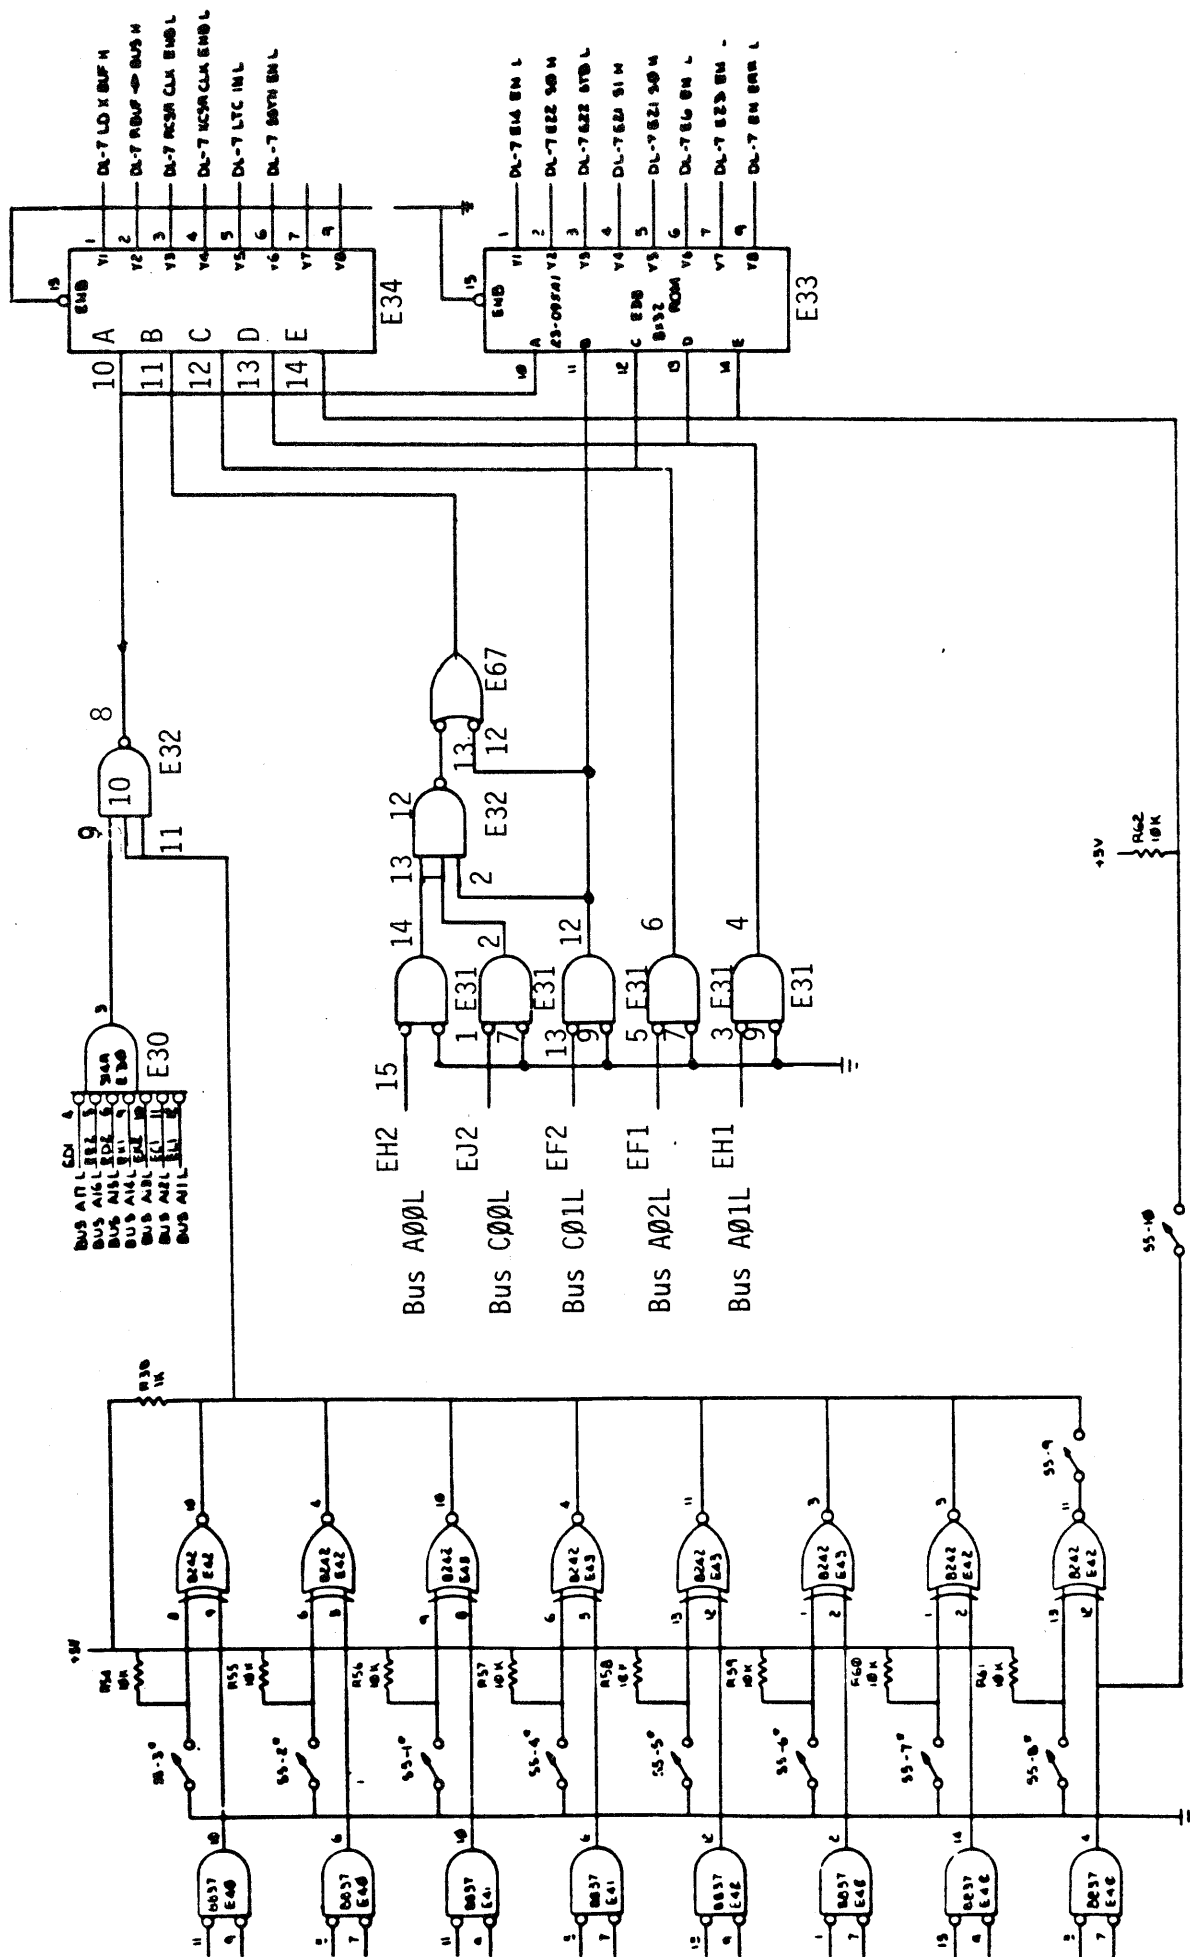
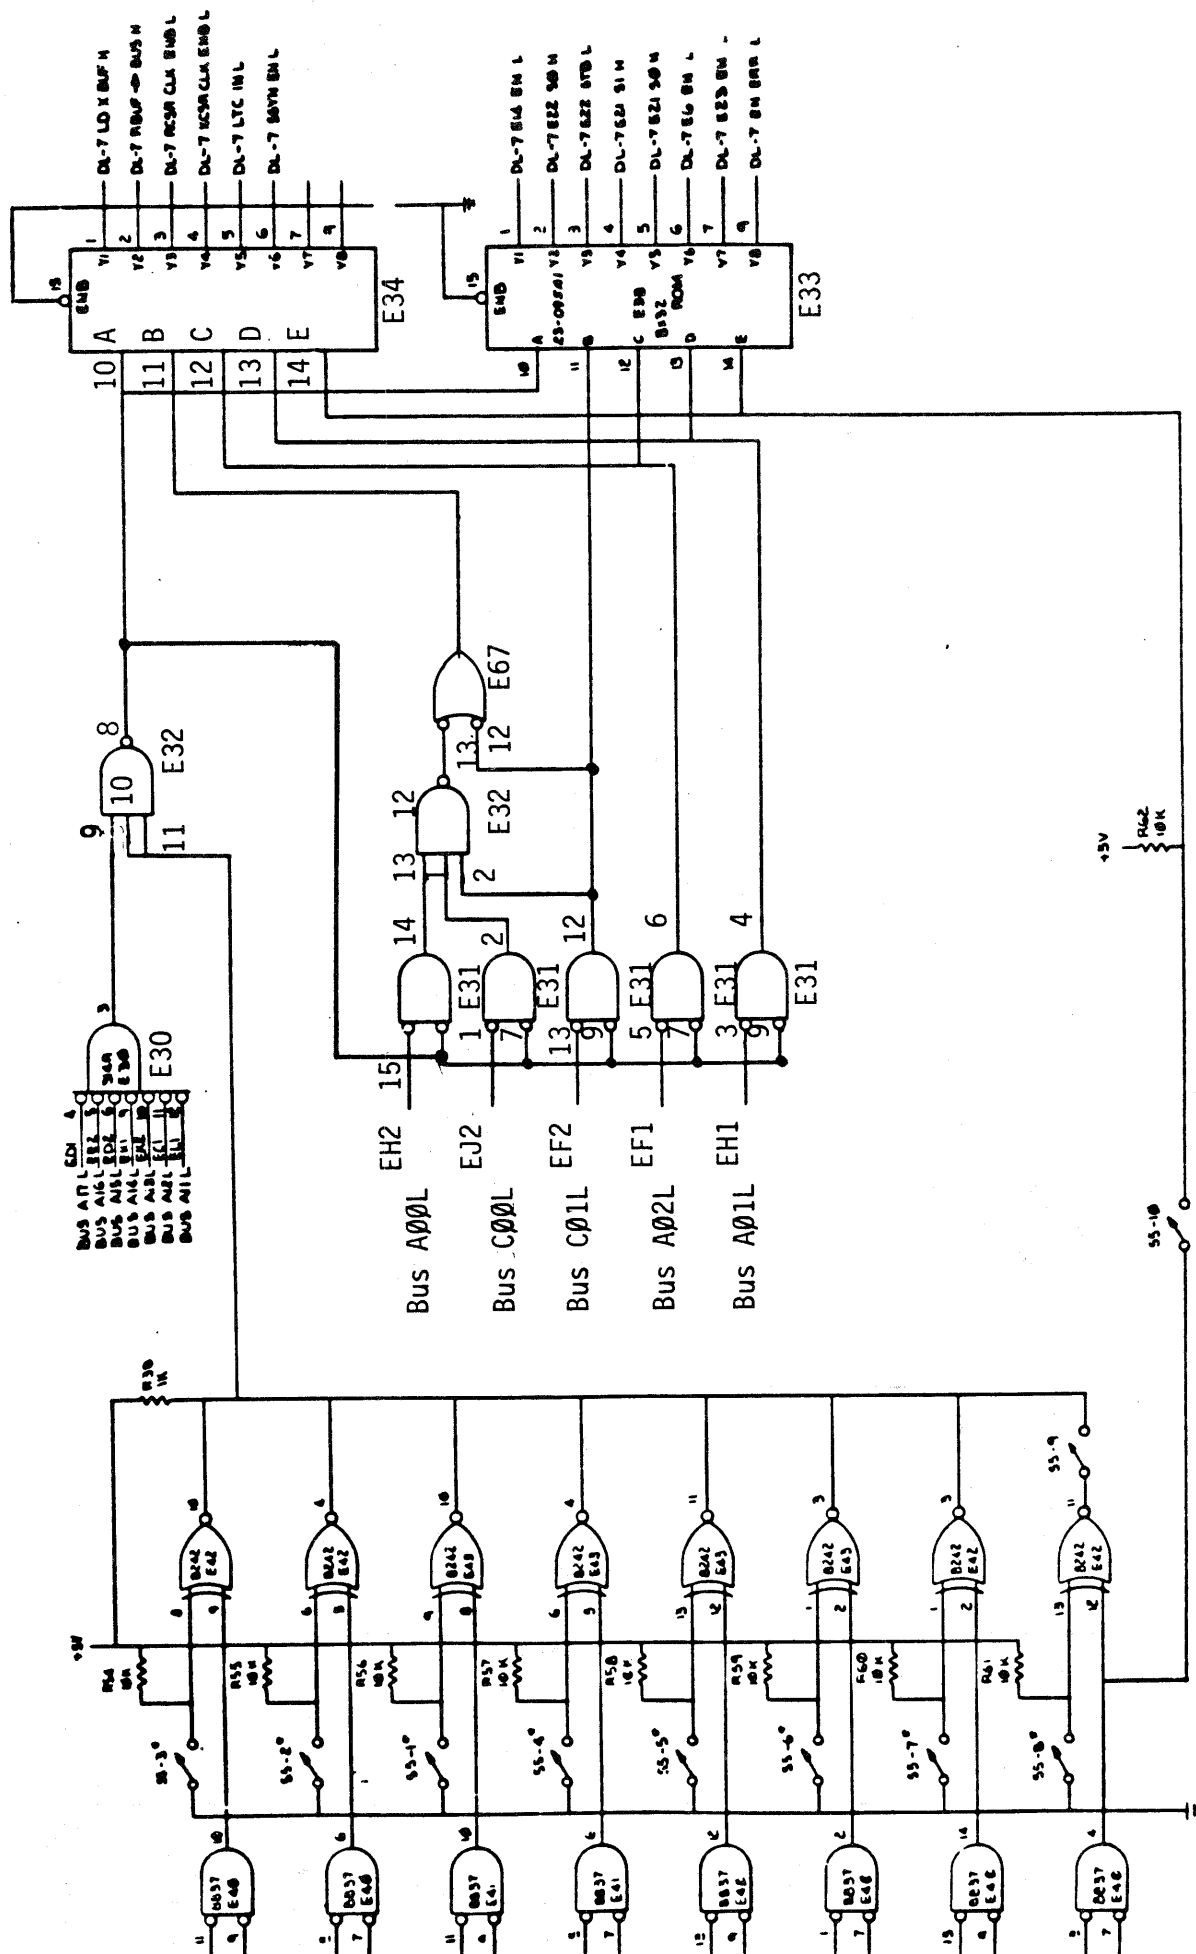
S-3200 SYSTEMS: CONSOLE TERMINAL HANGS UP (CONTINUED)

Drops INTR ENABLE (Rec and Xmit) caused by Rom E34. The Rom output is always enabled, thus the address lines on the Rom Change with the unibus address lines, causing spikes to appear on the output of the Rom.

Due to the confusion experienced with D.E.C. method, the following procedure is recommended.
