# Wizards Workshop

TEKTRONIX INTERNAL USE ONLY

April 18, 1980  
Issue 10-8

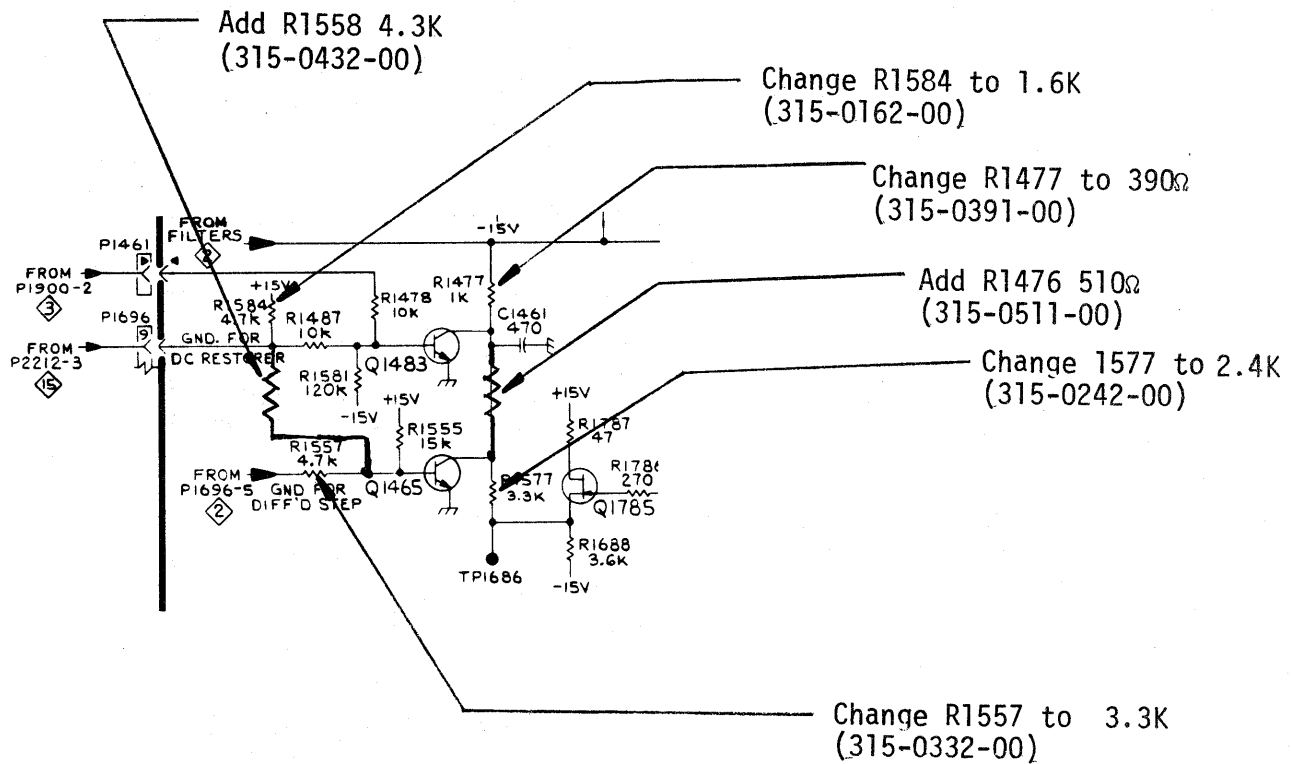
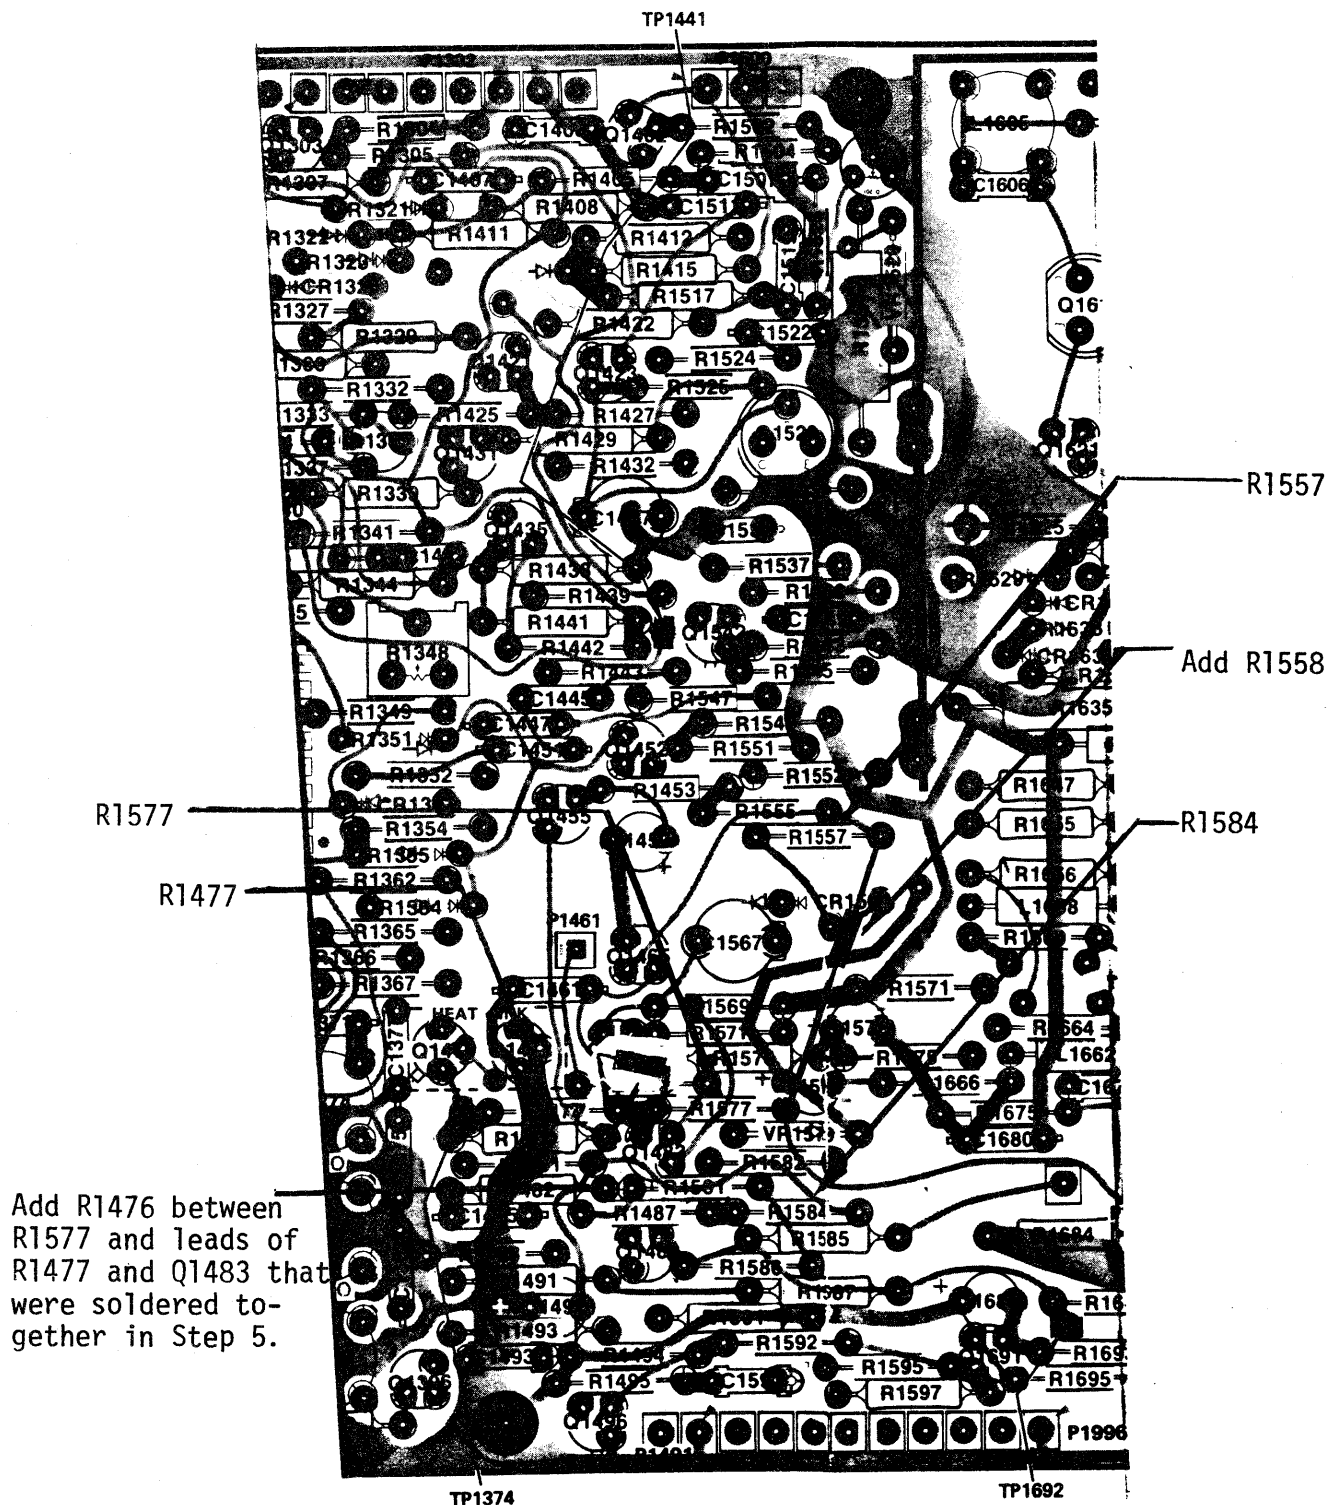
DC RESTORATION AND GAIN CONTROL  
SCHEMATIC 3

1480 SERIES, CORRECTION FOR INCOMPLETE D.C. RESTORER TURN-OFF (CONTINUED)

See the following drawing and schematic for location of changes.

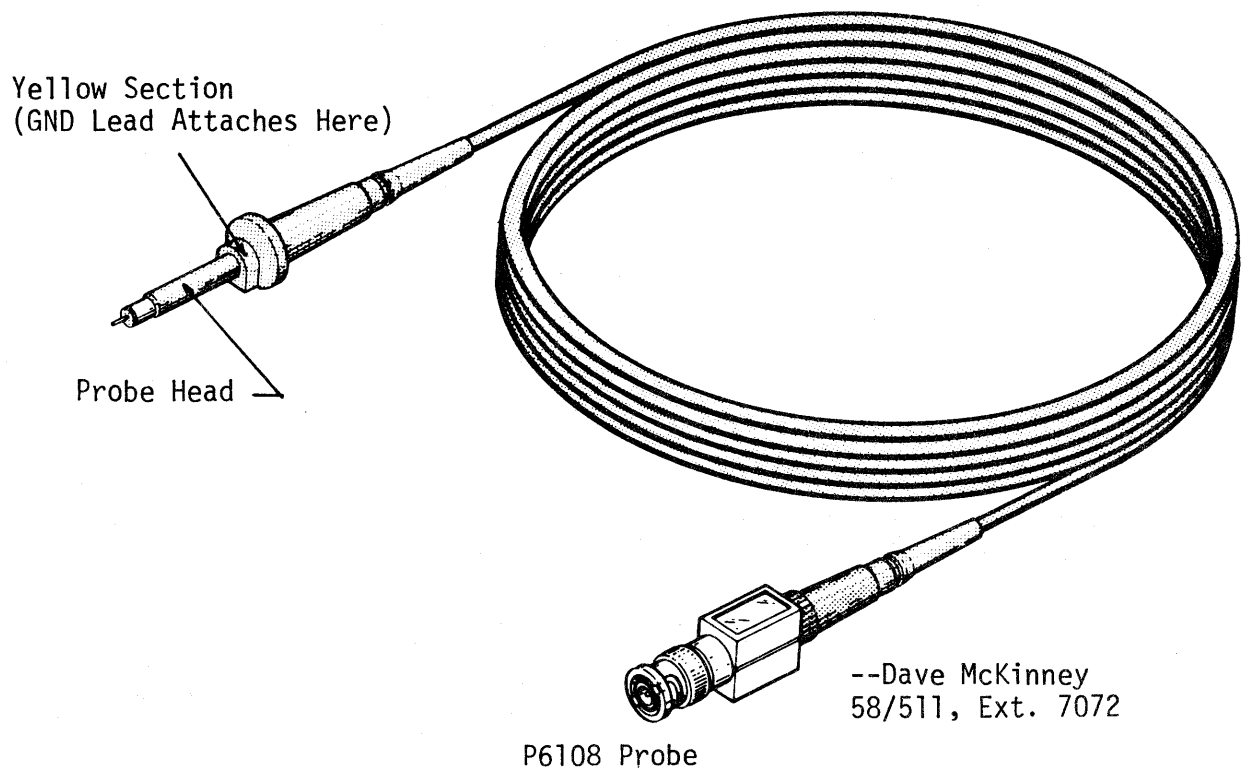
The difference between a standard P6108 and the hybrid version is on the probe head assembly. \*The ground lead for the probe, snaps into a yellow section on the probe head. There are letters on the top side of this yellow section. The standard version P6108 has white letters and the hybrid version has black. This is the only nonevasive visible difference. When a Service Center replaces a defective probe head assembly P/N 206-0225-00, PLEASE SEND ALL HYBRID VERSIONS TO ME FOR FURTHER EVALUATION.

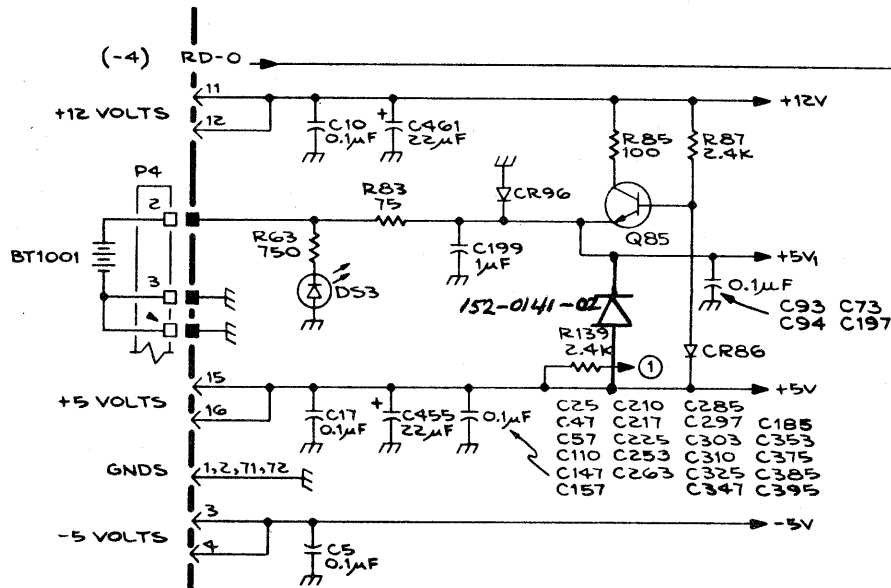
4025/27 Processor Board Battery Circuit

The 4027 and (or) the Polling Controller Interface Option 11 may lock up upon power up when the battery for the C-MOS RAM is not fully charged. A locked up condition will produce a horizontal line at the top of the display area and a row of cursors down the left side if the battery connected to the 4027 Processor Board is discharged. If Option 11 is installed the message "CRC CHECK OK" will not be displayed if the battery connected to the Polling Controller Processor Board is discharged.

The discharged battery will cause the 5V supply to the C-MOS RAM to drop below 4 volts on power up during the 30 msec delay it takes the +12V supply to come up after the 5V supply. The lowered Vcc voltage to the C-MOS RAM will cause the terminal to lock up. The battery circuit Mod will clamp the Vcc pin (+5 V1) for the C-MOS RAM so it will not drop below 4.4V during power up.

1. Connect the cathode side of diode 152-0141-02 to the pad which connects R88, R90, R92, C93, C94, R95 and CR96 together.
2. Connect the anode side of diode 152-0141-02 to the cathode side of CR86. The side closest to the edge of the circuit board.

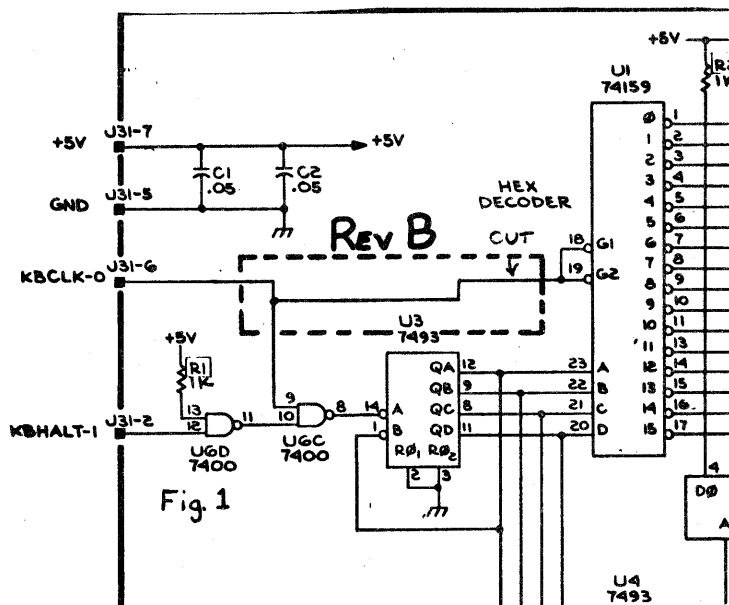
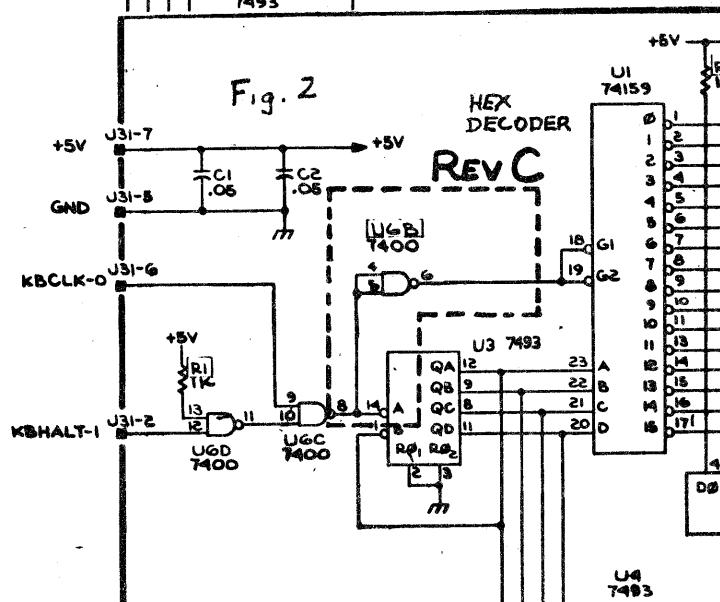
The mod #31903 uses the NAND gate of U6B. The mod is as follows. Refer to Figure 1 and Figure 2.

1. Cut the run on top of the REV B keyboard that comes off of pin 18 and 19 of U1. (Figure 1)
2. Strap pin 18 and 19 of U1 to pin 6 of U6. (Figure 2)
3. Strap pins 4, 5 and 8 of U6 together. (Figure 2)

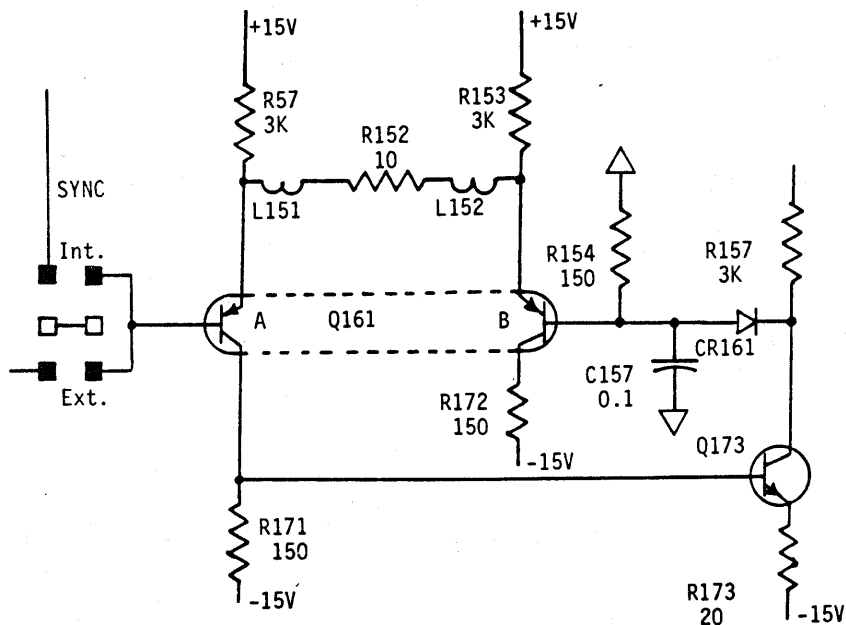
A herringbone pattern has sometimes been noted on copies produced by the 4632 Option 6 instrument. This effect is especially evident with a five to ten megahertz resolution signal such as that available from the 067-0690-00 and -01 test fixtures. The cause for the pattern is an oscillation of about 750 megahertz in the vicinity of Q161. The oscillation may diminish or disappear when an oscilloscope lead is connected to either end of R152.

To correct this, Mod #39499 calls for two toriodal ferrite beads to surround the leads of R152 and suppress high frequencies. These beads, L151 and L152, are part number 276-0507-00. A partial schematic illustrating their location is given below.

There is no need to modify existing Option 6 assemblies unless the effects of a high frequency oscillation appear evident after replacement of Q161.

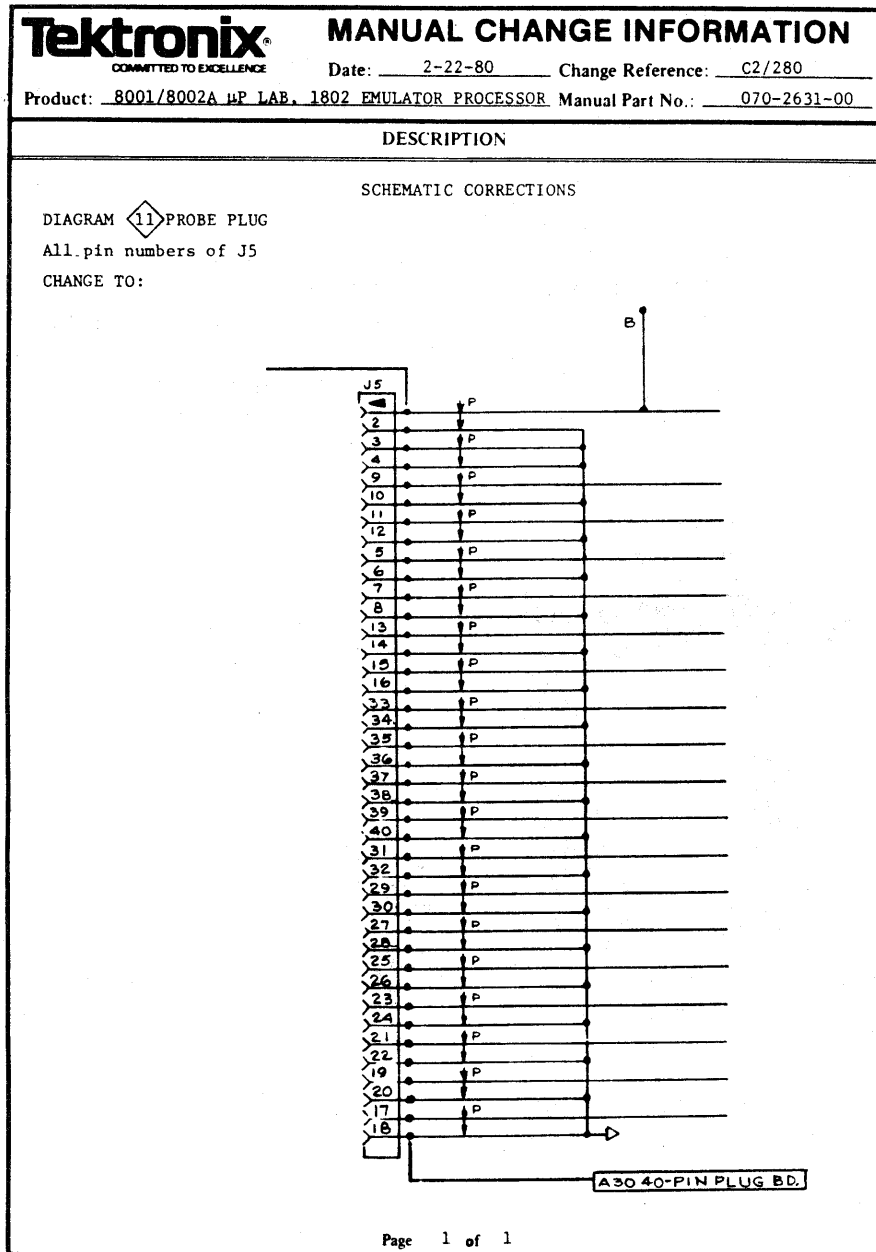
In the 1802 Emulator Processor Service Manual part number 070-2631-00 an error was found on Diagram 11, Probe Plug. The numbering on the connector J5 was found to be in error. A copy of the corrected Diagram is shown below.
