SERVICETEKNOTES

TABLE OF CONTENTS

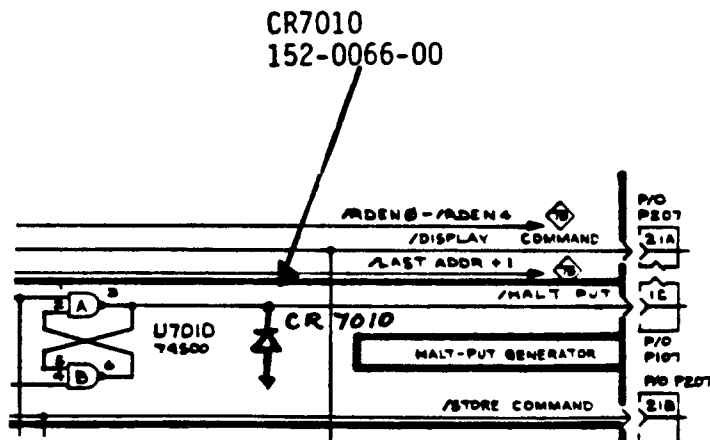
When inserting a personality module into a powered up 7D02 (hot plugging) it is possible to destroy or damage A07U7010. This will happen if the personality module is off center when hot plugged causing one of its conductors to short Pins 59 (-15 volts) and 61 (/halt put) of A01J8005. This effectively shorts the Pin 3 output of A07U7010 (/halt put) to the -15 volt supply.

To protect A07U7010 Mod #M46091 was implemented at Serial Number B021911. It places a protection diode, CR7010, 152-0066-00, between U7010-3 and ground (see included partial schematic 7A).

This diode should be added on the back of A07 with its anode soldered to U7010 Pin 7 and its cathode to U7010 Pin 3.

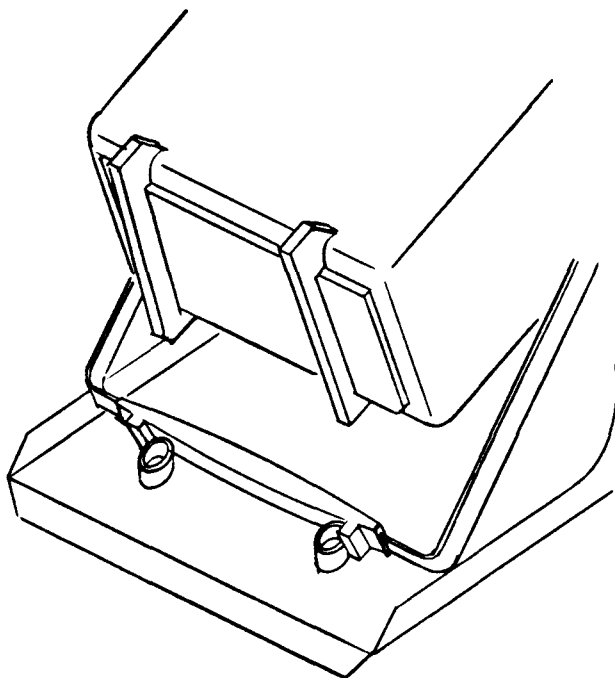
- because of the short instrument height represented by the 2335, 2336, and 2337 and non-compatibility of the instrument bottom feet/ the 200C top tray retaining feet plus the mismatch of instrument height relative to the 200C tie-down strap:

3rd - position the cushioned portion of the instrument handle against the 200C top tray, rear retaining feet (refer to sketch).

4th - and finally, secure the instrument by cinching down the tie-down strap over the instrument.

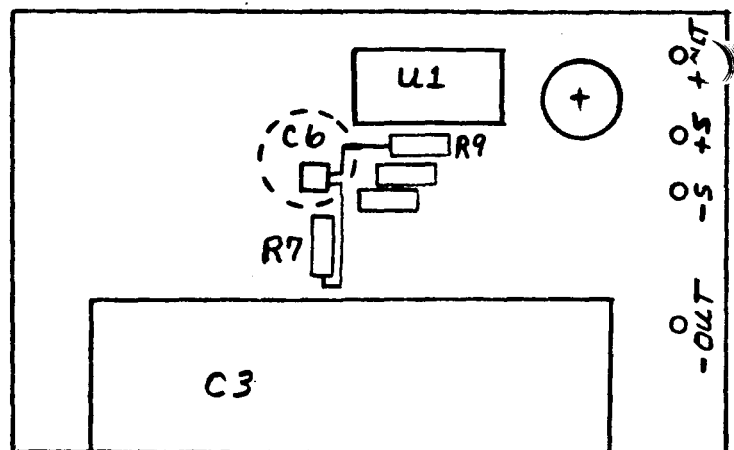
Figure 1 - ECB Layout
C6 Added

The PRAM -2 Volt Power Supply (P/N 119-0873-01) is mounted on the rear air duct housing of an 1803, 1804, or 1805 test station. The -2 Volt supply may oscillate at about 40 kHz with an amplitude of 200mV to 400mV. These oscillations may cause intermittent failures of the PRAM Option Verdict tests. Note that not all 119-0873-01 supplies will exhibit oscillations or instability.

Figures 1 and 2 show the -2 Volt power supply circuit board lay out. Note two different layouts can be found.

Power Supply part number 119-0873-01 changes to -02 with the addition of capacitor C6. The 119-0873-02 is a direct replacement for the 119-0873-01.

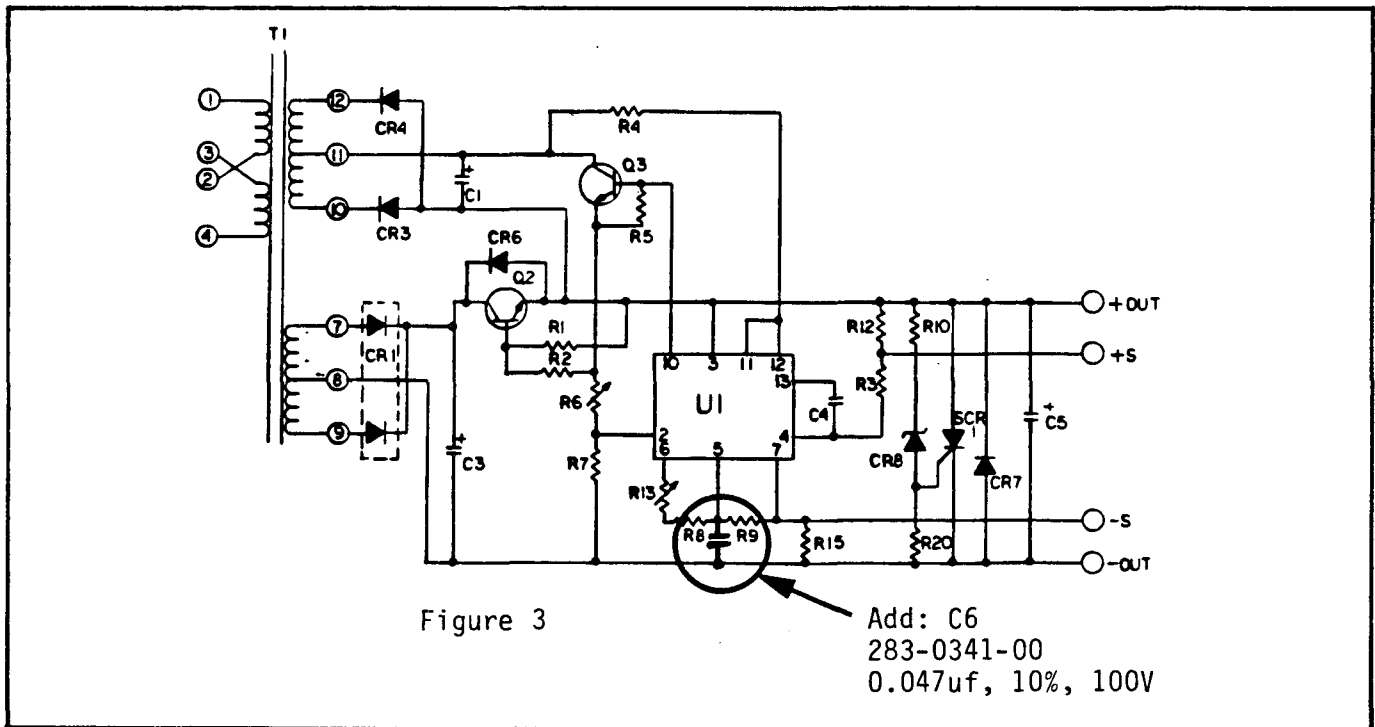
Figure 3 shows the schematic with C6 installed. This schematic is part of the 062-4428-00 Data Sheet.

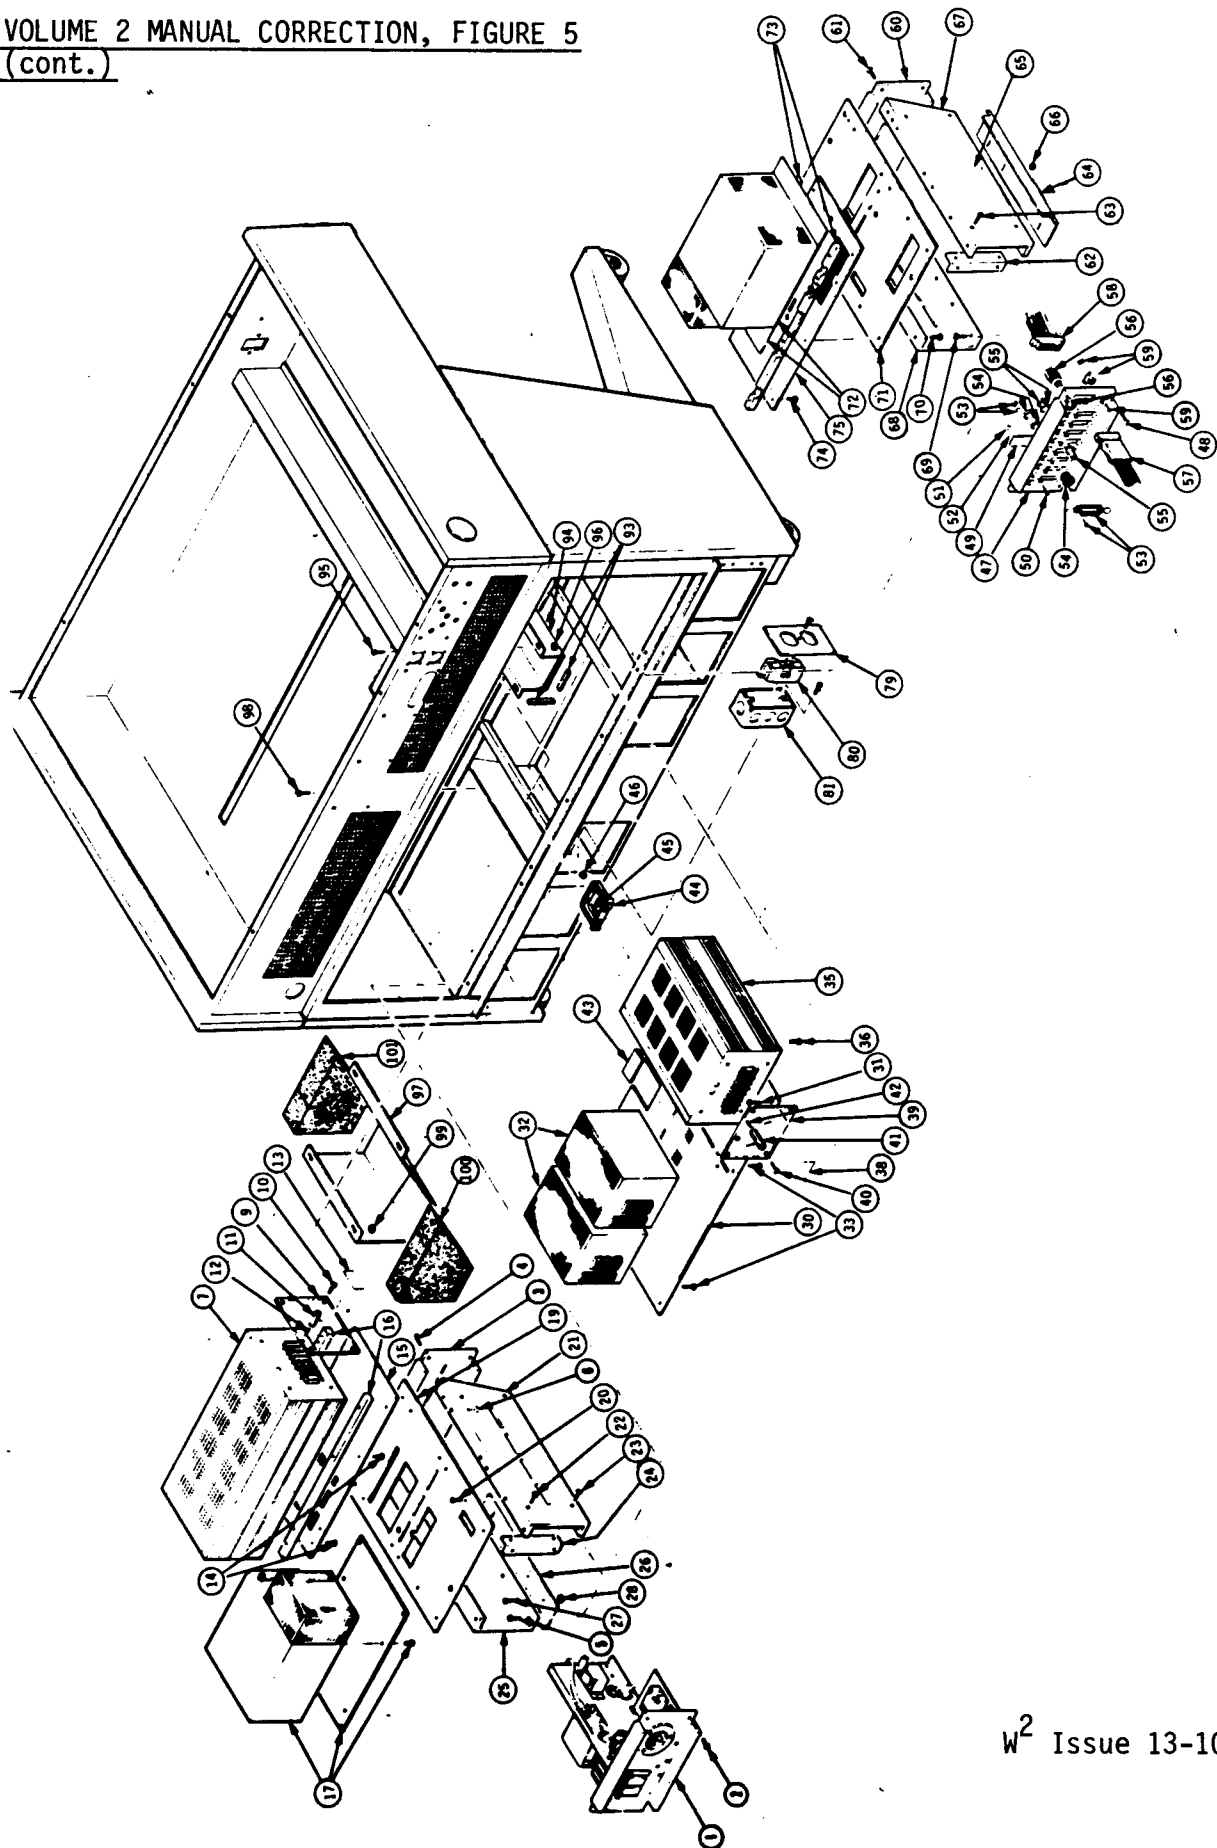
The index numbers in the mechanical view, Figure 5 Rear, do not match the replaceable Mechanical Parts List on pages 6-99 through 6-103. Attached is a mechanical view, Figure 1, which contains the correct index item numbers. Index numbers 8, 13, 18, 24.1, 24.2, 29, 34, 37, 76, 77, 82, 83, 84, 85, 86, 87, 88, 89, 90, and 91 are listed in the replaceable parts list, but are not shown in Figure 5.

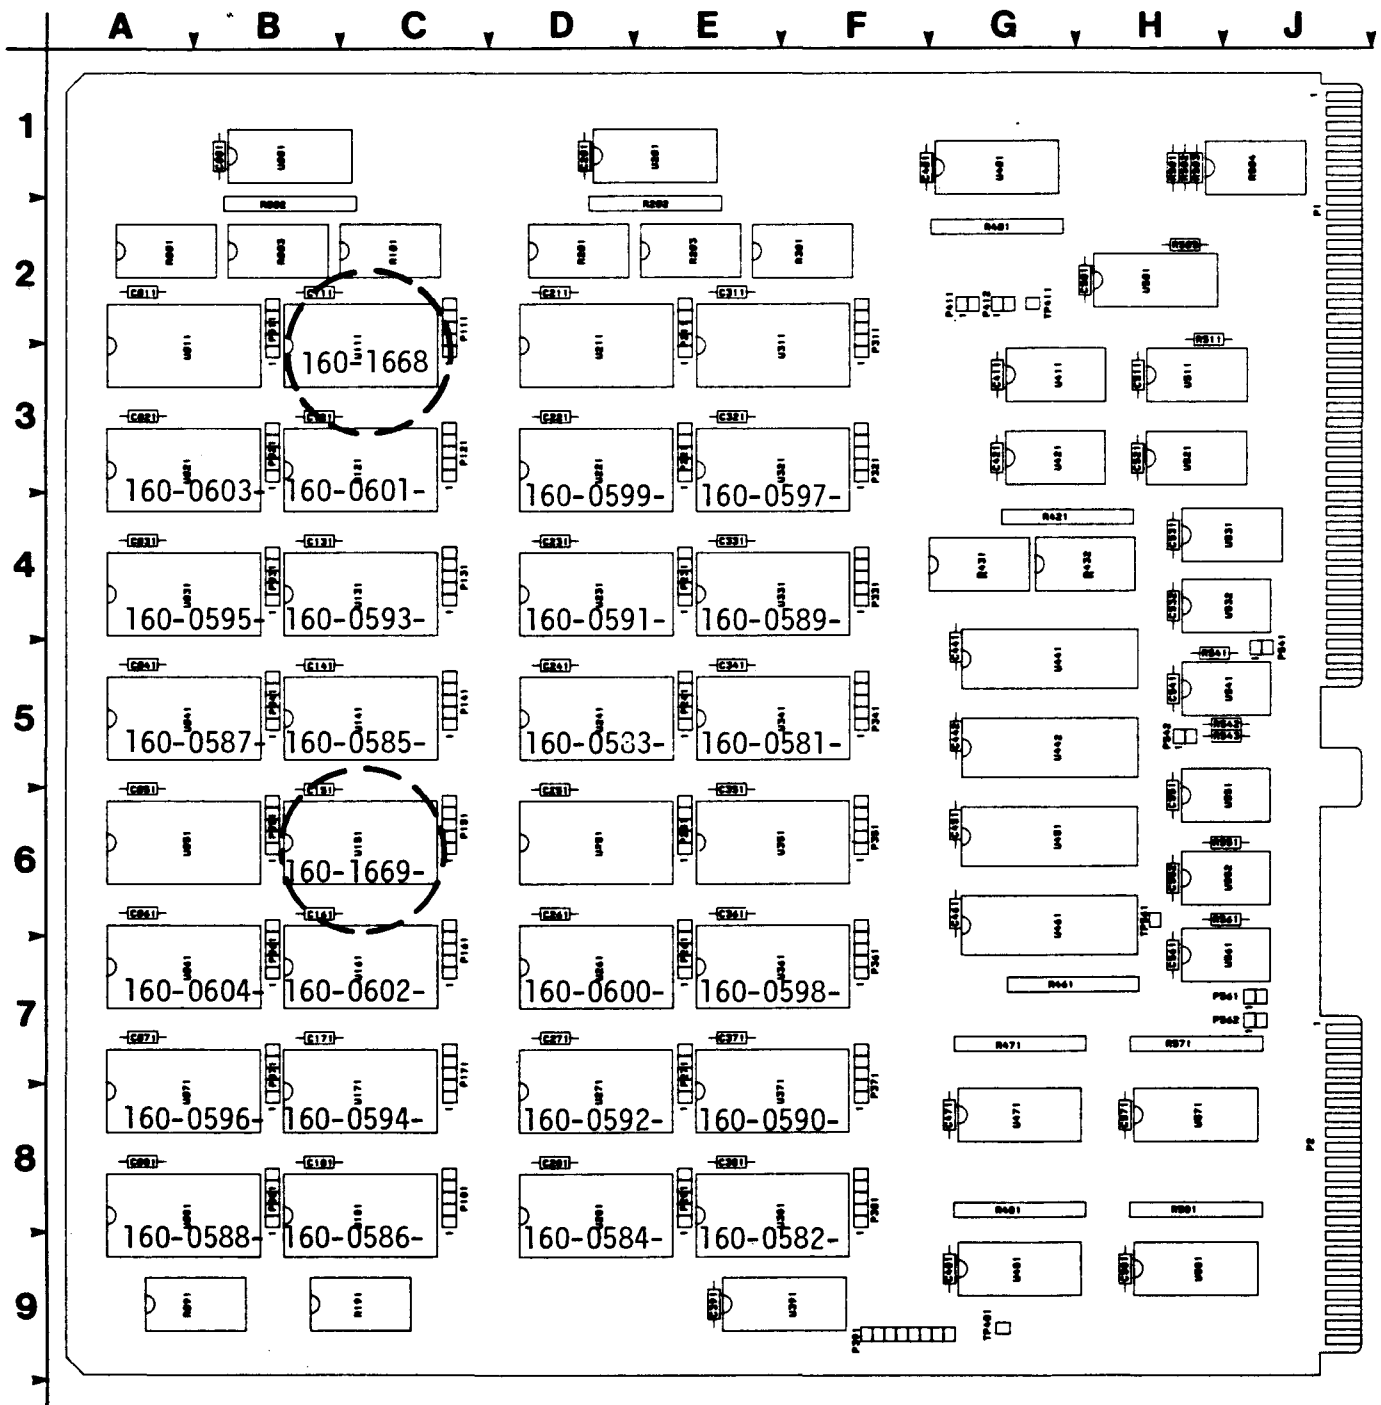
FIGURE A

A38 ROM/PROM Applications, PAL, Opt. 2

NOTE--These parts will not be supported through board exchange activities. If the board is faulty, and if the fault is localized to either of these parts through normal diagnostics, they will be replaced on an individual basis only. If the fault lies elsewhere on the board and the exchange option is to be exercised, these parts must be removed, and retained by the customer, or placed into the suggested locations on the replacement assembly.

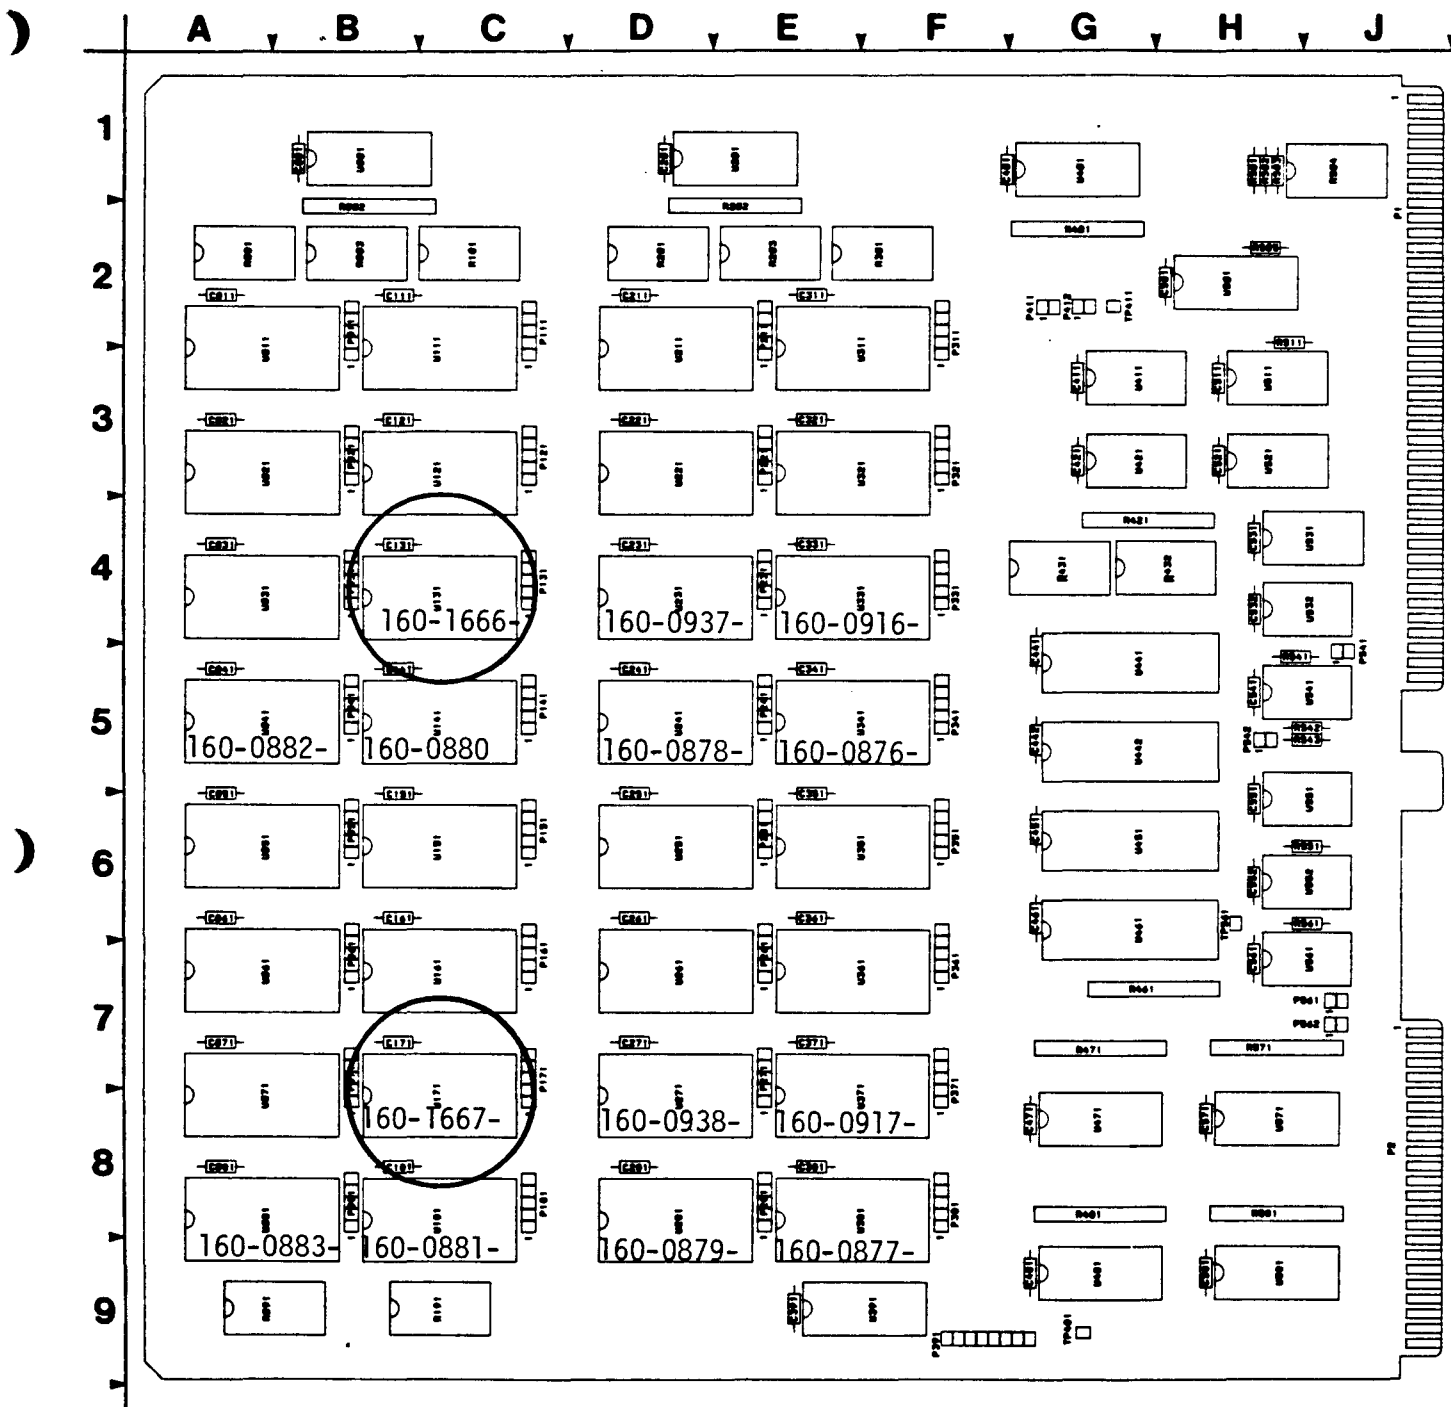
FIGURE A

A36 ROM/PROM
 Applications, NTSC, Opt. 1, Assy. B
 672-0939-00 with Patch PROM's Installed

These parts will not be supported through the Exchange processes. If this board is faulty and the fault is not related to these parts, the PROM's must be removed before the board is returned to the Module Exchange Center. The parts can then be retained by the customer or inserted into the appropriate sockets in the replacement assembly.
