WIZARDS WORKSHOP

TEKTRONIX INTERNAL USE ONLY

COMBINATION

TABLE OF CONTENTS

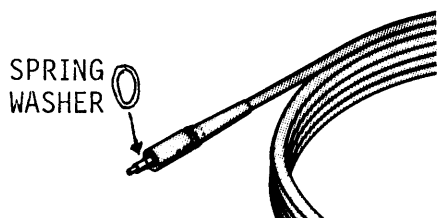
Some intermittent ground problems have been experienced in Manufacturing. A new spring washer, P/N 210-1377-00, has been added to the probe cable assembly to correct the problem. All P6120 cables can be retrofitted by simply slipping the washer onto the cable bushing at the compensator box end only.

The spring washers are small and can easily be lost when removing the compensator box from the cable assembly. I recommend that all Service Centers stock a small quantity of these spring washers.

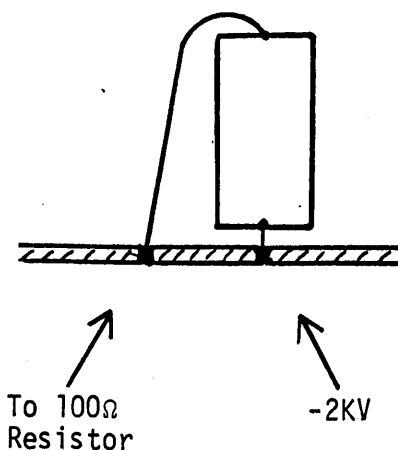
PARTIAL, FIGURE 9 - 8

In the listed serial number ranges, capacitors A10C990 and A10C995 in the CRT cathode circuit must be changed to reduce ripple on the cathode and the resulting intensity modulation on the display. The new part number for both capacitors is 285-1184-00. Both will be mounted on end, with the bottom connection to the -2KV (close to the board) and the long lead from the top to the 100Ω resistor junction (R990 or R995).
