SERVICETEKNOTES

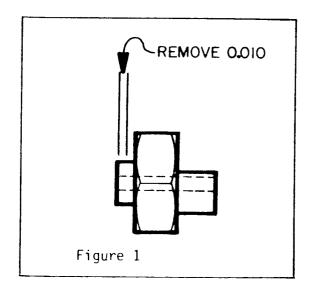
463X CASSETTE HANDLE LATCH ADJUSTING CAM WILL NOT TIGHTEN

Problems with tightening the handle latch have been reported.

The problems are caused by close tolerances for thickness for the adjusting cam's (401-0243-00) centered extrusion (the short one) and the chassis sides.

When this problem is encountered, the best remedy is to file the short extrusion on the adjusting cam until it no longer extends through the chassis side. Remove approximately 0.010

inches (see figure 1) so that the extrusion is about 0.1 inches after filing. This will keep the cam from binding.
