PG 506

# SERVICETEKNOTES

## TABLE OF CONTENTS

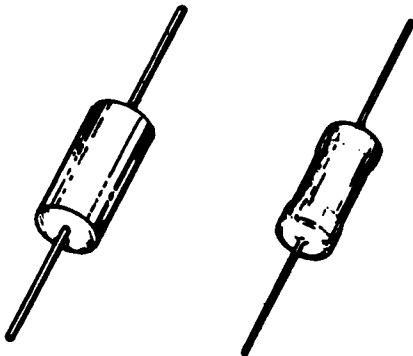
To correct this, only the carbon composition versions of the above part numbers should be used for these applications. Use of carbon film or metal film versions of these parts should be avoided. The distinction between composition and film parts is easily seen in the illustration below.

Figure 1.  
Composition and Film, respectively.

In high voltage applications, the film components have shown some distinct disadvantages. Metal film parts tend to open up without giving any visible evidence of their failure. Carbon film parts may drift in value due to migration of conductive particles (the Lorenzo effect). It is therefore advisable to avoid film resistors in any high voltage application.

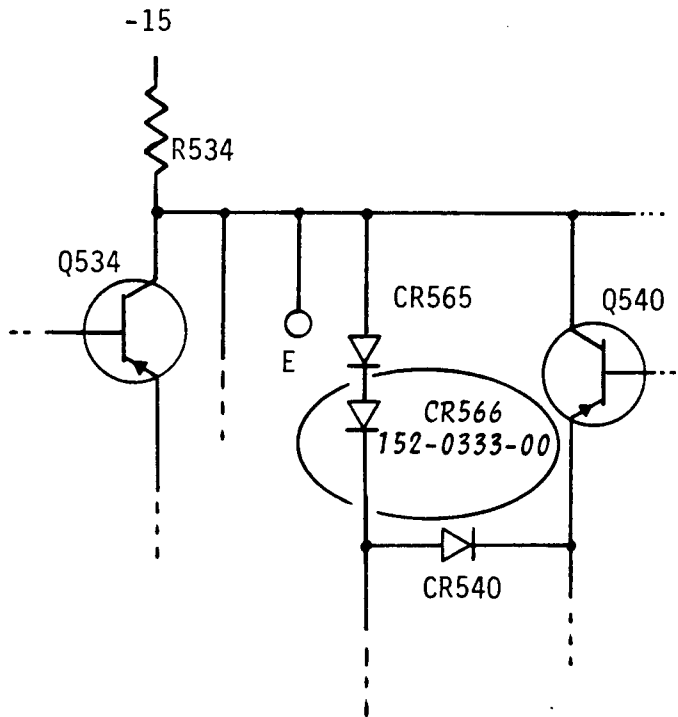
The 608 CRT specifications exceed the range of the Z-axis amplifier. As a result, setting cutoff on the 608 may not be possible with some CRTs.

Figure 1. CR566 Added.

To correct for this problem, a diode is added in series with CR565 in the Z-axis amplifier. The new diode, CR566, is part number 152-0333-00 and is mounted in tee-pee fashion. The part number of the Z-axis amplifier board rolls from 670-5216-02 to 670-5216-04 with this change.

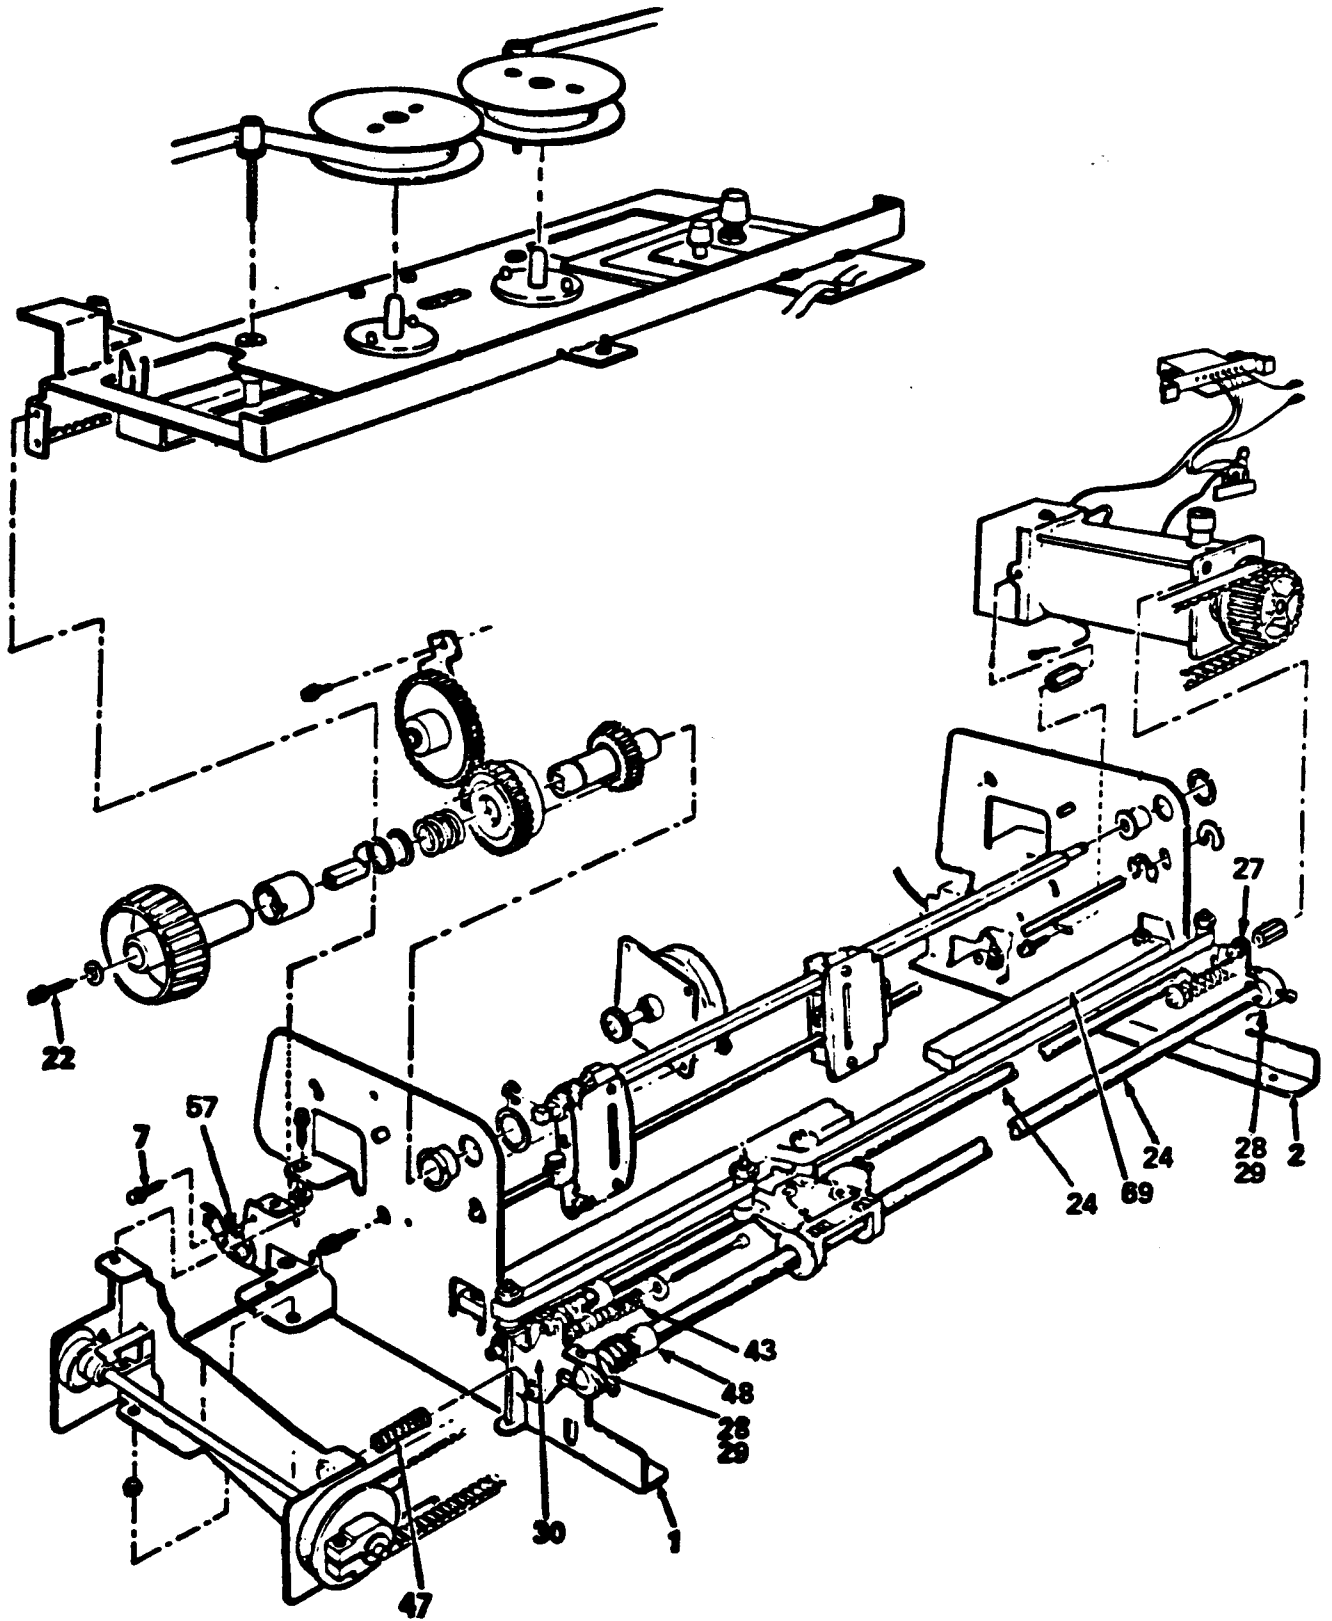
*Printer Mechanism Assembly*

The parts list only covers the parts that were affected by DEC's modification. Refer to the service manual to find part numbers for parts that were not changed. The parts affected by the change are not interchangeable between older and newer version printers. It is not recommended that these parts be purchased for local stock, they should only be ordered on an as needed basis.

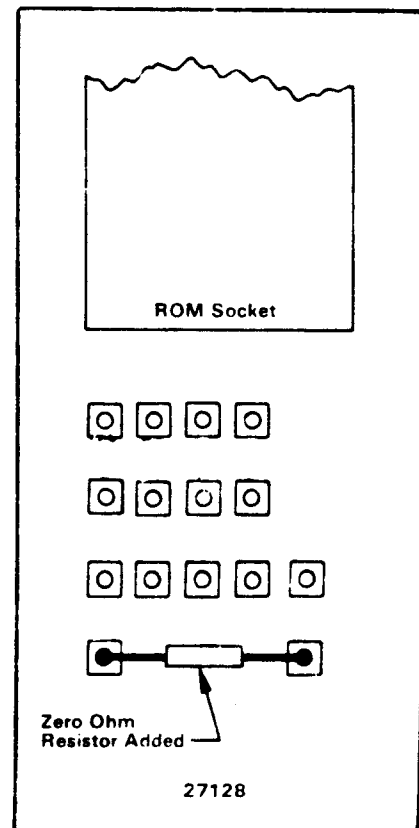
NOTE: This strap enables address line 13 to pin 26 of the corresponding ROM socket. Pin 26 of a 2764 EPROM is not connected internally; therefore a socket that has been modified to accept 27128 EPROMs will work fine with a 2764. New System ROM boards shipped from Manufacturing and Board Exchange have zero ohm resistors installed for all ROM locations.

A wire strap or zero ohm resistor must be added to each chip location of the System ROM board before they will accept the 27128 devices. The strap should be added as shown in the following illustration:
