SERVICETEKNOTES

TABLE OF CONTENTS

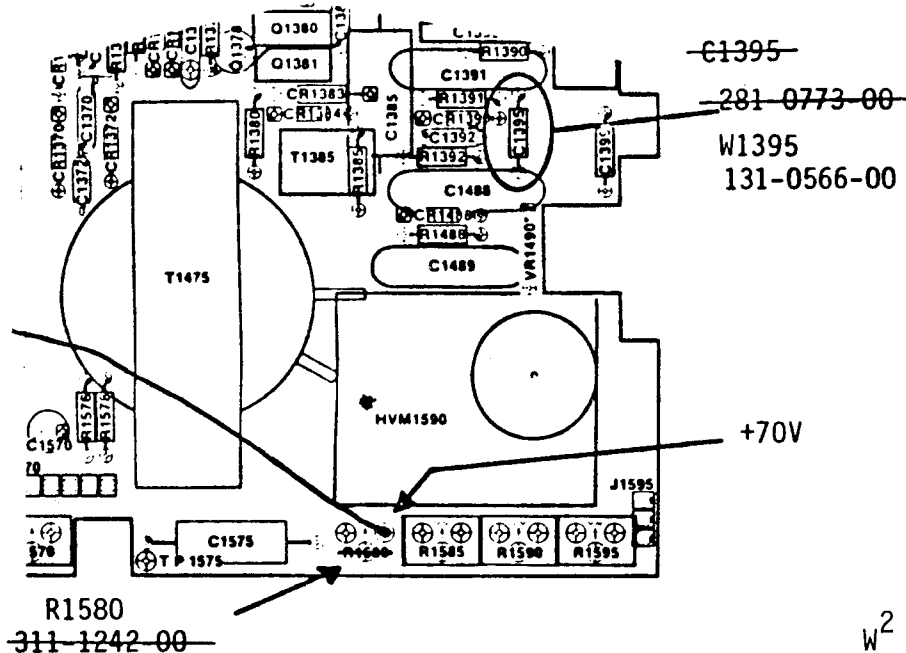
instruments, a new CRT must be added along with the following circuit changes:

1. V1000 CRT changes to P/N 154-0859-00
2. C1395 replaced with W1395, wirestrap, P/N 131-0566-00.

3. R1580 removed.

4. Add a 6 inch length of wire from pin 13 of the CRT socket to the +70 volt terminal from which R1580 was removed.

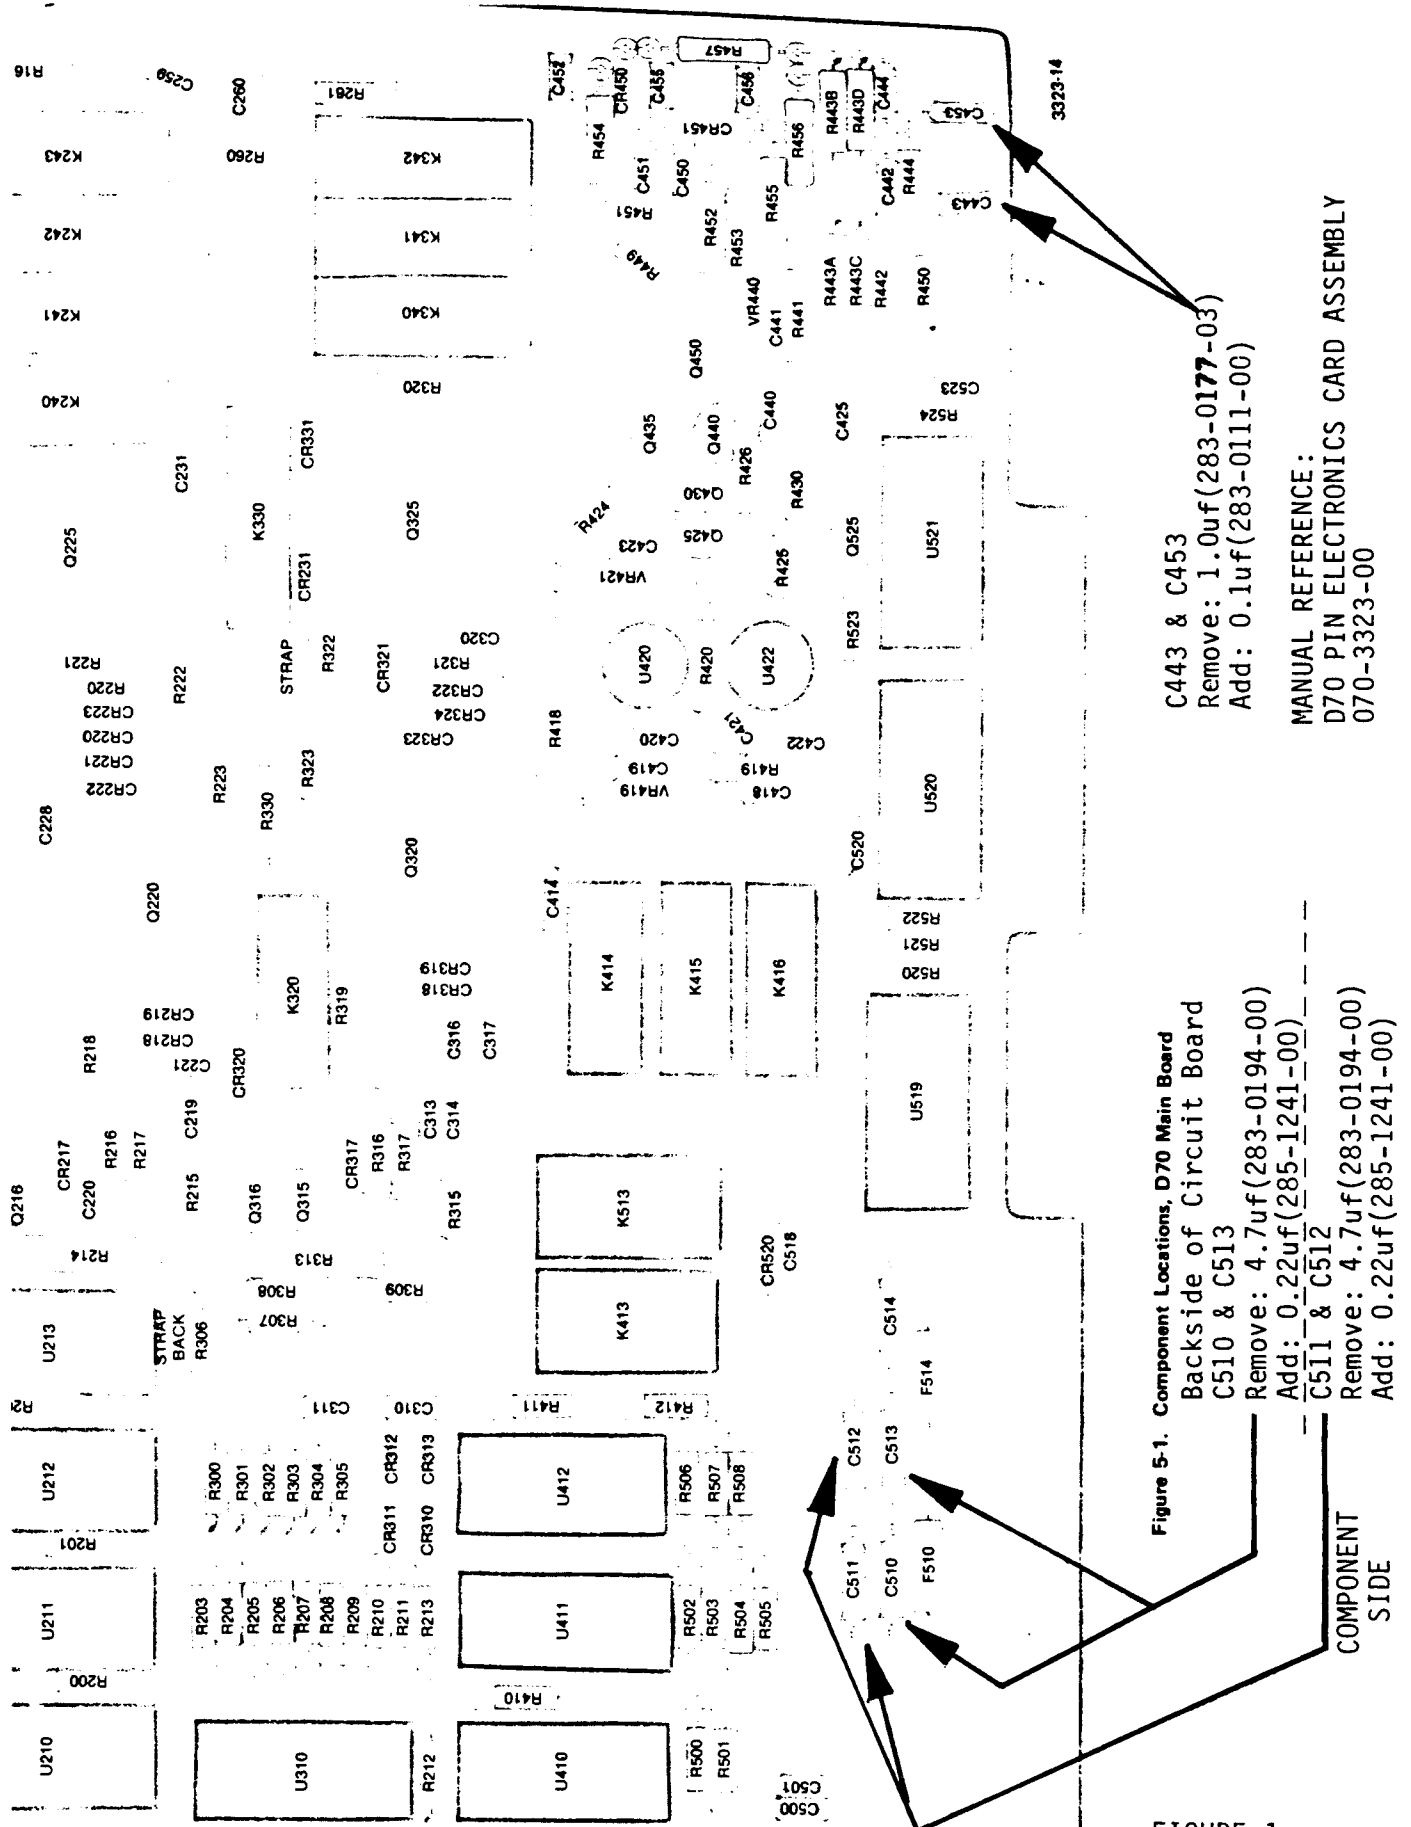
FIGURE 1

Figure 5-1. Component Locations, D70 Main Board
 Backside of Circuit Board
 C510 & C513
 Remove: 4.7uf(283-0194-00)
 Add: 0.22uf(285-1241-00)
 C511 & C512
 Remove: 4.7uf(283-0194-00)
 Add: 0.22uf(285-1241-00)

C443 & C453
 Remove: 1.0uf(283-0177-03)
 Add: 0.1uf(283-0111-00)
 MANUAL REFERENCE:
 D70 PIN ELECTRONICS CARD ASSEMBLY
 070-3323-00

C510, C511, C512, and C513 with 4 each, Capacitor 0.22uf, 10%, 100V (285-1241-00). Replace 2 each, Capacitor 1uf, +80-20%, 25V (283-0177-03) located at C443 and C453 with 2 each, Capacitor 0.1uf, 20%, 50V (283-0111-00). The D70 Pin Electronics Card changes from 670-5347-03 to 670-5347-04. See Figures 1, 3, 4, and 6.

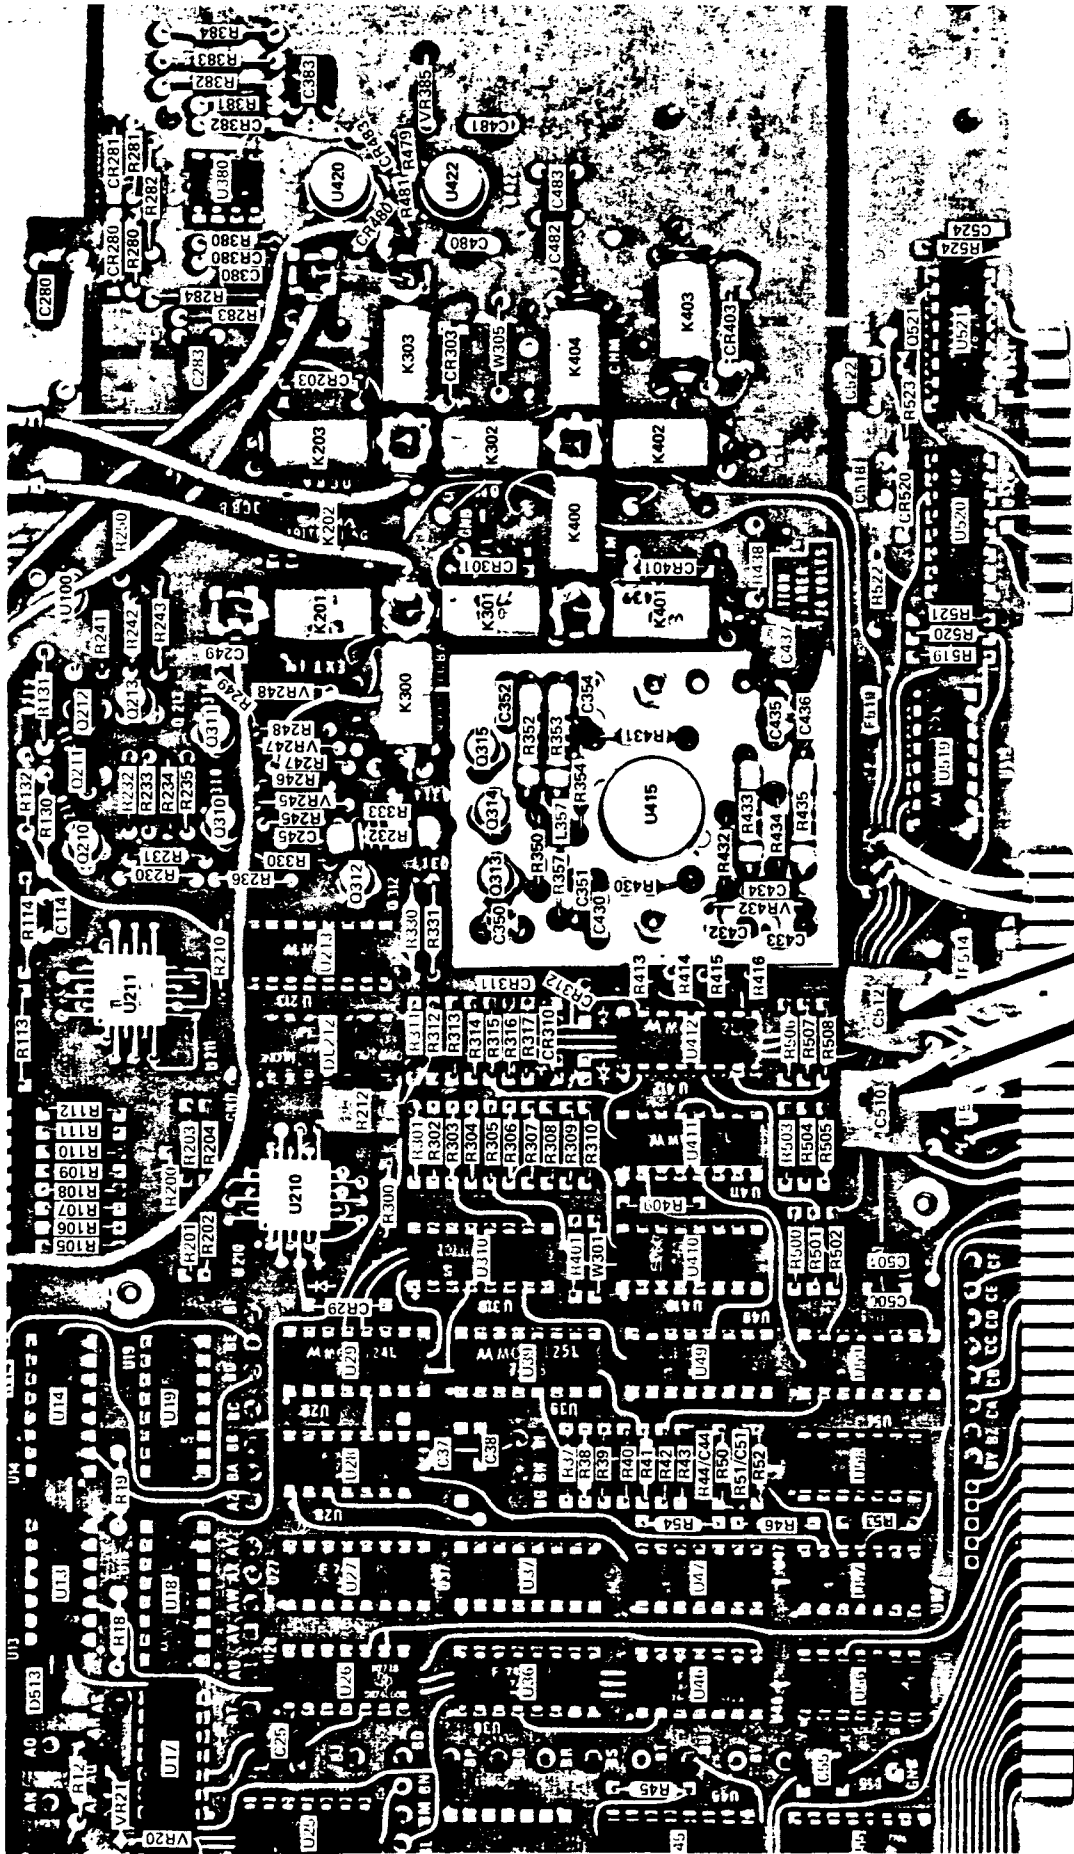
FIGURE 2

- C512 Remove: 4.7uf(283-0295-00)
Add: .22uf(285-1241-00)
- C510 Remove from Front: 4.7uf(283-0194-00)
Add to Backside: .22uf(285-1241-00)
- C511 Remove from Backside: 4.7uf(283-0294-00)
Add to Front: .22uf(285-1241-00)
- C513 Backside Remove: 4.7uf(283-0294-00)
Add: .22uf(285-1241-00)

Figure 4-1. D80 Component Locations (Front)

Replace 4 each, Capacitor 4.7uf, 20%, 50V (283-0194-00) located at C510, C511, C512, and C513 with 4 each, Capacitor 0.22uf, 10%, 100V (285-1241-00). The D80 Pin Electronics Card changes from 670-5412-02 to 670-5412-04. See Figures 2, 3, and 5.

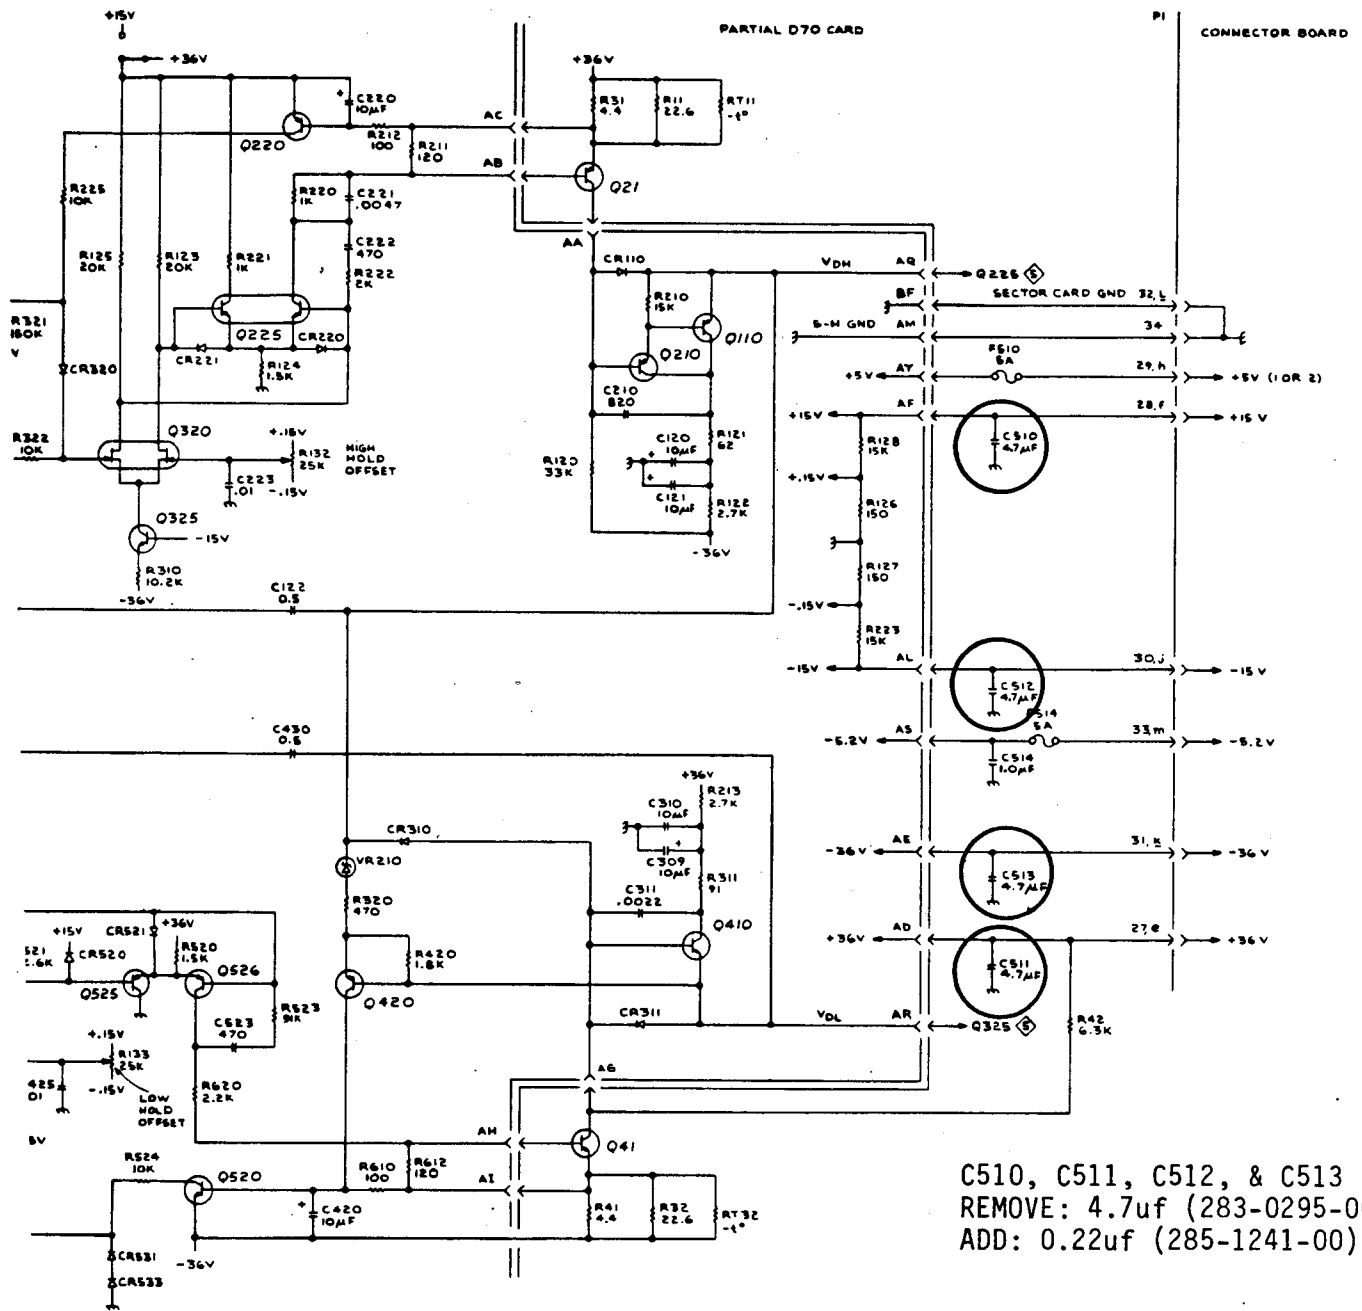
FIGURE 4

C510, C511, C512, & C513
 REMOVE: 4.7uf (283-0295-00)
 ADD: 0.22uf (285-1241-00)

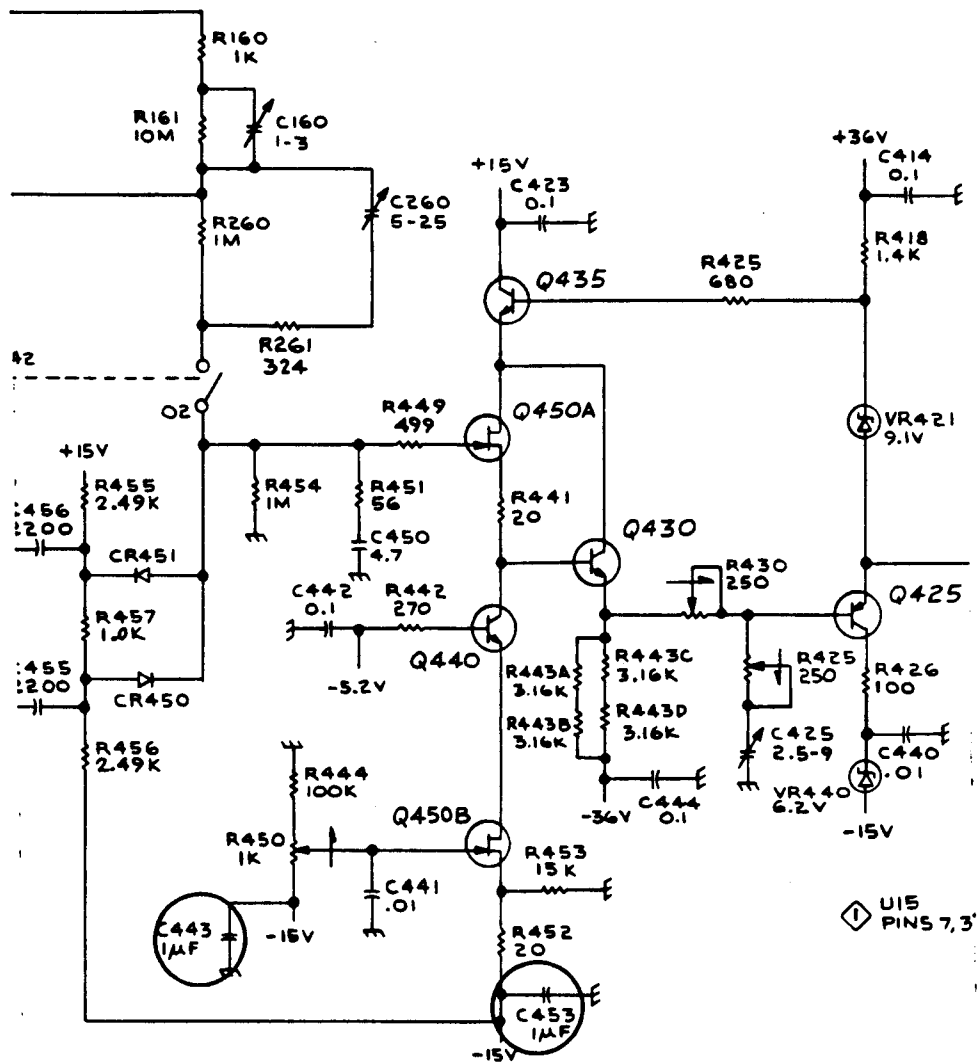
FIGURE 6

C443 & C453
 REMOVE: 1uf (283-0177-03)
 ADD: 0.1uf (283-0111-00)

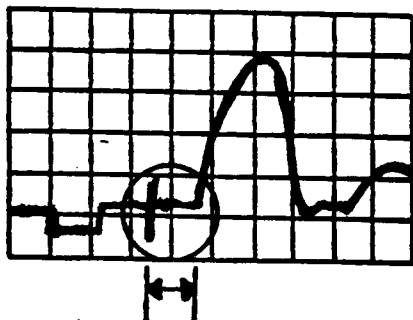
Figure 1

Mod Kit 050-1369-00 was designed to provide correction to horizontal deflection problems that were caused by unspecified turn off times of Q5030. Some of the effects of this defect are horizontal breakup and oscillations, an apparent heat sensitivity associated with T5090, and failures of Q5030.

As vendors for Q5030 have changed, and since there is no specification for the turn-off delay of Q5030, a problem has been discovered where installation of the mod kit will cause the circuit to malfunction, whereas the original values of L5085 and R5085 may be the appropriate values to use under certain conditions.

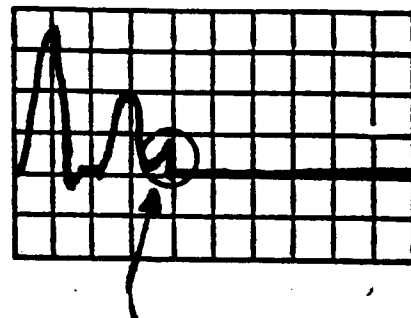
Figure 2 illustrates a waveform that may be seen with the mod kit installed. The extra overshoot noted in the figure is caused by the mod, and is a normal waveform to be expected. This does not affect performance of the circuit.

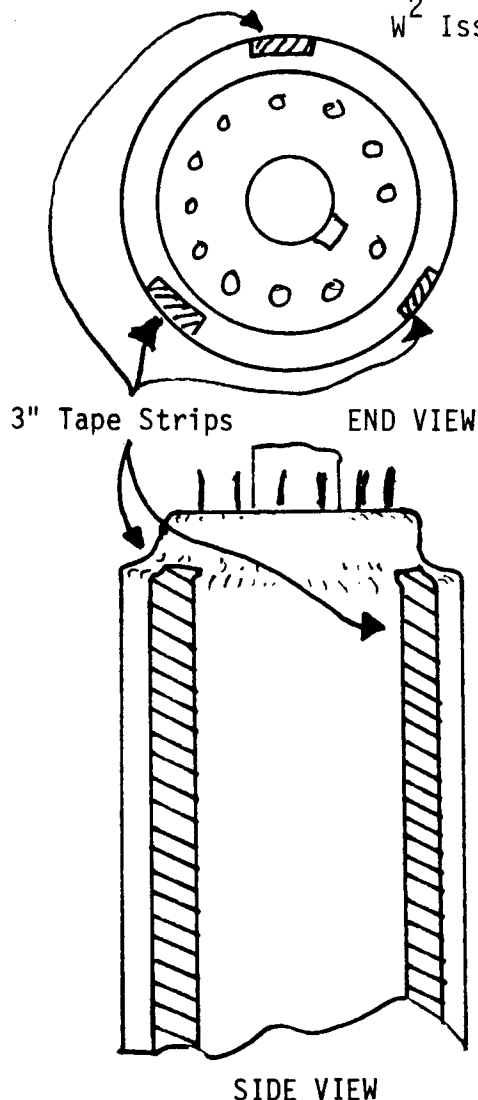
Some people have experienced difficulties with the tape on the CRT retaining clamp falling off during replacement. This will necessitate removing the clamp from the CRT shield to replace the tape, thereby adding unnecessary time to the repair function.

When replacing the CRT, install three (3) pieces of tape approximately 3" long laterally on the CRT neck, equidistant about the neck circumference. (See illustration). The tape is 006-3436-00 for a 9 foot roll.

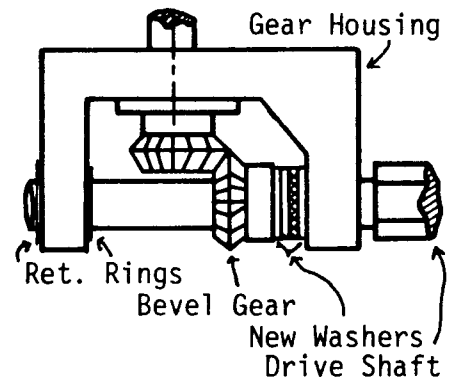
There is an 050-1555-00 kit that will improve the operation of the actuator arm that lifts the test head. On some test stations the drive shaft retainer (snap) rings have come loose causing the gears to misalign and making the actuator arm assembly (crank) inoperable.

The 050 kit replaces the drive shaft with a new drive shaft, P/N 384-1298-01. The new drive shaft has had two snap ring slots made deeper and has had the third retainer ring slot deleted. A combination of steel and brass washers are used to obtain proper gear alignment.

Typically, it takes three steel washers and one (or two) brass washers. The thrust washers remove the stress of cranking the table from the snap rings. The stress is now on the level gear, washers, and gear housing, thereby keeping the level gear aligned. (See figure on next page).

Periodic lubrication of the washers should be performed every six months.

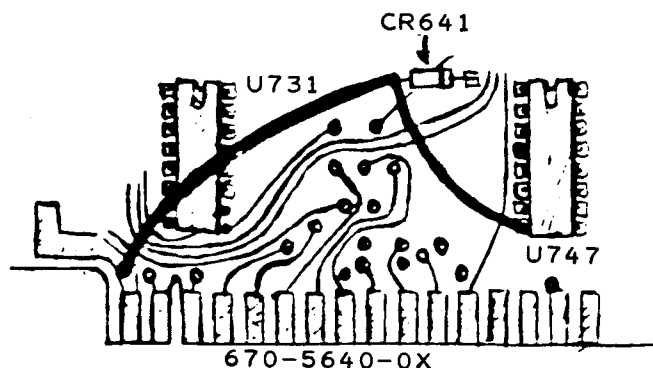
GROUND IMPROVEMENT

A sparkling effect, where vertical lines and horizontal scan lines jump back and forth may be observed on the screens of 4027s and 4027As. This effect may be more noticeable on the "A" version than the non "A"s.

The cause of this phenomenon has been traced to noise on the Display Control boards, 670-5640-02 and below. The final fix will be a layout change to the ECB which will add a ground plane and a +5 volt plane. On the current boards there are only runs for these functions.

The manufacturing line has been hand adding number 26 gauge wire in strategic points to better ground out the noise. This is not considered a modification because the ground runs are already there. Also the revision level of the board does not change.

The wire is added from Buss pin 72 to the anode of CR641 and to U747 pin 8 as shown in the drawing.
