SERVICETEKNOTES

TABLE OF CONTENTS

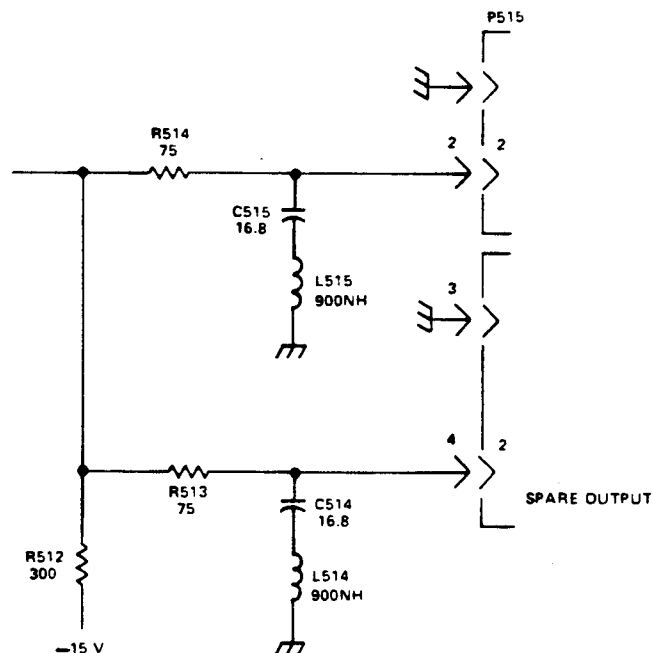
- o L514 (P/N 108-0683-00) was added, "teepee" fashion, in series with C514
- o L515 (P/N 108-0683-00) was added, "teepee" fashion, in series with C515.

The schematic below illustrates the circuit changes.

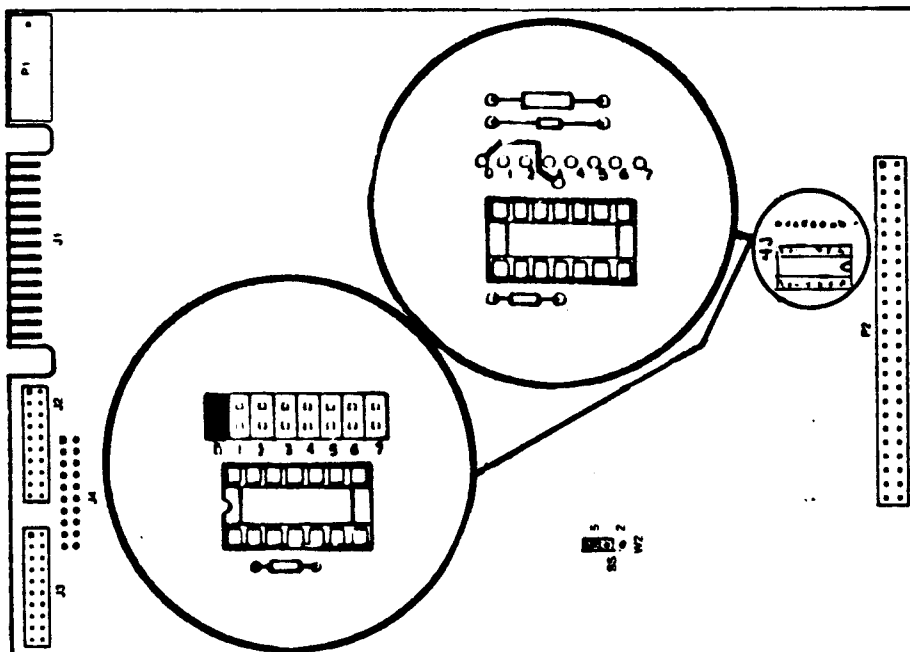
Figure 1

The 670-8437-00 rolled to -01 when the wire jumper at board location 4J, to select a device address, changed to a double row of pins and a moveable jumper, see figure 1. Xebec rolled the board assembly number from 104526 to

Sector size should be set for 512 bytes, strap W2 (on the 104526) or W2(on th- 104527) should be set at 5, as shown in Figure 1.

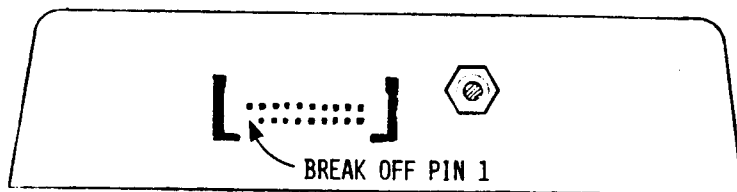
T.V. Pattern Generator Connector

The ribbon cable from the T.V. Pattern Generator is polarized at the 4692 end to prevent reversal. Unfortunately we failed to polarize it at the other end and it can still be reversed, which typically blows two axial lead fuses, F851 and F855 (P/N 159-0090-00), on the 4692 Drive Module.

To prevent this occurrence, you can easily polarize the plug at the test fixture end. Use a needle-nose pliers to "wobble" and break off pin 1 at the test fixture. Insert a plug, P/N 134-0153-00, into pin 1 on the ribbon cable (it is marked with an arrow and is on the red stripe side). See the figure below.
