SERVICETEKNOTES

TABLE OF CONTENTS

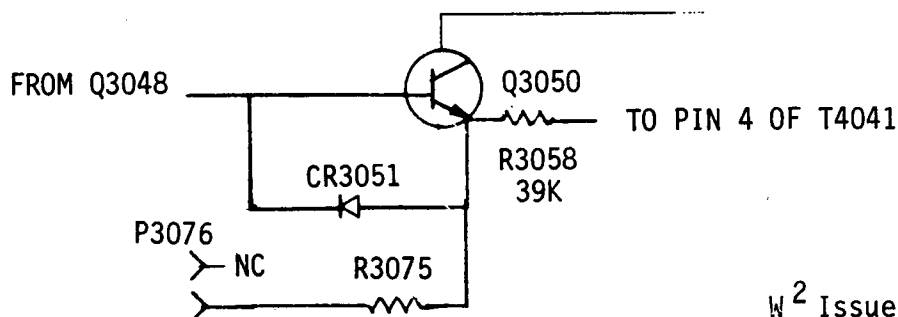
The above parts are located on A38 Optical Pulse Generator board and shown on Diagram 2 OPTICAL PULSE GENERATOR - Partial

CHANGE TO:

A38C2053	290-0523-00	CAP., FXD, ELCTLT: 2.2UF, 20%, 20V
A38R3046	321-0304-00	RES., FXD, FILM; 14.3K OHM, 1%, 0.125W
A38R3050	321-0246-00	RES., FXD, FILM: 3.57K OHM, 1%, 0.125W

ADD:

A38R3058	315-0393-00	RES., FXD, FILM: 39K OHM, 5%, 0.25W
----------	-------------	-------------------------------------

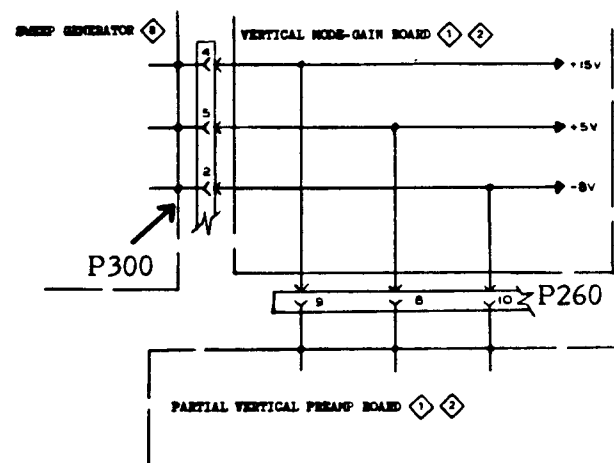
The power distribution diagram in the early 475 manual, below B250000, has an error in the power supply voltages shown on the Vertical mode--gain board. The diagram below shows the correct pin numbers and voltages.

P300, shown at the left edge of diagram 3, should be changed to show the + 5 V going to pin 5.

Change power connections on P300 and P260 as follows:

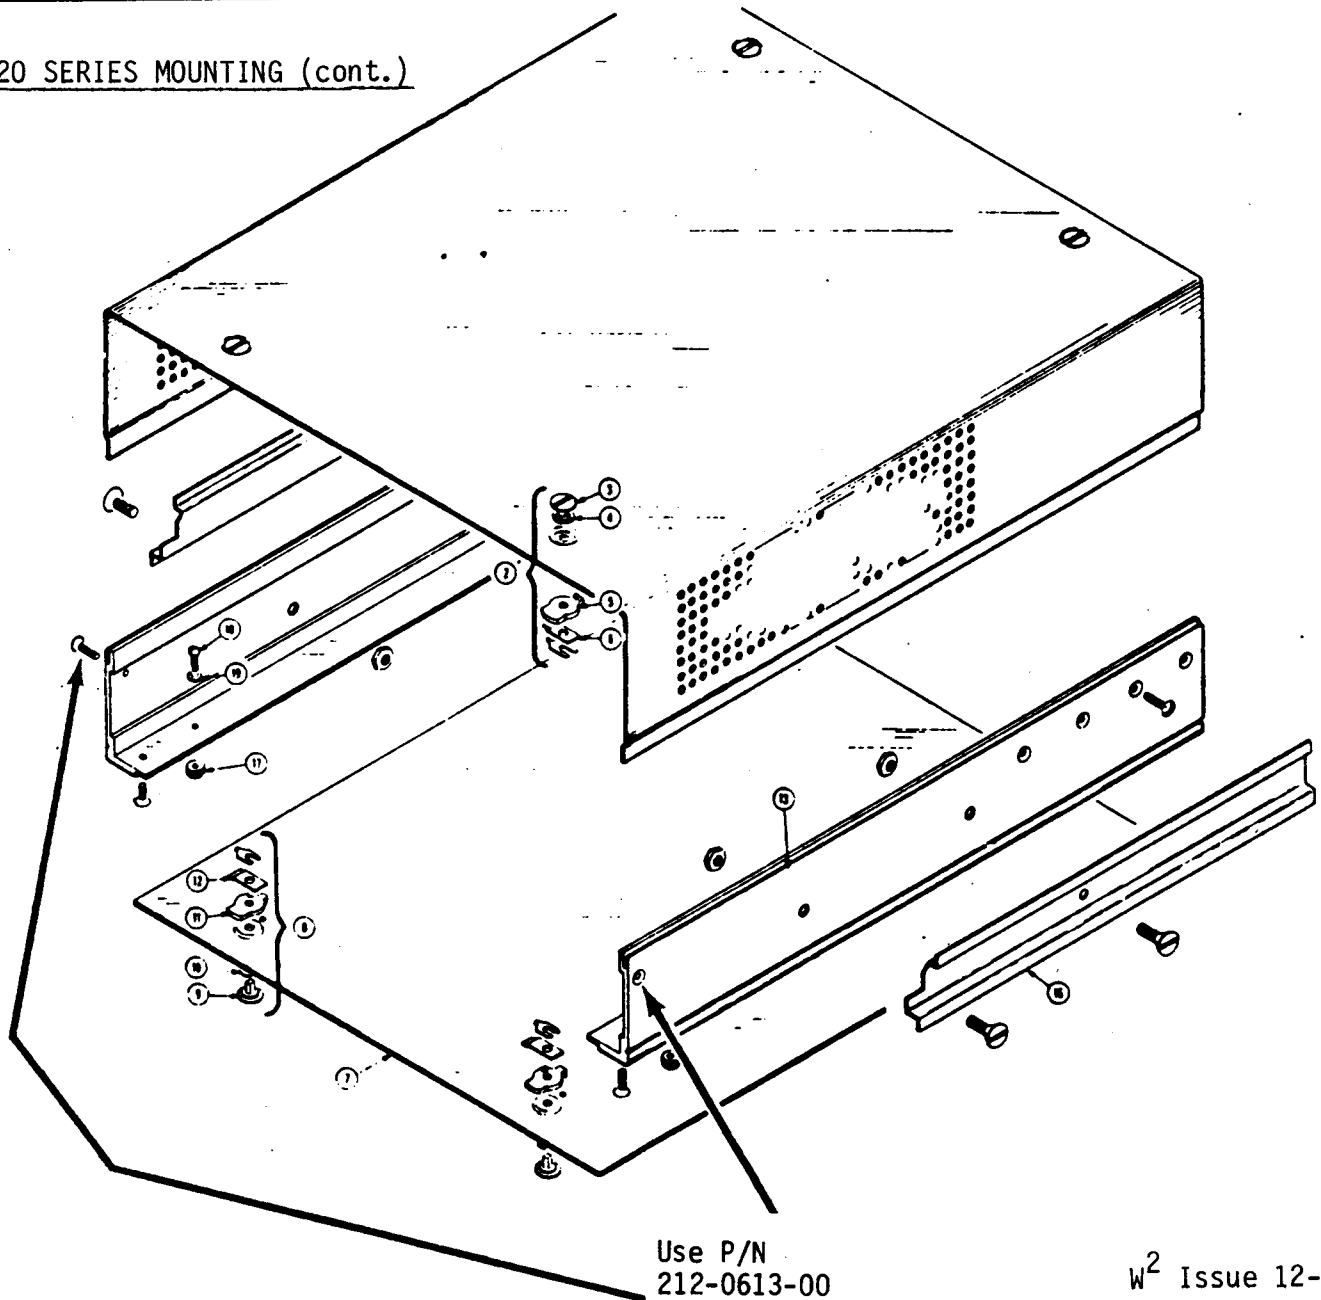
A screw of insufficient length has been used to fasten the side rails to the main chassis, causing stripped threads. Where a bad screw is found, replace with 212-0613-00 (see illustration).

Use P/N
212-0613-00

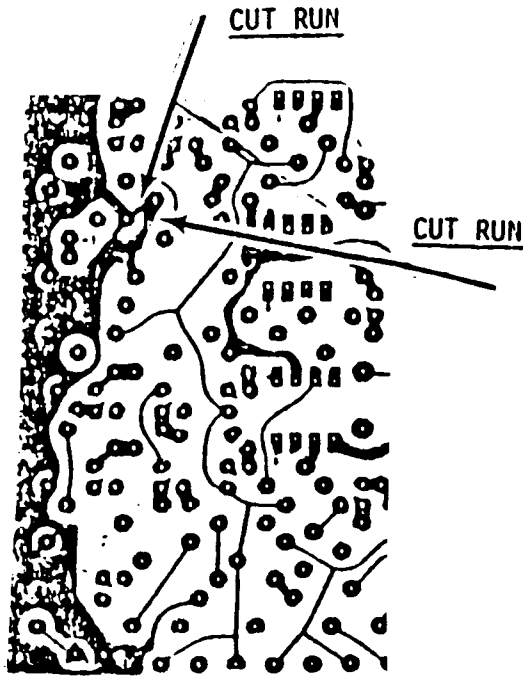
DECODER BOARD
670-2611-07

The Decoder Board (670-2611-07) has an ECB layout error which shows up as a 400KHz ripple of about 200mV P-P riding on the R-Y output. The cause is one end of R2739 being shorted to ground. The suggested fix is to cut the ground plane surrounding the bottom pad of C2641 (See illustration).

INTERIUM SOLUTION

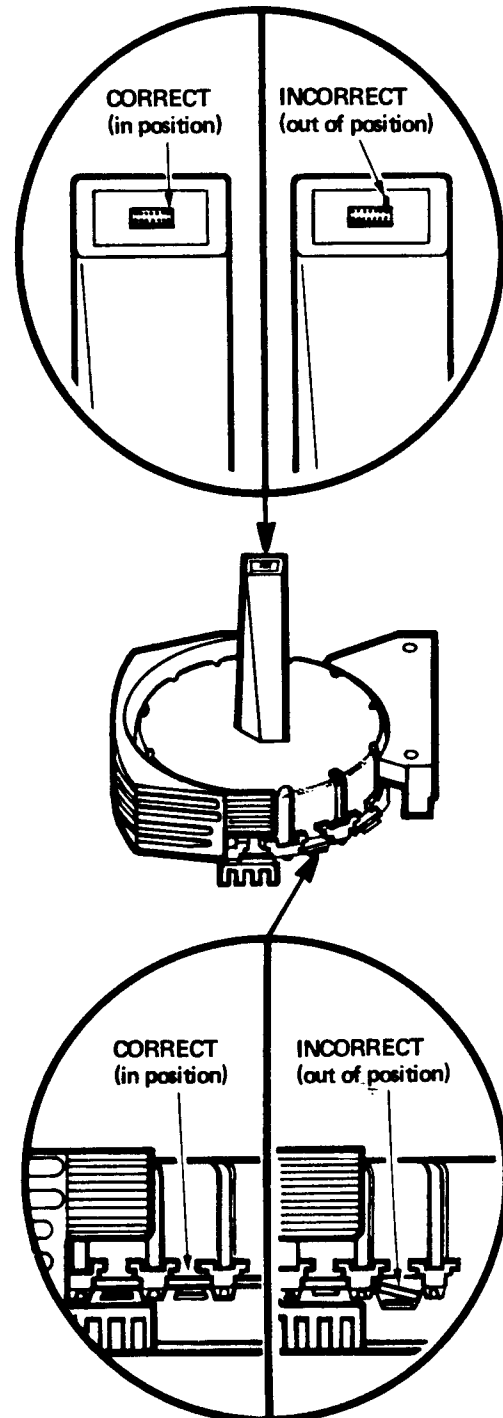
The metal plates that cause the printhead wires to move can be jarred out of position during handling or replacement.

If the printhead is operated with the

solenoid plates out of position it will result in a damaged printhead.

Be sure to inspect printheads after product shipping or during printhead replacement. If a wire is protruding from the printhead, it indicates that the metal plate is lifted from its normal position. Be sure to reseat the metal plate back to its proper position. See illustration.

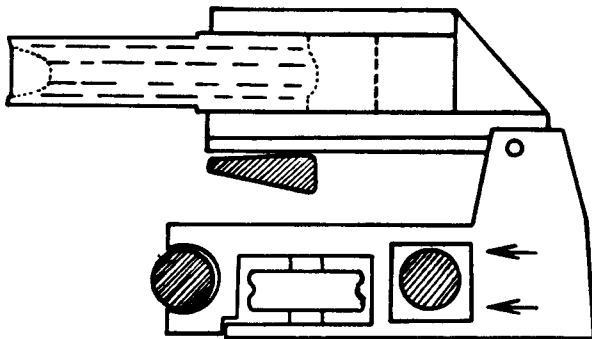
Figure 1

The 4662 can be visually inspected to determine if the rear of a pen carriage is positioned too high. Looking at the side of the pen carriage, observe the square hole surrounding the rear slide shaft. The slide shaft should be positioned closer to the top of the square hole. See figure 1.

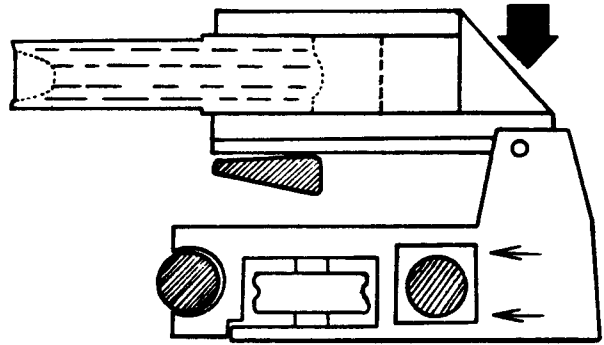
Figure 2

It is possible to jar the rear of a 4662 pen carriage into an incorrect position on the carriage slide shafts. If the rear of the carriage is incorrectly positioned, the result can be line skipping, or with option 31, pen exchange problems.

If the carriage slide shaft is located closer to the bottom of the square hole, figure 2, the pen carriage needs to be correctly positioned. This can be accomplished by placing firm downward pressure on the rear of the pen carriage just above the pivot point, see figure 2, while supporting the bottom of the carriage slide shafts to keep them from becoming bent or warped. The downward pressure should cause the pen carriage to snap back into its normal operating position.
