SERVICETEKNOTES

TABLE OF CONTENTS

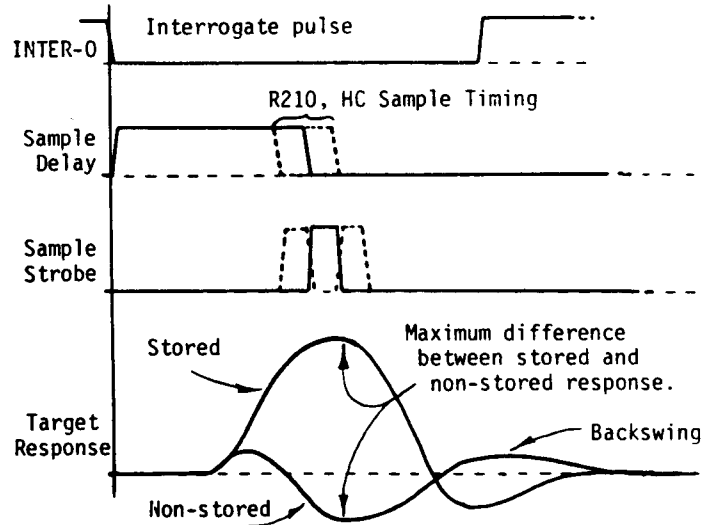
Fig. 1: Strobed Hard Copy Board Timing Diagram

The new board "reads" the CRT target only when a target response is most expected. This reduces the noise produced in the hard copy, especially with CRT targets exhibiting substantial backswing (see the timing diagram). The strobe window can be adjusted with R210, hard copy sample timing. Typically, R210 can be set to midrange and forgotten. Noisy copies may be improved by straying from midrange either clockwise or counterclockwise.

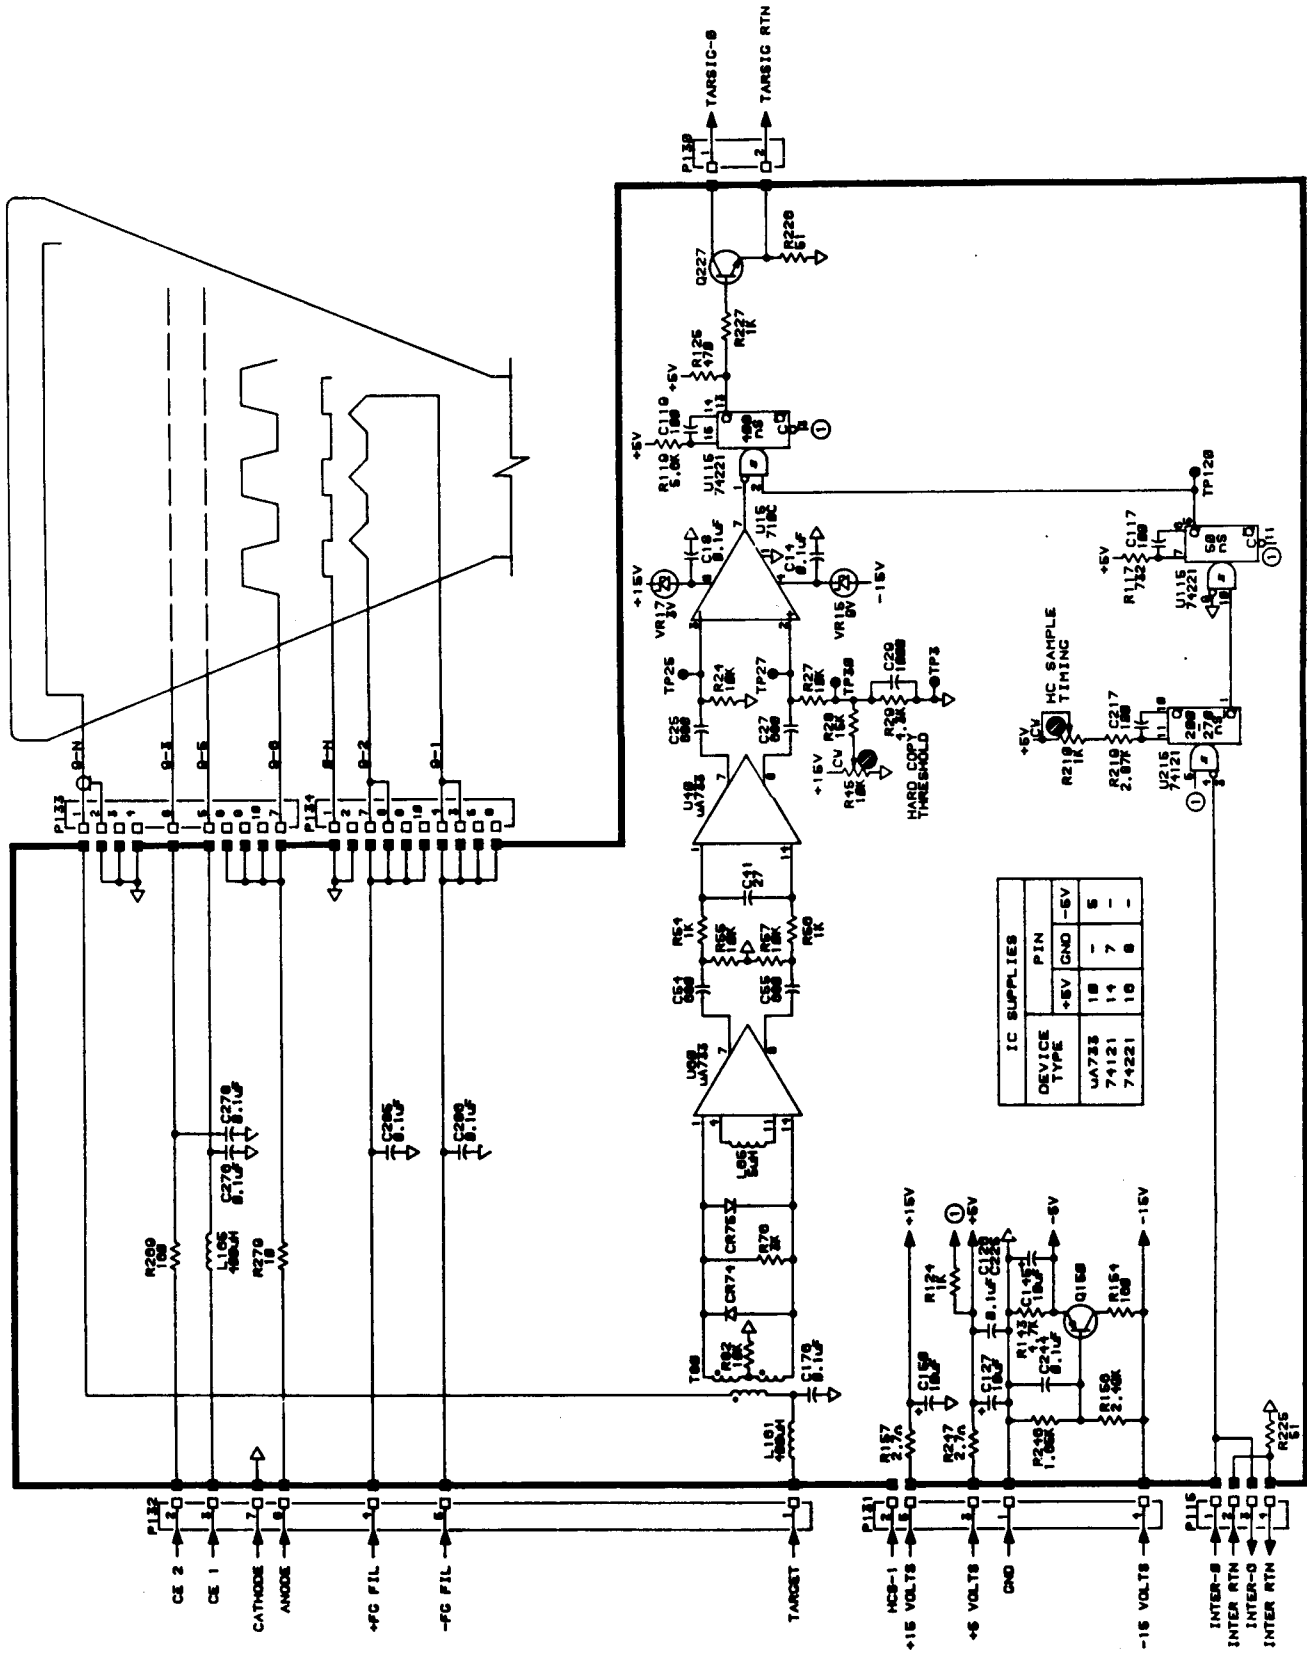
Figure 2

Schematics of the new board and hard copy cable assemblies are given in Figures 2 and 3. Note that the added circuits around U215 (sample timing delay) and U115 (sample strobe) distinguish this board from the earlier 670-3097-XX hard copy board. Note also that the INTER-0 signal produced by the hard copy unit is routed directly to the hard copy board to trigger the strobe. The HCS-1 signal produced on the storage board and necessary with the earlier 670-3097-0X is no longer used.

Schematic of 670-7550-00 strobed hard copy board.

Three kits have been set up to retrofit the strobed hard copy board into earlier products. These kits should be used only when needed to improve the hard copy quality, especially the ring of noise commonly seen in the center of the copy.

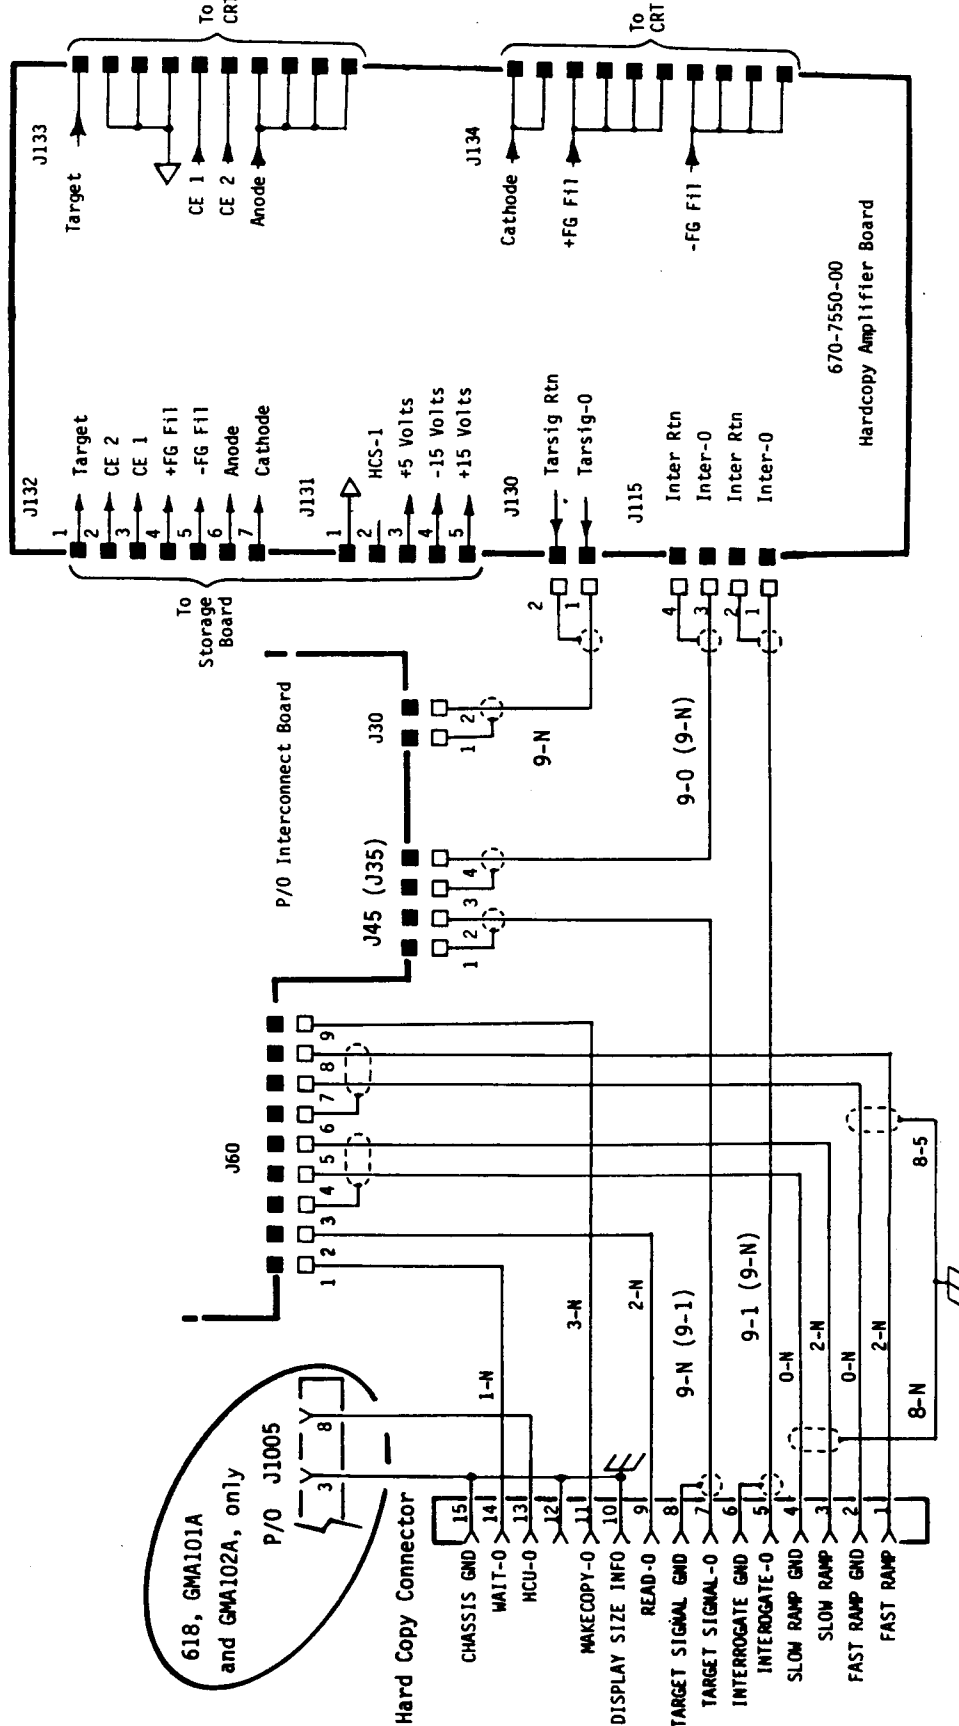
Figure 3

Schematic of the 179-2876-00, 179-2877-00, 179-2879-00 and CM179-2880-00 cable assemblies used with the 670-7550-00 strobed hard copy board. Numbers in parens apply to some 4054 products only.

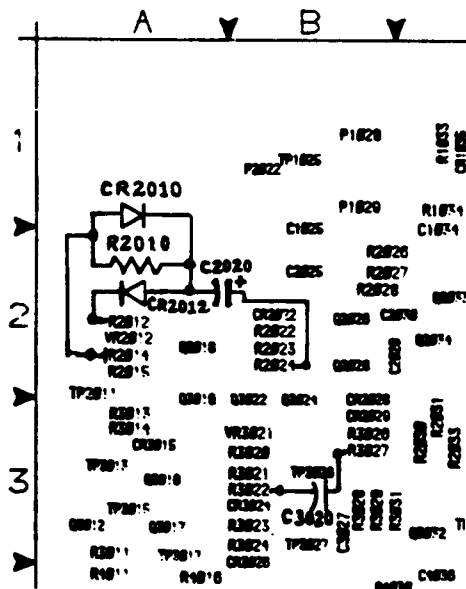
A38 —Optical Pulse Generator circuit board.

Because of an excessive failure rate of Laser Diodes in the Coupler Assemblies of early OF150's, it is imperative that all instruments within the serial number range of B010100 to B010200 entering the Service Center have the installation of the following mod physically verified.

The above parts are located on the A38 Optical Pulse Generator board and shown on diagram 2 OPTICAL PULSE GENERATOR.

1. To top of Optical Pulse Generator Circuit Board Assy 670-7153-00, add a 15 uf capacitor (C2020) with the positive lead at the +5V end of a 100K resistor (R2024). Connect the negative lead of C2020 to the anode lead of an added diode (CR2012) and connect cathode lead of diode (CR2012) to junction of 12K resistor (R2012) and the emitter of transistor Q2018.

Connect an added diode (CR2010) and added 100K resistor (R2010) in parallel and connect the cathode end of pair at the junction of the negative lead of 15 uf capacitor (C2020) and anode lead of diode (CR2012).

Connect the anode lead of diode (CR2010), which is paralleled with resistor R2010, to the ground lead of a 100K resistor (R2014).

2. On back of the same circuit board assembly, add a .1 uf capacitor (C3020) between junction of a 360Ω resistor (R3022) and a 1.37K resistor (R3024) and the ground lead of a 20K resistor (R3027).

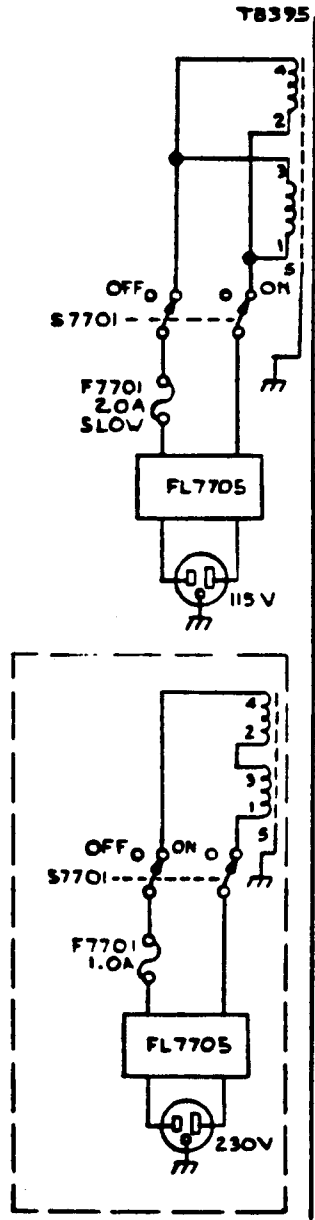
FL7705 is added as shown in partial diagram 18

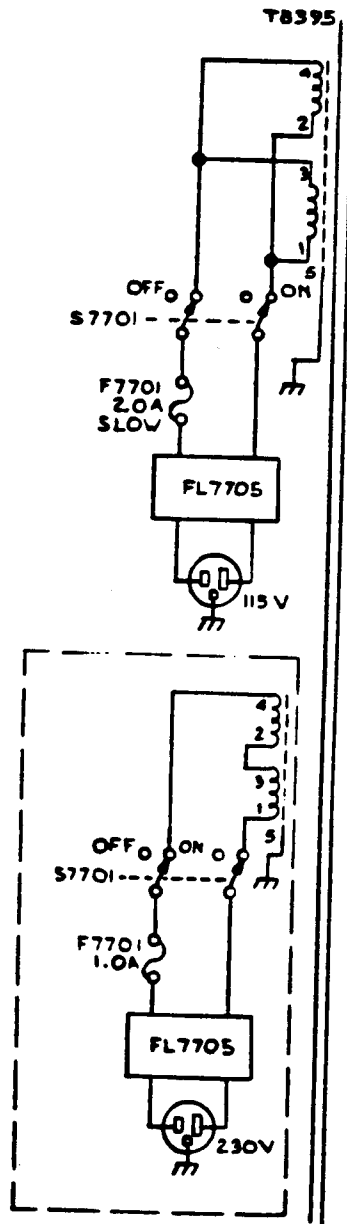
FL7705 is added as shown in partial diagram 16

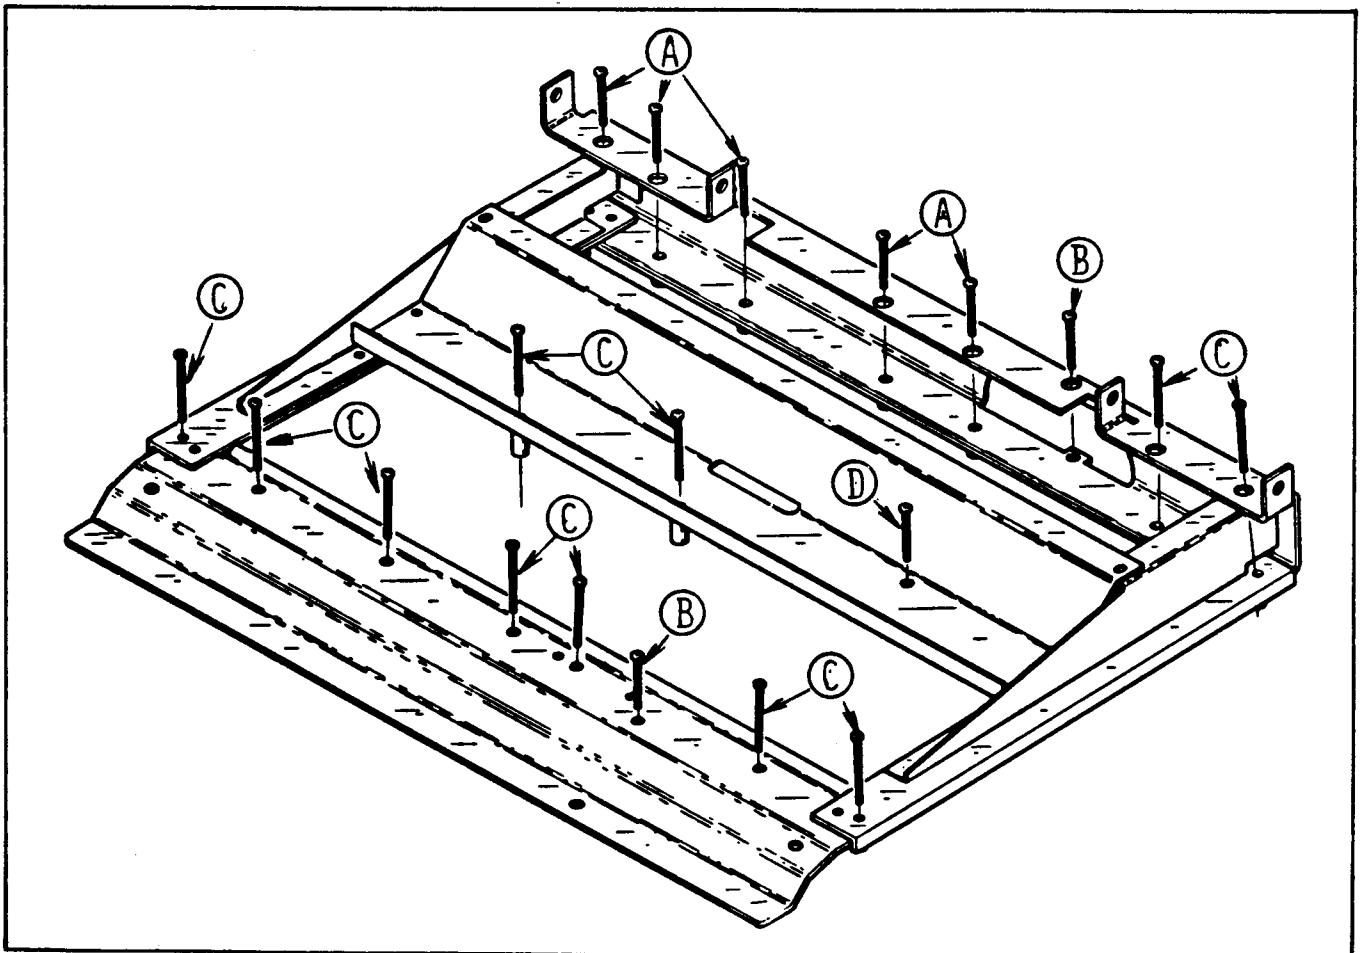
Figure 1

Many 4054 products have been experiencing intermittent start-up malfunctions as well as intermittent "locked busy" failures during operation. These malfunctions are usually caused by failures on the I/O or MAS boards, with RAM failures the most predominant. These failures have been traced to poor or intermittent connection of the cables to Q5001 and Q5002. These transistors are mounted to the CPU frame and are connected to J117 and J118 on the I/O board.

Note that there are two "D" type screws listed. On the 4054A this screw goes through the ALU board and into the I/O board, whereas on the 4054 it only screws to the ALU board.
