# SERVICETEKNOTES

Published by Tektronix Service  
Administrative Support

## TABLE OF CONTENTS

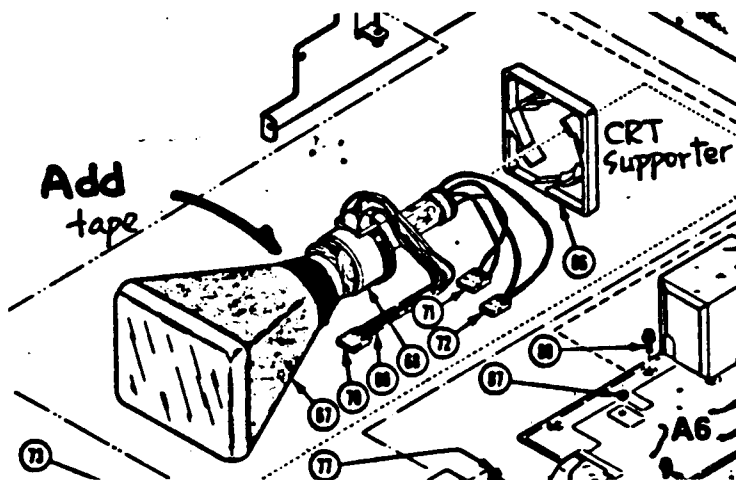
308 CRT TILT

Some CRT's rotate in the vertical axis (tilt) due to shock and vibration. To alleviate this problem a piece of adhesive tape, 10 cm x 2.5 cm, is wrapped around the CRT where it is bracketed by the CRT supporter. (See Illustration). This effectively increases the friction between the CRT and bracket, reducing rotation.

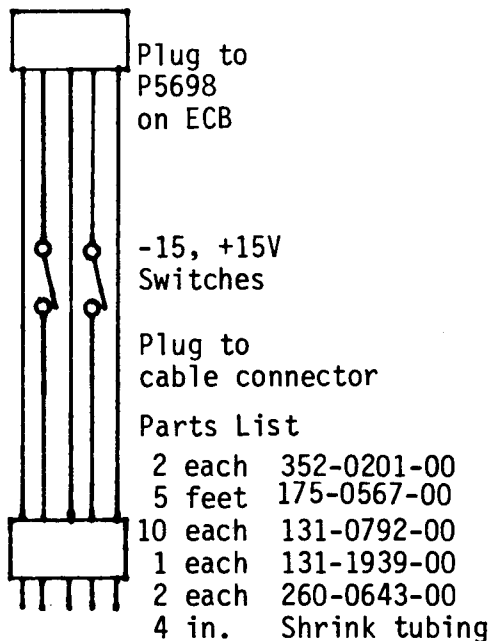
Figure 1  
RCU Power Fixture

In later model 1440 Mod instruments, the power that is supplied to the RCU passes through diodes CR5691 and CR5692. In older instruments, there were fuses. The calibration procedure starting at step 18 on page 3-7 talks about removing these fuses as a part of the calibration procedure. Since the fuses have now been replaced by soldered in diodes, removal is not a clean and easy process.

1. Pull P5698 and temporarily remove the wires from slots 2 and 4 on the 5-pin connector as appropriate for the calibration steps.
2. Construct a fixture as shown in Figure 1. This fixture can then be inserted in series with the connection at P5698, and will provide the ability to disable the RCU supplies.

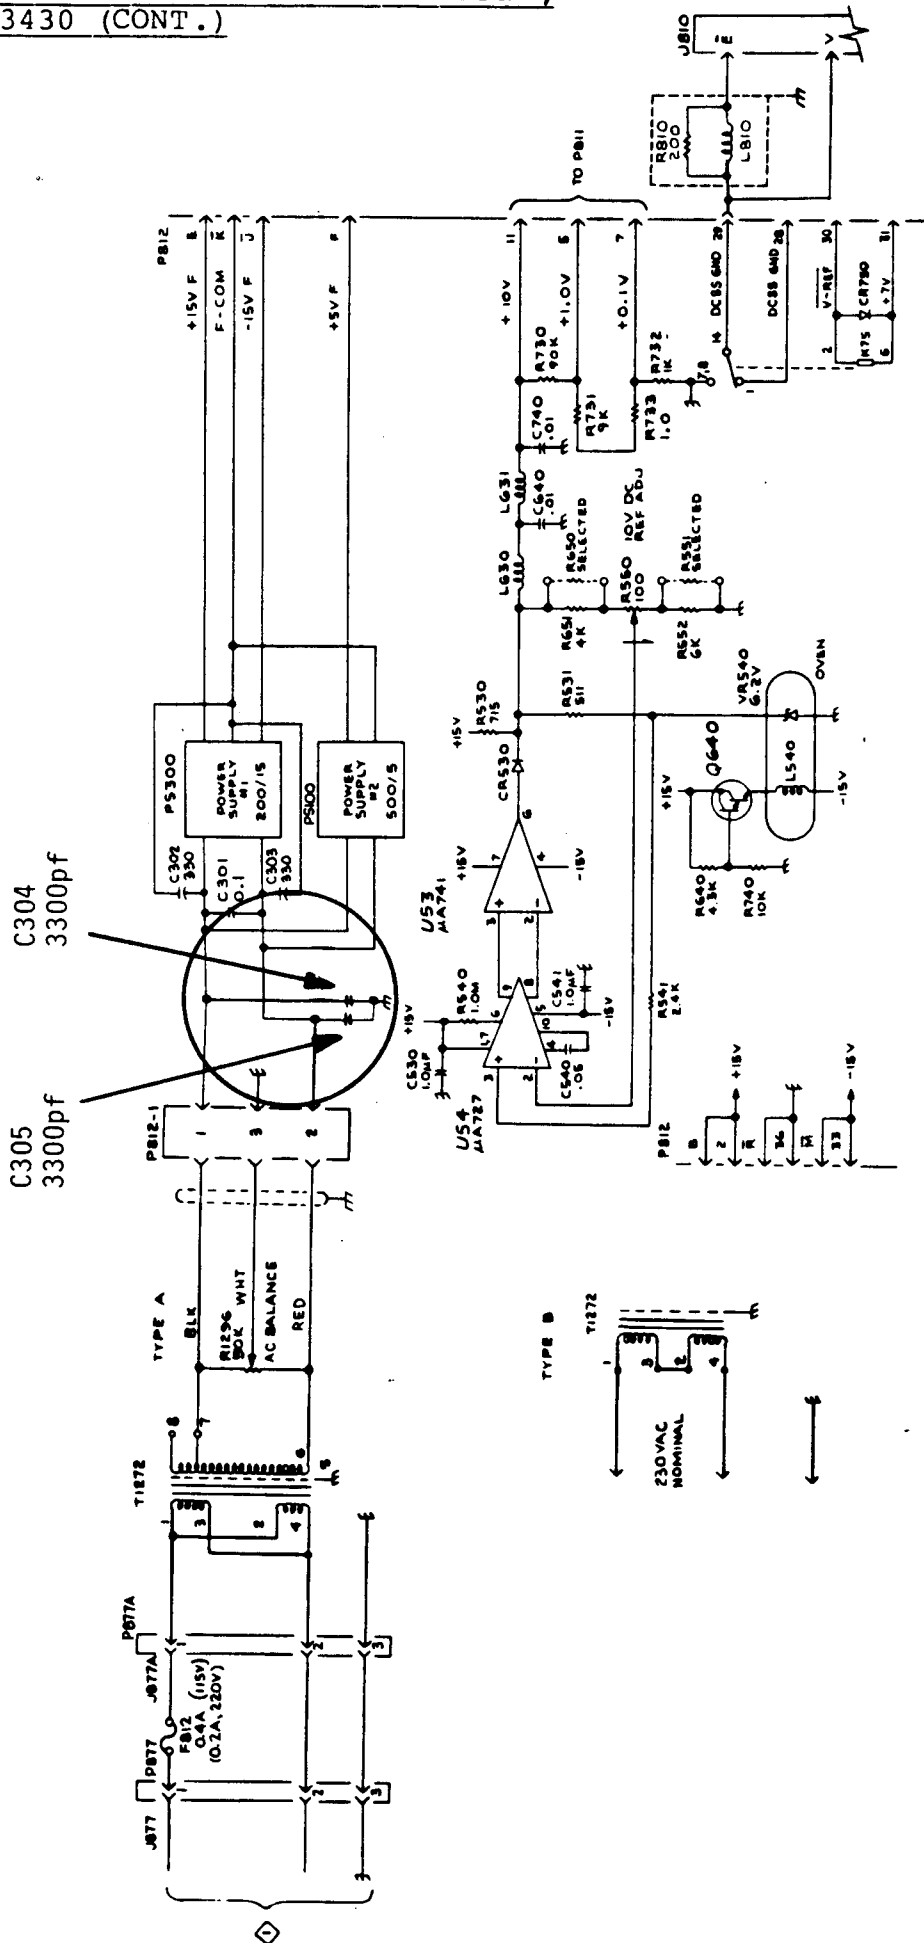
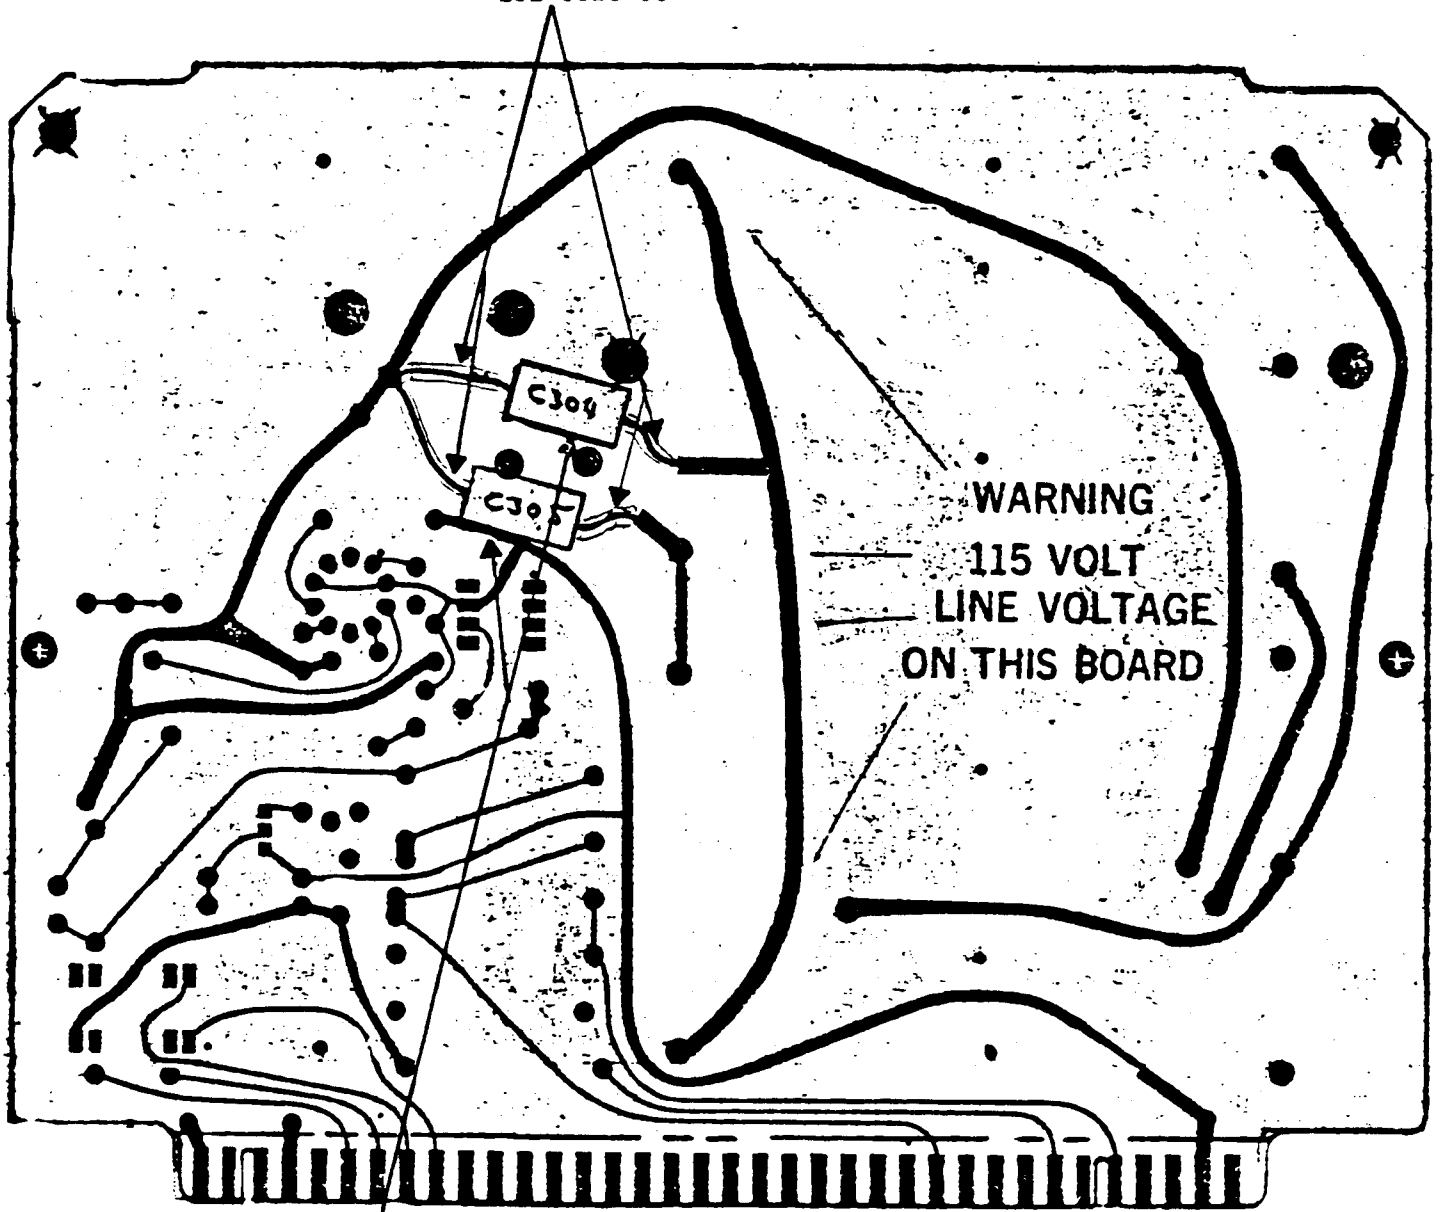
M43430

Switching noise on the AC line gets on the floating common of the DC subsystem and may cause F040 (T1140A.EDT) to fail.

**WARNING**  
115 VOLT  
LINE VOLTAGE  
ON THIS BOARD

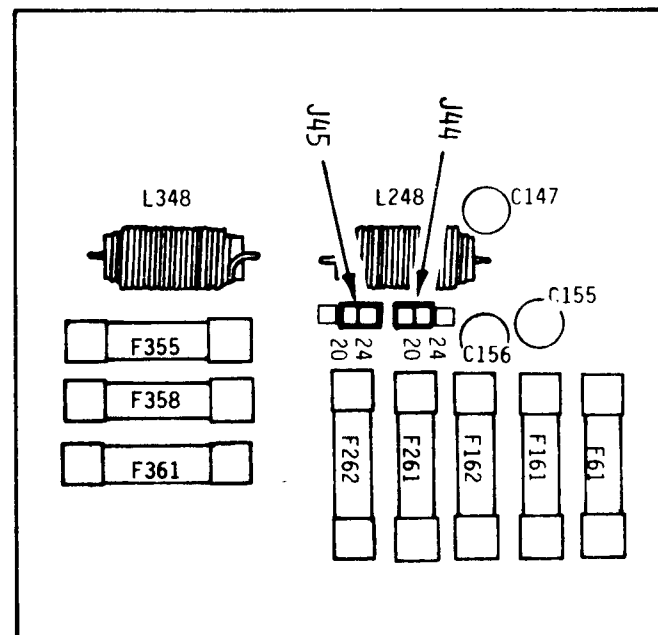
Figure 1.

One possible cause of premature failure of replacement CRTs in 4016 terminals and GMA125 monitors are flood gun heater straps that are not set for optimal performance. When a CRT is replaced, the flood gun heater straps, J44 and J34 on the secondary LVPS board, should be placed in the 44V settings. Leaving the straps in the 48V settings may severely curtail the life of the CRT. The 48V setting is used to extend the life of an old CRT. The 40V setting is not recommended because it may cause early CRT failures. To strap J44 and J45 to the 44V setting, it requires that one be strapped to 20V and the other to 24V. They are strapped to 48V when both J44 and J45 are in the 24V position.

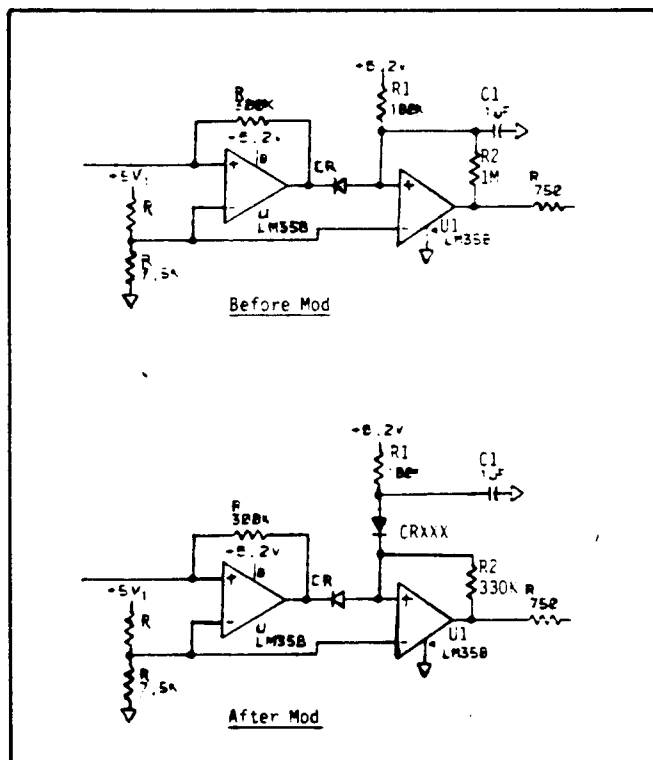
Schematic Changes

Identical power up restart circuits on the 4052/4052A power supply, 4054/4054A I/O boards and the 4050E01 power supply have a design defect which can cause the restart signal to pulse several

times. This can cause the system to hang or for the 4050E01 to power up in the opposite mode than the product to which it is connected. The malfunction can also show up on the 4050E01 as intermittently changing modes.

One end of both a 1 uf cap (C1) and a 180K  $\Omega$  resistor (R1) are connected to the plus input of the OP AMP (U1) in the circuit involved. Lift this end of both components and "teepee" together. Insert and solder in the cathode end of a 1N4152 diode (CRXXX) into the hole from which the end of the "teepeed" resistor (R1) was removed. Connect the other end of the diode to the "teepeed" resistor and capacitor (R1, C1) and solder together. Last, replace the 1M  $\Omega$  resistor (R2) with a 330K  $\Omega$  resistor. Below are part numbers for CRXXX and R2.

Board Name - Input/Output Board  
Board P.N. - 670-7630-01 rolls to -02  
Ckt. Involved - U265B (+ input = pin 5)  
Lift - R265 and C267  
Add - CR265  
Change - R266
