52504
485
2215

SERVICETEKNOTES

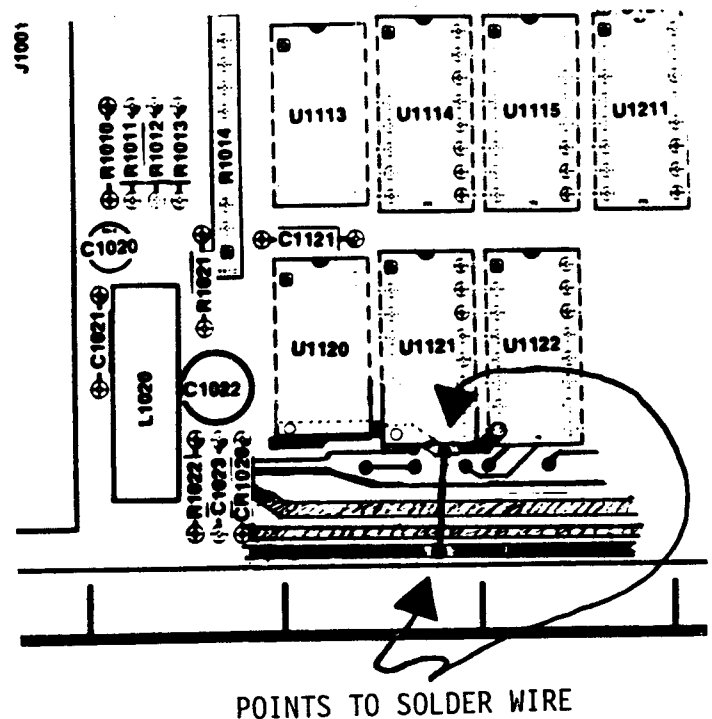
DC5010 H.F. COUNTING FLUCTUATES BY
4 OR 5 LEAST SIGNIFICANT DIGITS

Fluctuation of >10kHz on the last four to five L.S.D.'s may occur when measuring frequencies between 100MHz to 350MHz (the symptom normally shows at 350MHz). First, vary the signal source to ensure it is not the cause of the erratic display. If the source is stable,

In some extreme cases U1120 may be part of the noise and will have to be replaced.

1) One end of an insulated wire is soldered to the ground plane run located on the bottom front of the A16 Digital Board. See the diagram for the exact location.

(Scrape the solder mask from the run at the point of soldering, being careful not to damage the run. Too much heat on the run can separate it from the board, so use care when soldering.)

2) Solder the other end of the wire to the ground plane which attaches together Pin 7 of U1120 and Pin 8 of U1121 and U1122. (Follow the soldering procedure in Step 1.)

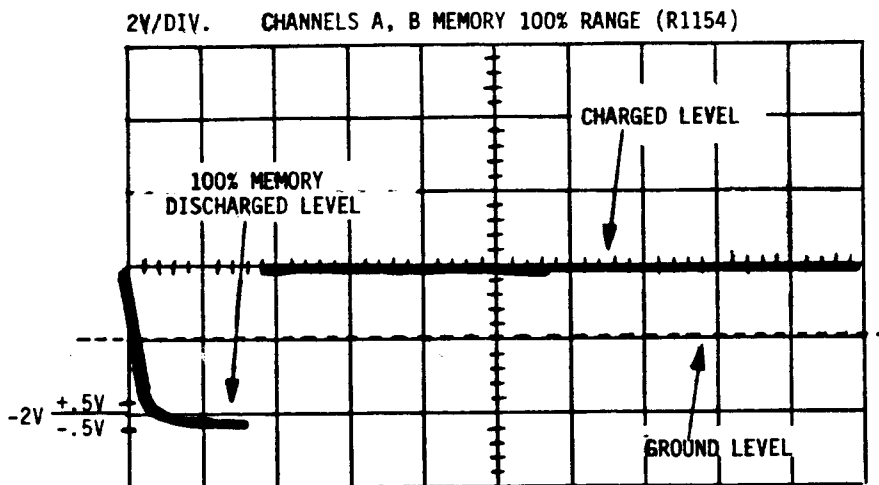
070-1976-00 FIG. 7-4 (B)
 OLD ADJUSTMENT RANGE LIMITS -2V ($\pm .5V$)

The 100% memory range test and adjustment section of the 070-1976-00 manual includes a check procedure for the 100% memory discharge voltage level. Section 9 on pages 7-6 and 7-7 checks and adjusts R1154 for a -2 volt level (with a ± 0.5 volts tolerance) below ground reference.

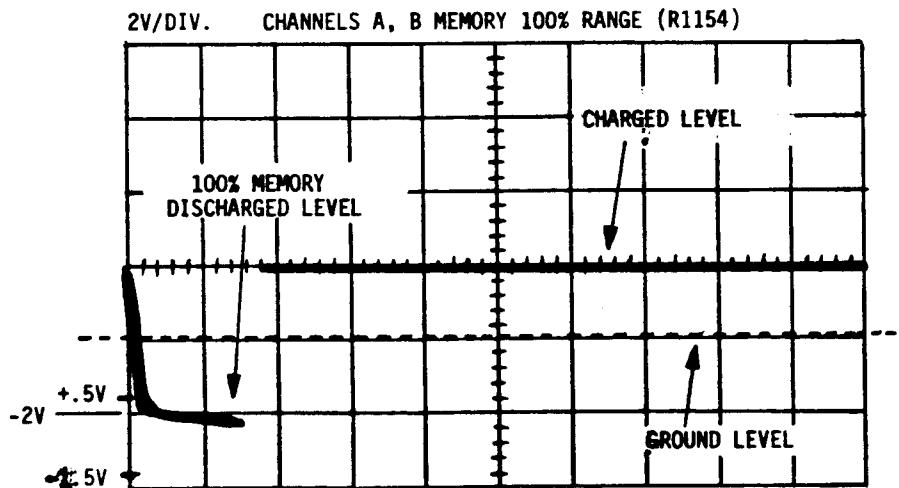
070-1976-00 FIG. 7-4 (B)
 NEW ADJUSTMENT RANGE LIMITS -2V (+.5V, AND -1.5V)

The tolerance range for the -2 volt (R1154) adjustment has been changed from ± 0.5 volts to to + 0.5V through -1.5V from the -2 Volt level. From Ground reference, the R1154 Adjustment range is -1.5 Volts to -3.5 Volts.

In some instances when Q1155 (151-1002-00) is a Motorola part, the wider tolerance range is necessary. The increased tolerance window will not affect memory operation or operating specifications.

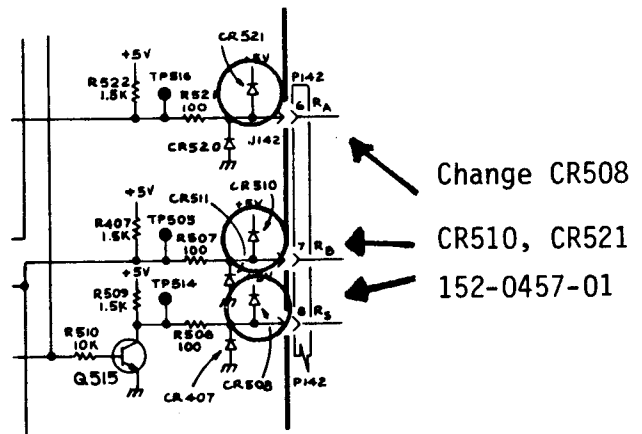
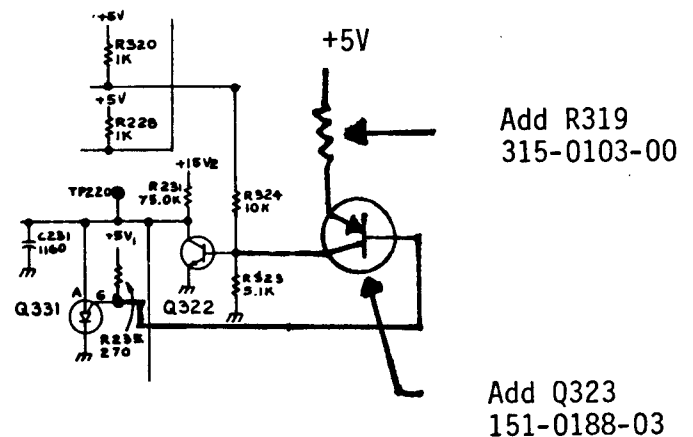
Starting at S/N B011080 on the 6942 and B010410 on the 690SR, a mod was implemented to take care of three problems in the instrument. These changes all occur on the H Delay board, A11 A2.

1. At high scan rates (37.5 kHz) the unit would not always function properly since U332 was in voltage limit prior to the retrace command occurring. To correct this, VR335, an 11 volt Zener diode was added in parallel with C335, cathode to the U332-pin 6 end of C335 (see diagram).
2. To improve reliability, CR508, CR510 and CR521 were changed to burned-in parts (see diagram).
3. With the monitor set for a high scan rate mode, it occasionally would not free-run with the interface module removed. This was caused by the valley current of Q331, a Programmable-Unjunction Transistor, being too low in some devices. To eliminate the need to select Q331 for proper operation, a kit (050-1675-00) has been established that will add another transistor and a resistor in a "teepee" fashion to the circuit. This will insure high-rate, free-run capabilities. (See diagram.)

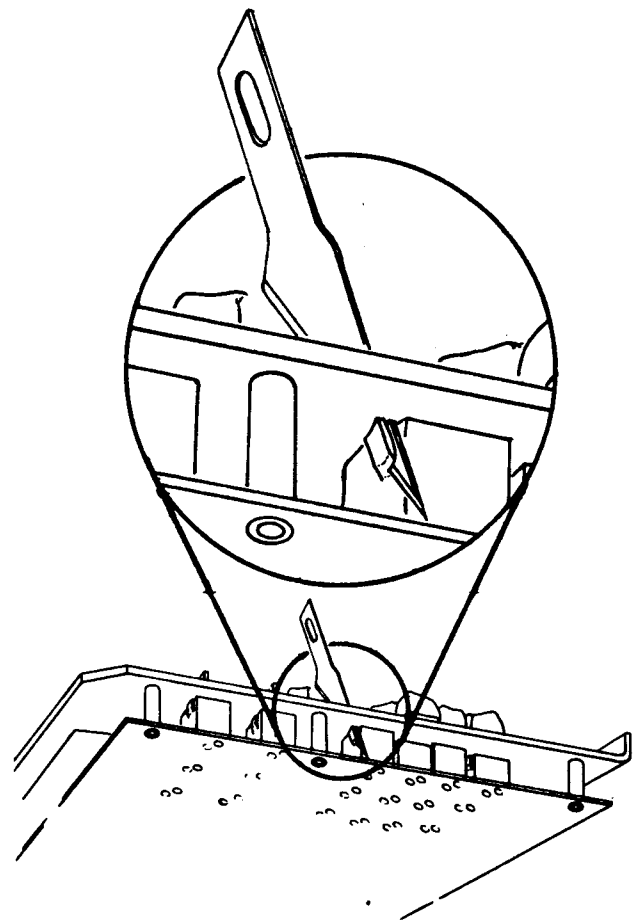
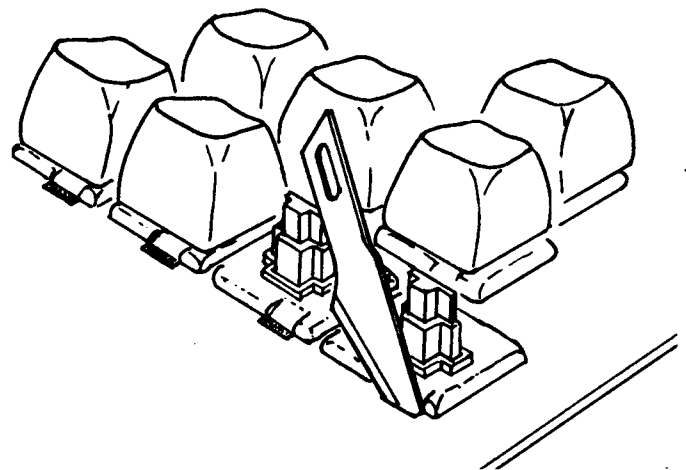
The late style cherry keyswitch, with the expanding mounting tabs, is difficult to remove from the keyboard without first cutting the mounting tabs off.

Older keyswitches have bumps, rather than locking expanding tabs; therefore, do not require cutting.

It has been found that the X-acto blade #11, 002-1040-00, with the long straight edge, works quite well in cutting the cherry keyswitch tabs. Insert blade in keyboard as pictured and cut off tab.
