# SERVICETEKNOTES

## TABLE OF CONTENTS

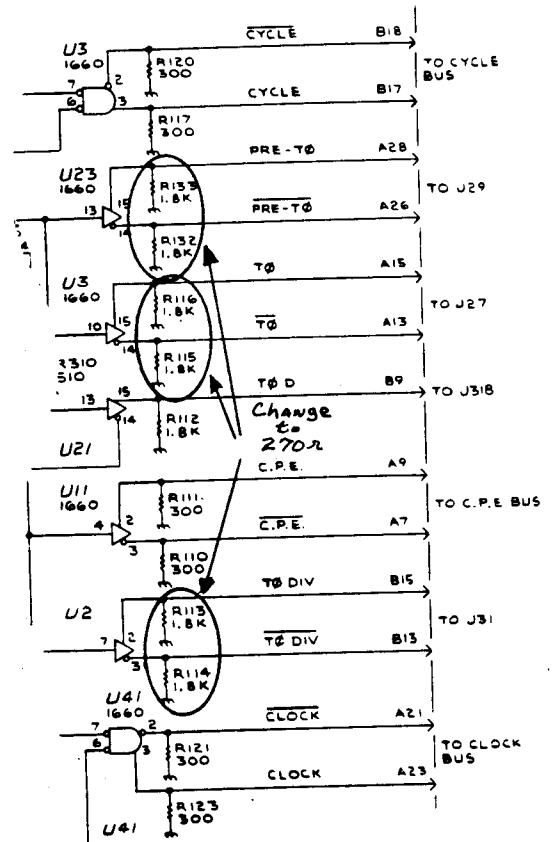
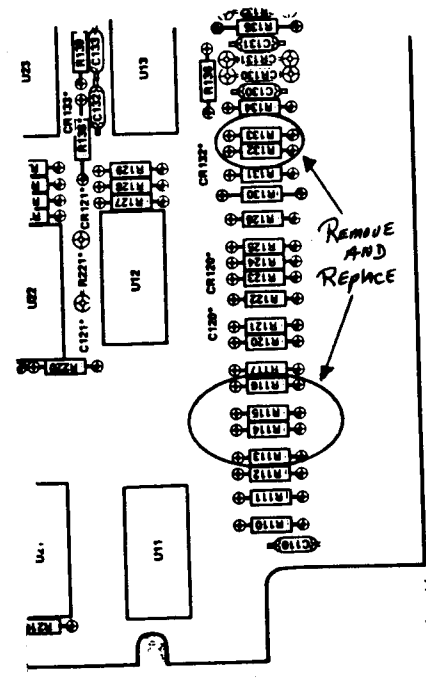
670-5383-06  
P4 Cycle Length

In some 2943/2944 clock generators the clock signal edges may vary (jitter) between 400 ps to 1 ns. The jitter is caused by high signal impedance, signal sources and cross talk to adjacent signals.

On the Cycle Length Board 670-5383-05 change R113, R114, R115, R116, R132, R133 from 1.8K P/N 315-0182-00 to a 270 ohm P/N 315-0271-00. Change board P/N to 670-5383-06. On the Clock Phase Board 670-5425-01 change R300 and R301 from a 1.5K ohm P/N 315-0152-00 to a 270 ohm P/N 315-0271-00, change board P/N to 670-5425-02. On the Programmed Cycle Board 670-5417-01 change R211 and R212 from 1.8K ohm P/N 315-0182-00 to 270 ohm P/N 315-0271-00, change board P/N to 670-5417-02.

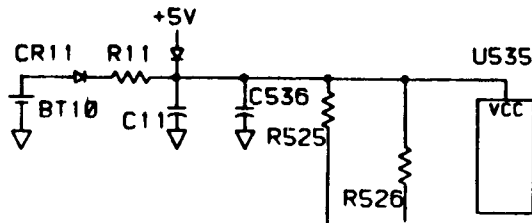
Fig 1. Schematic Diagram

The NiCad battery on the Processor board has had a high rate of failures. This battery, p.n. 146-0040-00, is used to power the CMOS RAM which stores the user selectable operating parameters. If the battery fails, the set up parameter stored will be returned to their default conditions. This is indicated by a message, "Setup Default Reset", displayed on the screen at power-up. The replacement battery is a lithium battery, p.n. 146-0045-00, with a life rating of ten years, and requires no charging circuit. The charging circuit components will be removed with the old NiCad battery.

1. Remove CR9, CR10, CR11, BT10, R11.
2. Add new CR10 (152-0322-00) to replace old CR10.
3. Cut run on surface of board between R11 and CR11.
4. Insert CR11 (152-0322-00) where R11 was removed. Place CR11 in the circuit so the anode is to the battery and the cathode is connected to the run just cut.
5. Move R9 (270 ohms) to bridge the cut run. Attaching one leg to the cathode of CR11 and the second leg to the pad at the other end of the cut run. This 270 ohm resistor will now be referred to as R11.
6. Install the new battery to replace the old battery which was removed. Keep the negative lead short. This battery is slightly longer than the one removed. It will need to be installed at a slight angle for clearance. Use the insulation to cover the positive lead which will need to loop back to the pad labeled with a plus.

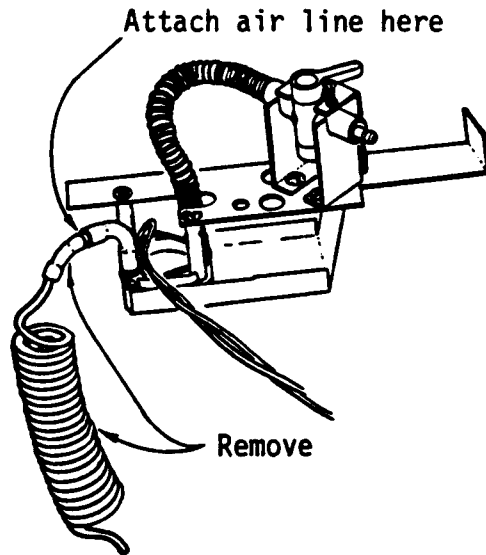
**Ink Jet Head Assembly**

The 4691 is shipped with spiral hoses hooked up to the air inlet of the ink jet heads. The spiral hoses are only part of the shipping paraphernalia and should be removed when the 4691 is installed. At installation, the spiral hose and its attendant 1" piece of rubber tubing should be removed from each head. The air lines are then hooked up to the remaining short piece of rubber tubing coming from the air inlet on each head. Hooking the air lines up to the end of the spiral hoses and then operating the units in such manner may cause a spurious splatter on the copies.
