465/475
492/P
2215

SERVICETEKNOTES

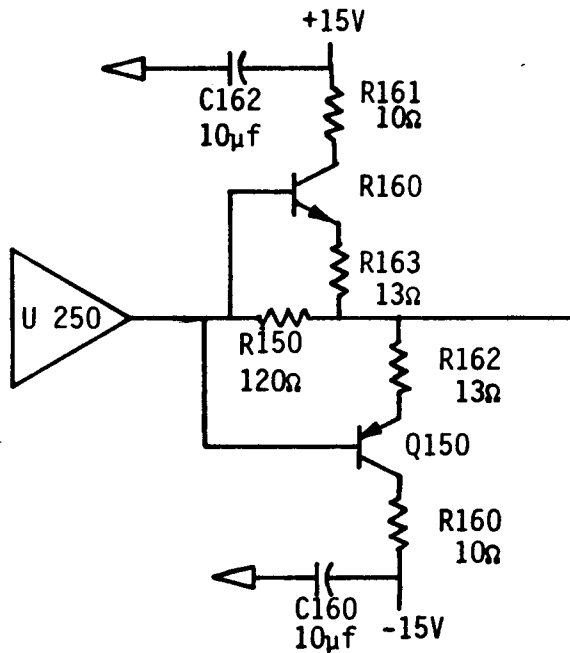
which are caused by the cascaded emitter follower (U250, Q150, and Q160 connections).

Change DC Subsystem amplifier schematic as shown below:

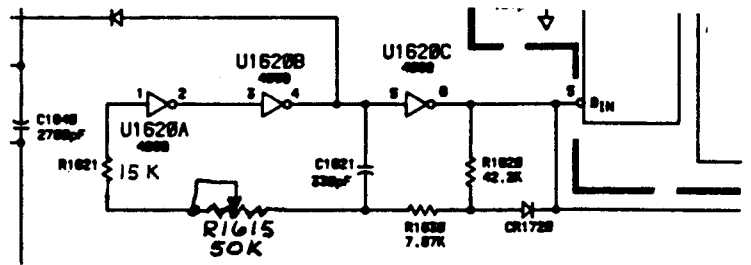
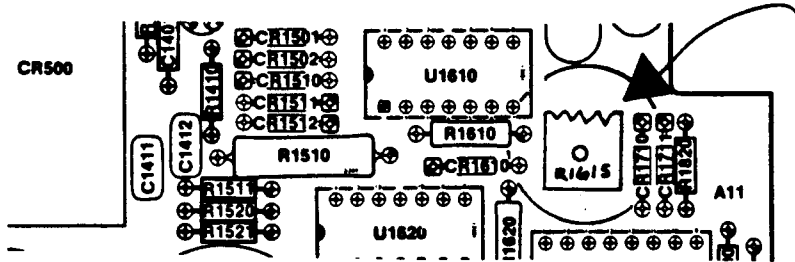
TM 5003

Damage can occur to the switching transistors Q1300 or Q1301, TM5003, (Q1640 or Q1650, TM5006) if the oscillator frequency of the TM5000 mainframe does not meet the 40 kHz to 42 kHz specification as tested at R1510 (R1860). A symptom of an audible high pitch noise indicates

the oscillator is off frequency. Batch variances of the oscillator I.C. U1620 (U1840) P/N 156-0745-00 can cause the oscillator frequency not to meet specification. If it is determined the frequency is not correct or when replacing U1620 (U1840) the following changes should be made.

After the modification is complete the following adjustment procedure for the clock oscillator should be performed:

- a. Connect a probe from the test oscilloscope to Pin 5, U1720 (TM5003) and Pin 5, U1940 (TM5006).
- b. Adjust R1615 (R1855) for a frequency of between 40 kHz and 42 kHz at Pin 5, U1720 (TM5003) and Pin 5, U1940 (TM5006).

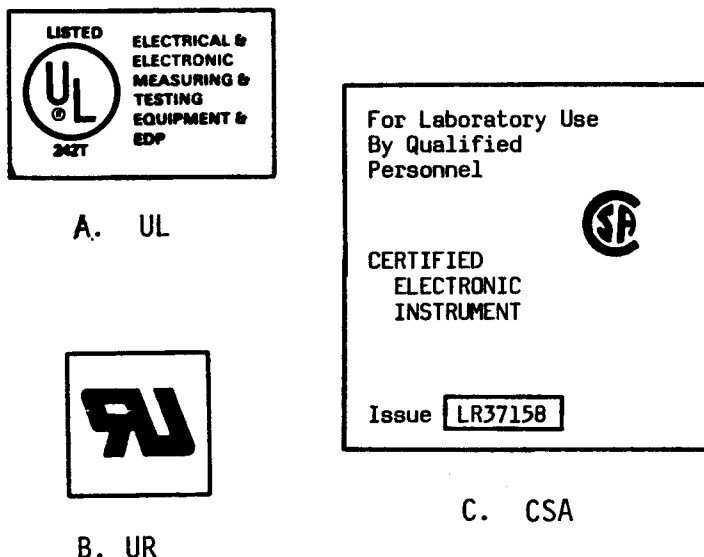
Figure 1
SAFETY LABELS

Starting at B010180 (690SR) or B010647 (6942) several labels have been added to the mainframe. Figure 1 illustrates the three safety certification labels that will be used. Labels 1A & C will be found on 690SR instruments in most applications, and labels 1B & C will be found on 6942 instruments and some 690SR options.

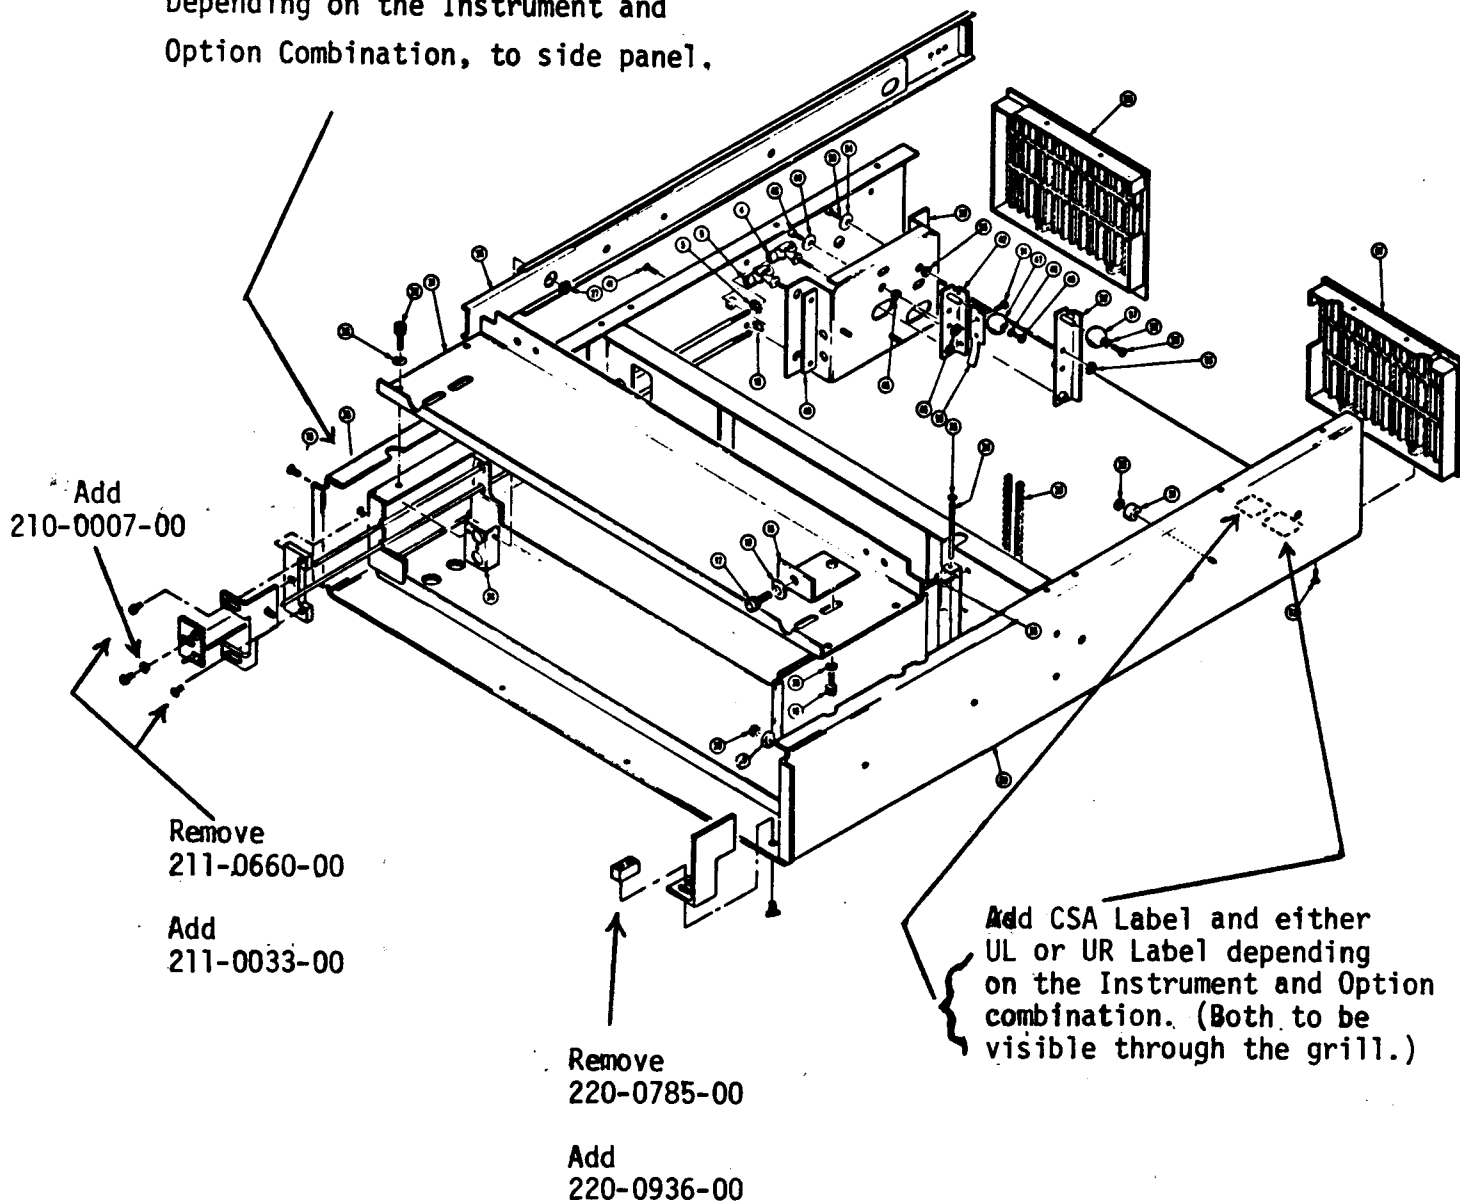
Figure 3

These labels are located at the rear of the bottom chassis as per Figure 3. These labels are not field replaceable. If one of these labels is damaged and must be replaced for customer requirements, the instrument must be returned to the factory. Contact Factory Service and arrange for the instrument to be sent in for recertification on the manufacturing line.

The second part of this mod changes several pieces of hardware to allow for control drawer mechanical adjustments (see Figure 3). These parts are contained in a kit, P/N 050-1539-00, and can be installed if one has trouble aligning the control drawer in its rails.

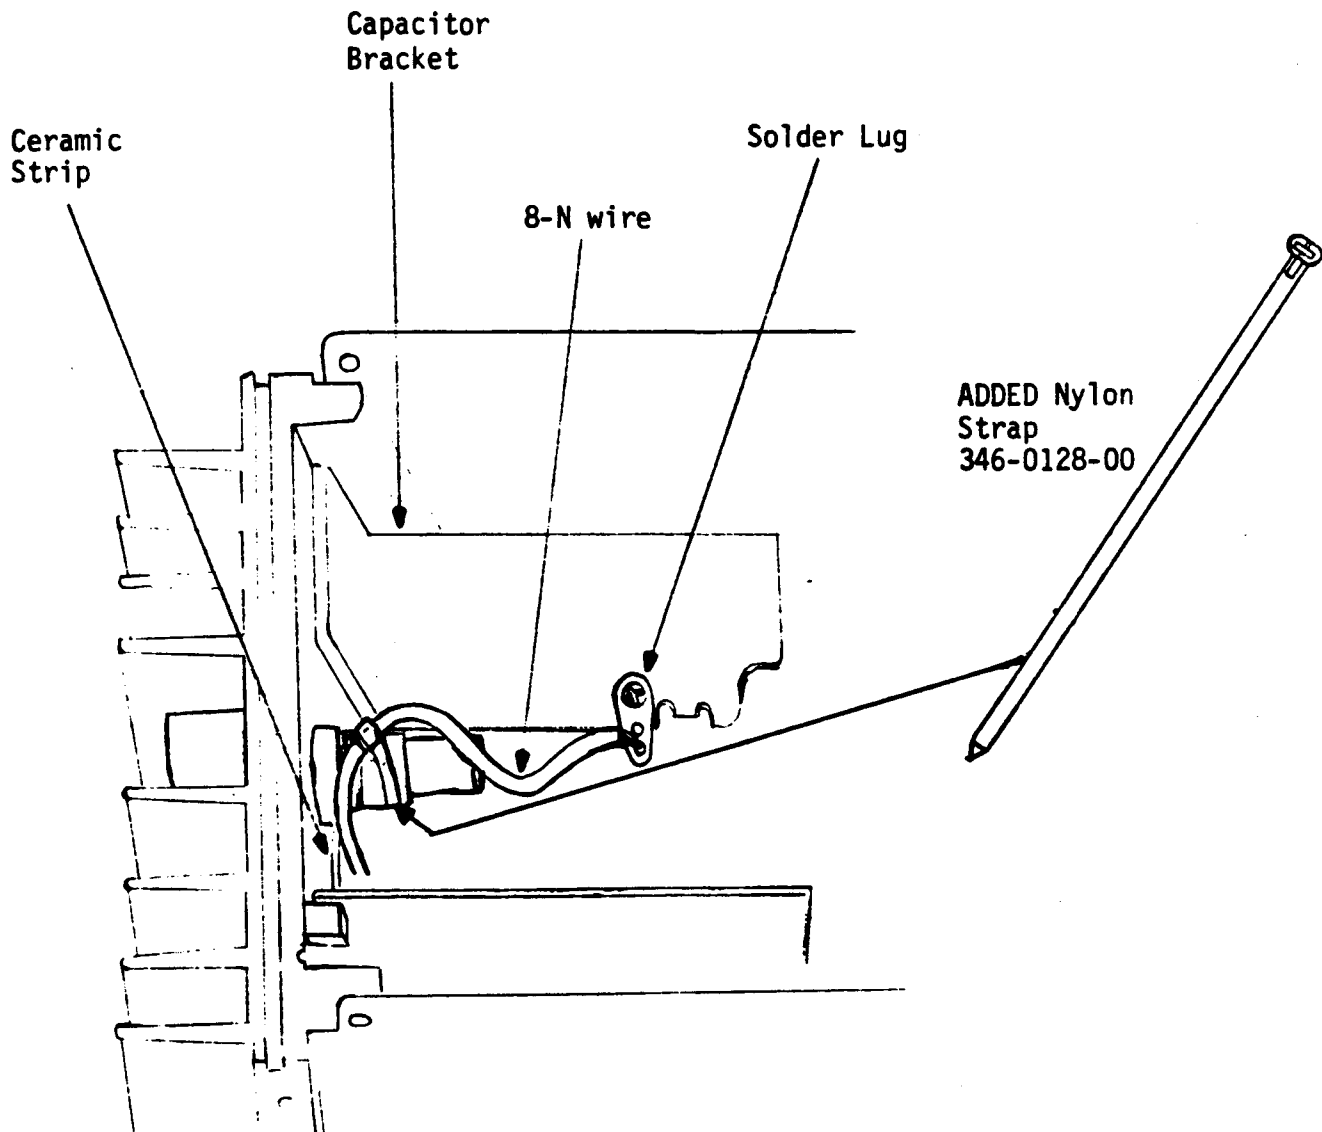
Partial View Low Volts Power Supply assembly 672-0873-02.

One of the requirements for UL recognition of the 690/6942 family was a tie-down strap on a grounding wire, holding it to the fuse holder case. In order to maintain UL integrity, this strap must be in place on any instrument repaired. This applies to those units that were UL

rated from the factory only, but since the power supply assemblies are on Repair and Return, please insure that the strap is also in place on any power supply module that is repaired under R & R. (See attached diagram.) Starting serial numbers for UL rated units are B010987 (6942) and B010361 (690SR).
