TM 5000

# SERVICETEKNOTES

Published by Tektronix Service  
Administrative Support

## TABLE OF CONTENTS

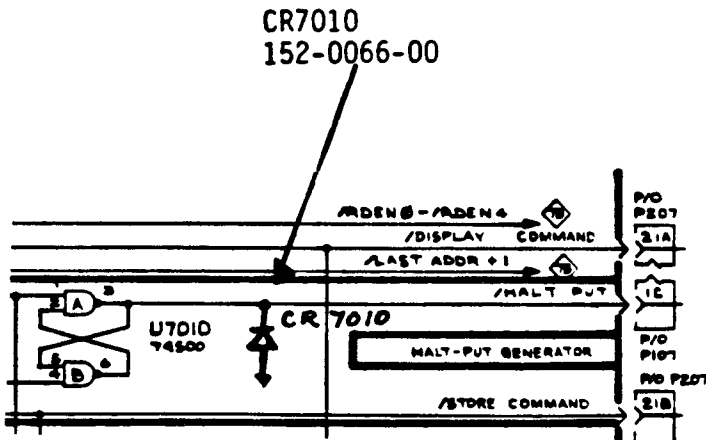
When inserting a personality module into a powered up 7D02 (hot plugging) it is possible to destroy or damage A07U7010. This will happen if the personality module is off center when hot plugged causing one of its conductors to short Pins 59 (-15 volts) and 61 (/halt put) of A01J8005. This effectively shorts the Pin 3 output of A07U7010 (/halt put) to the -15 volt supply.

To protect A07U7010 Mod #M46091 was implemented at Serial Number B021911. It places a protection diode, CR7010, 152-0066-00, between U7010-3 and ground (see included partial schematic 7A).

This diode should be added on the back of A07 with its anode soldered to U7010 Pin 7 and its cathode to U7010 Pin 3.

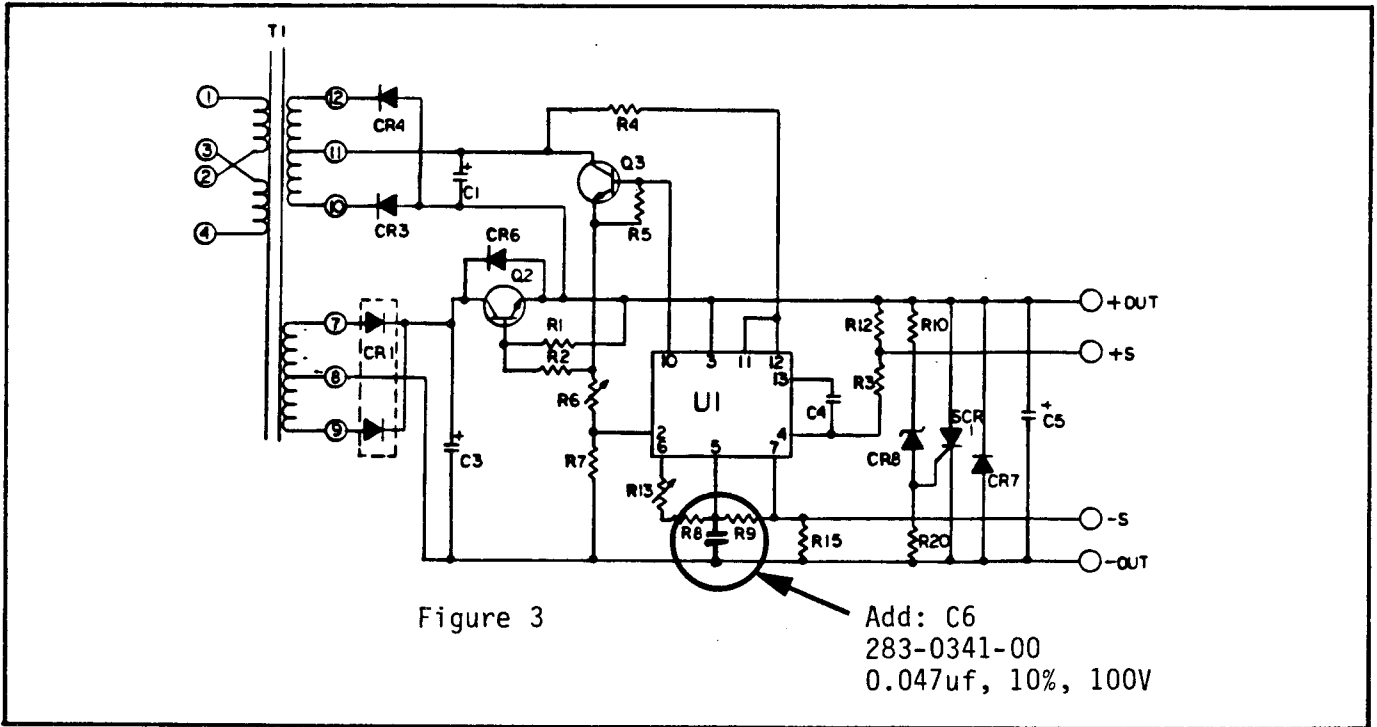
Figure 3

1800 PRAM -2V PWR SUP OSCILLATIONS, MOD NO. M50427

Add: C6  
 283-0341-00  
 0.047uf, 10%, 100V

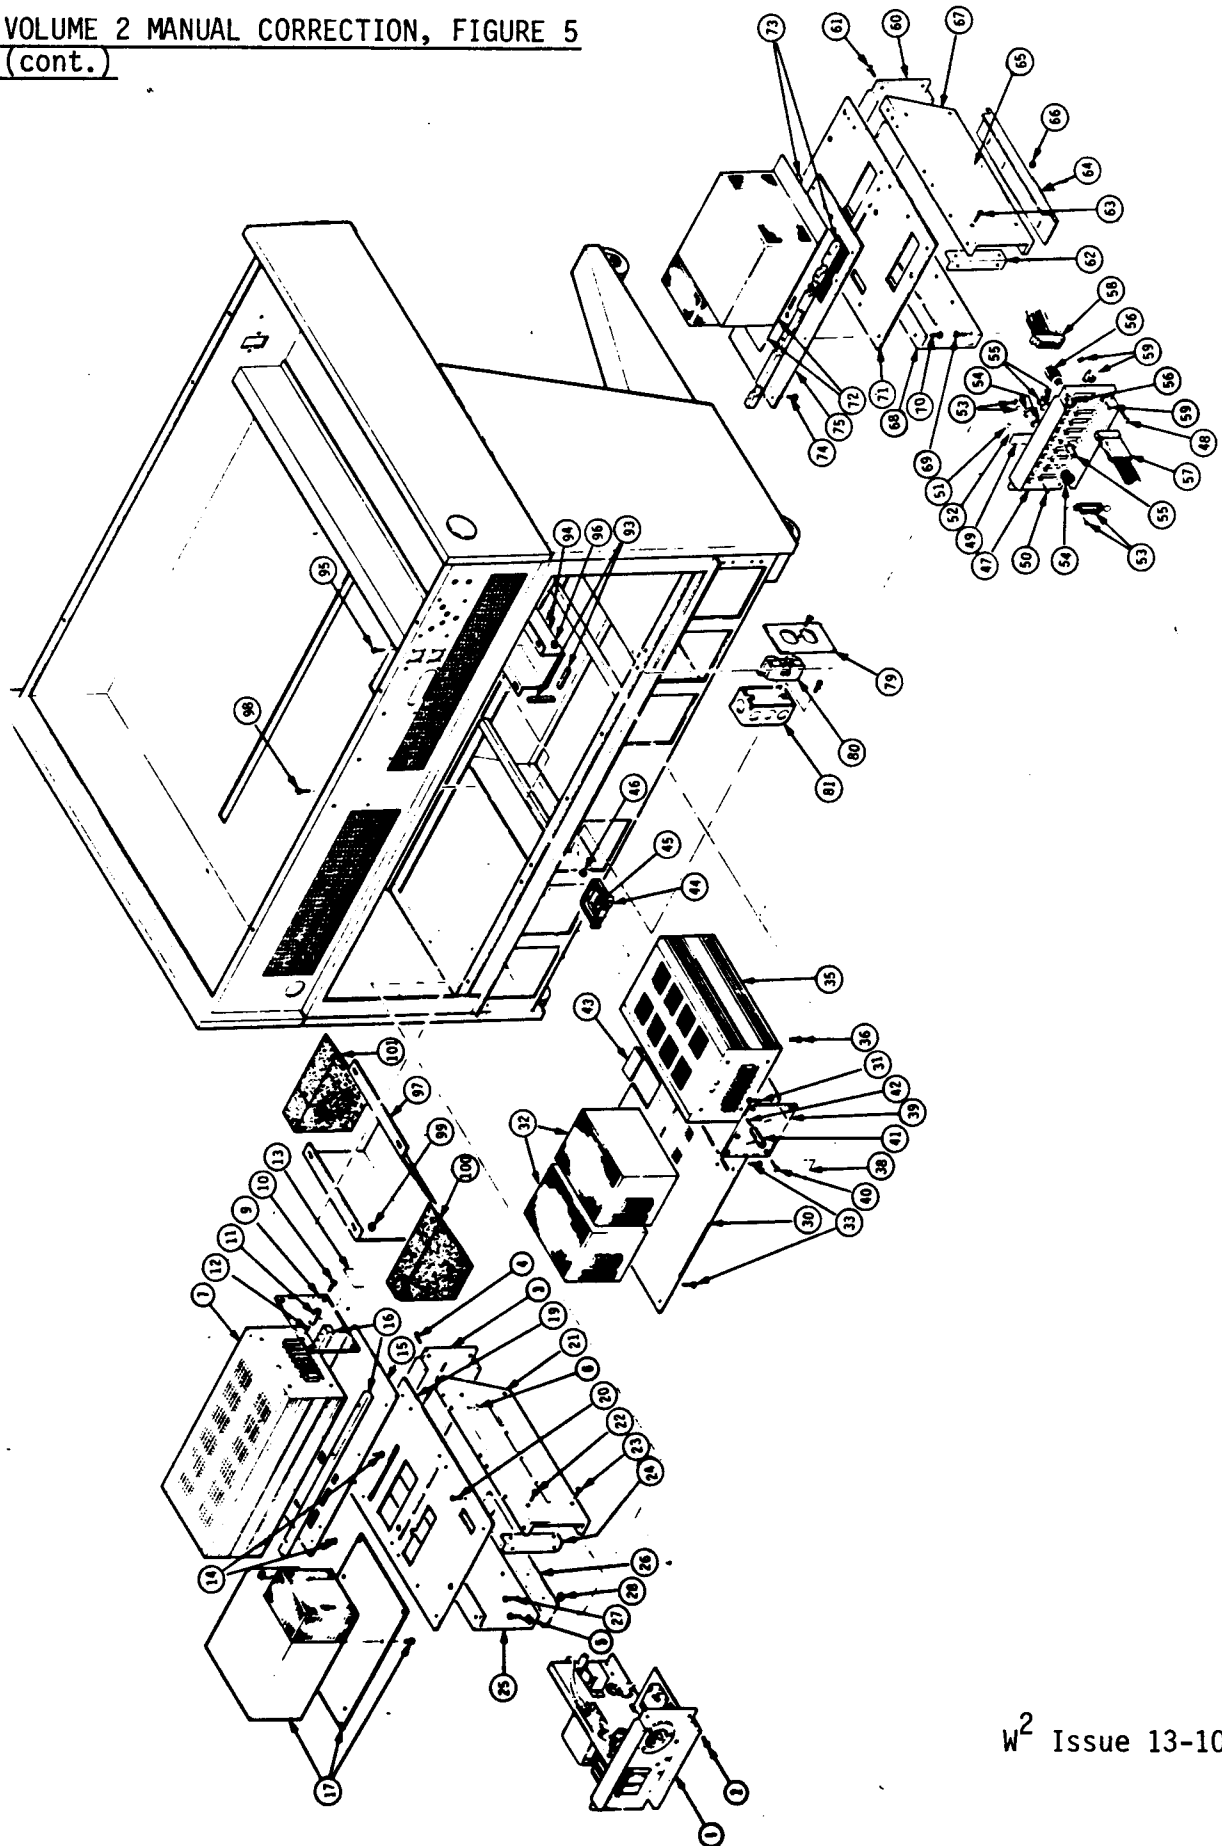
1804 VOLUME 2 MANUAL CORRECTION, FIGURE 5  
REAR (cont.)

The index numbers in the mechanical view, Figure 5 Rear, do not match the replaceable Mechanical Parts List on pages 6-99 through 6-103. Attached is a mechanical view, Figure 1, which contains the correct index item numbers. Index numbers 8, 13, 18, 24.1, 24.2, 29, 34, 37, 76, 77, 82, 83, 84, 85, 86, 87, 88, 89, 90, and 91 are listed in the replaceable parts list, but are not shown in Figure 5.

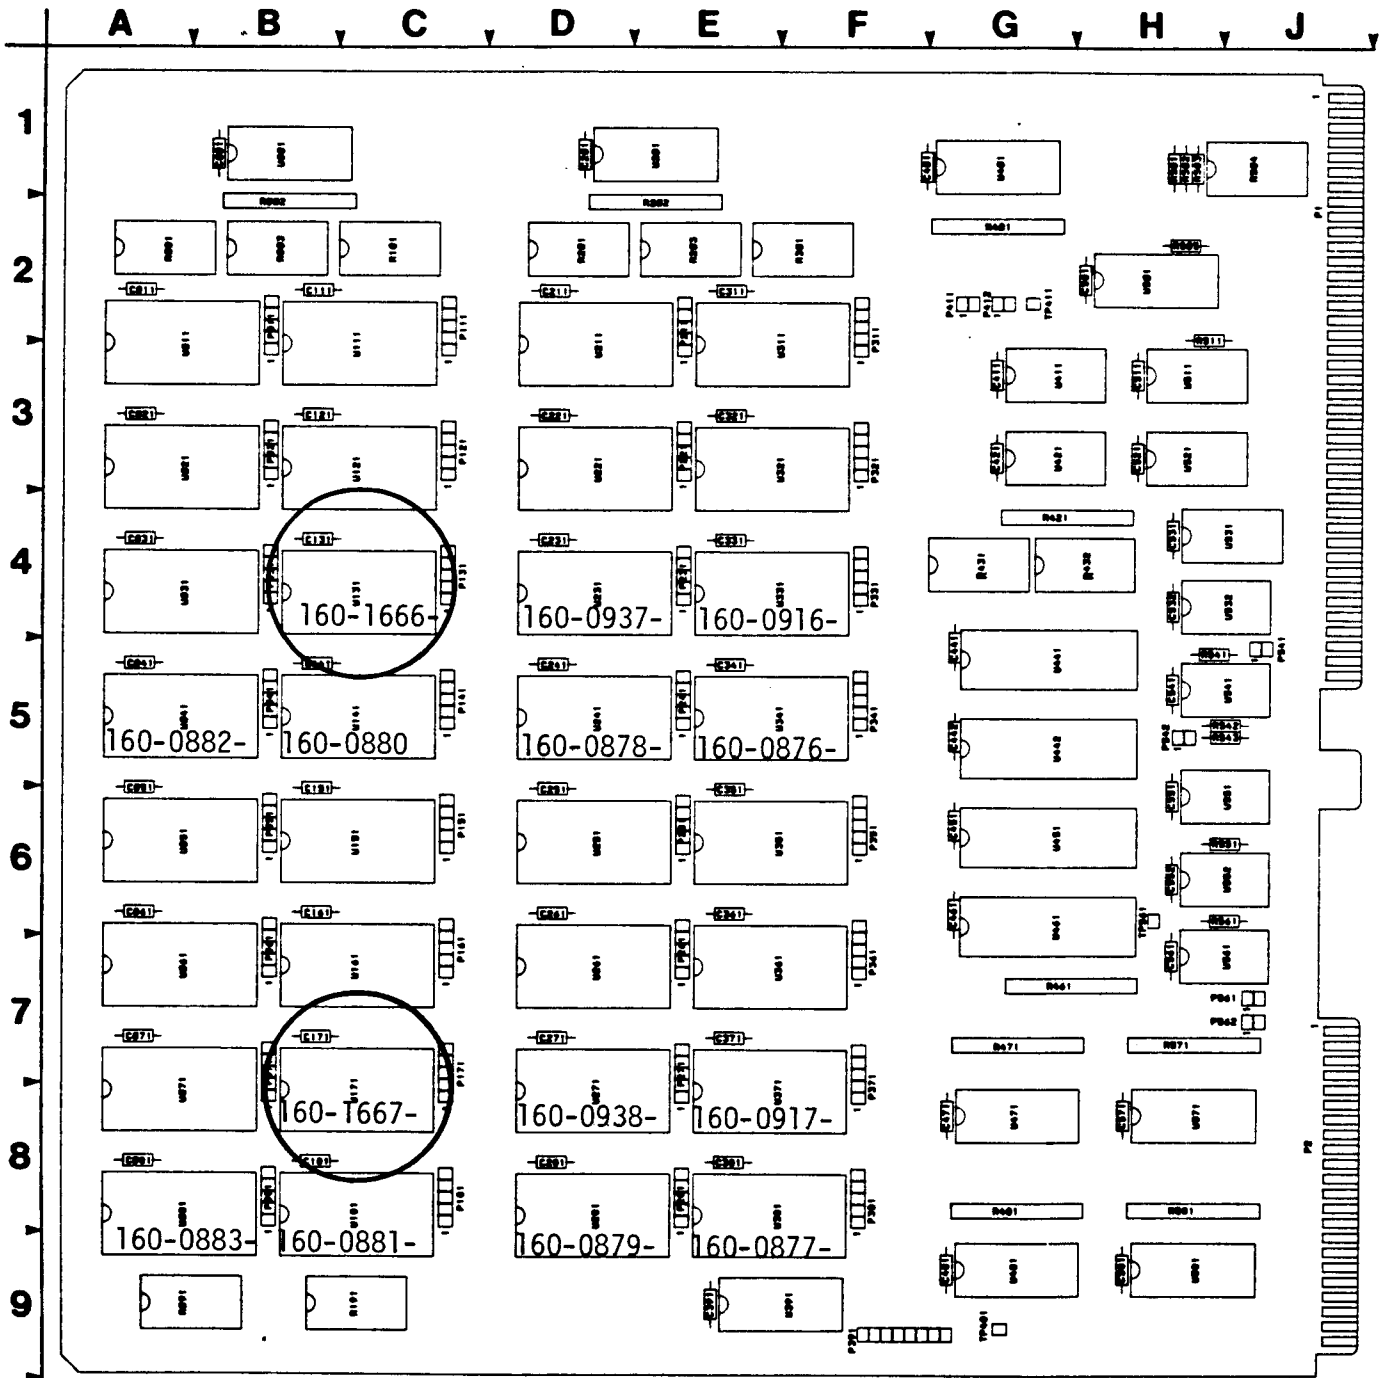
FIGURE A

A36 ROM/PROM  
Applications, NTSC, Opt. 1, Assy. B  
672-0939-00 with Patch PROM's Installed
