# SERVICETEKNOTES

#### TABLE OF CONTENTS

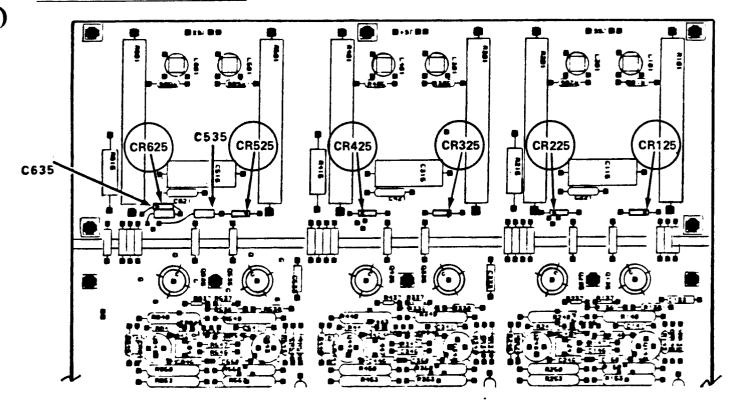
### 4115B FET KIT (050-1829-00) AND DIODES FOR ARC PROTECTION (CONT.)

The new bipolar transistors on the Video Amplifier, for the 4115B, will fail on occasion with CRT arcing. Six diodes P/N 152-0333-00 have been added to the video output circuitry to provide protection from CRT arcing.

The cathode end of the diode is connected to a by-passed 62V supply and the anode end connects to the collectors of each of the video output bipolar transistors. See figure for placement; note, cathode band for polarity.

The Video Amplifier board rolls to 670-7651-02. The FET replacement kit 050-1829-01 will contain the six new diodes.

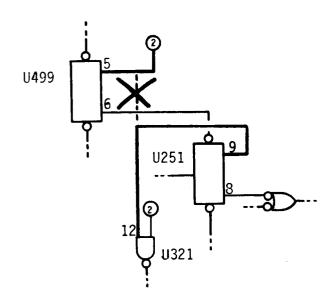
Figure 1.

The trace from pin 5 of U499 to pin 12 of U491 is in error. A correct schematic showing pin 9 of U251 to pin 12 of U491 is given below.

Corrected Schematic for CM670-6391-53 Logic Board

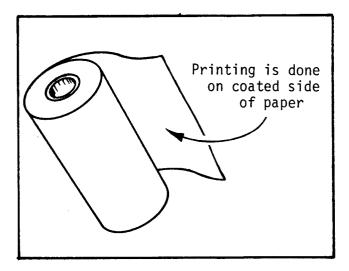
Figure 1.

Bad batches of paper have been found that failed to accept ink altogether, but confusion has also produced some false alarms. To reduce the confusion, please recognize that the 4695 paper is made to accept ink on only one side; the coated side. This coated side feels finely abrasive, tacky when

moistened and has a matte finish (no The uncoated side is smooth luster). low lustre. and has a concluding that a given roll of paper is bad, check that the paper is loaded 3-4 correctly. Figure illustrates the operator's manual loading of paper. If this is not the problem, check that the roll is wound correctly. The coated side of the paper should be on the inside of the roll (see figure 1 below). As a check, tear off a portion of paper and run it through the copier "inside out."
