# SERVICETEKNOTES

## TABLE OF CONTENTS

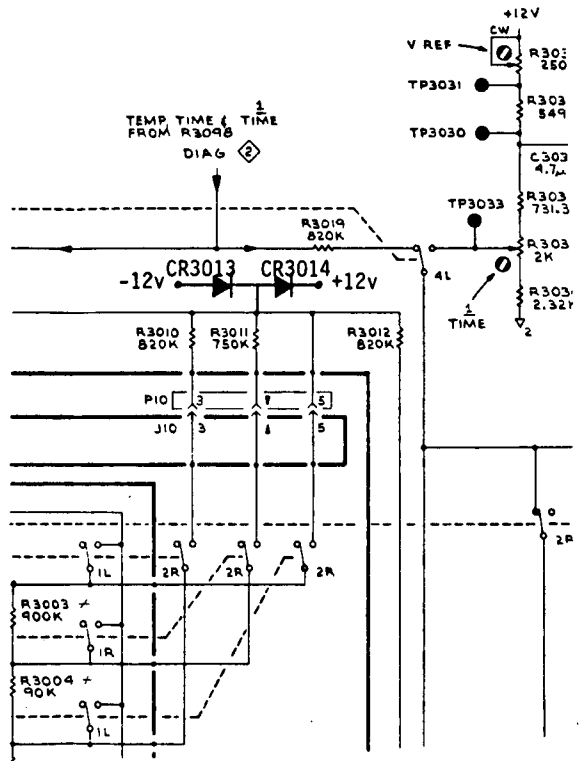
The old I.C., P/N 156-0477-00, used for the A/D processor, U3165, is no longer

available. A new I.C., P/N 156-1268-00, is now used for a replacement. The I.C. is not a direct replacement and the circuit must be modified as follows:

1. Remove VR3149
2. Add CR3013 & CR3014, P/N 152-0323-00, at location shown in the diagram. (CR3013 anode to R3153 [-12 volt supply], CR3014 cathode to R3113 [+12 volt supply], the two diodes are joined together and wired to R3010.)
3. Replace U3165.

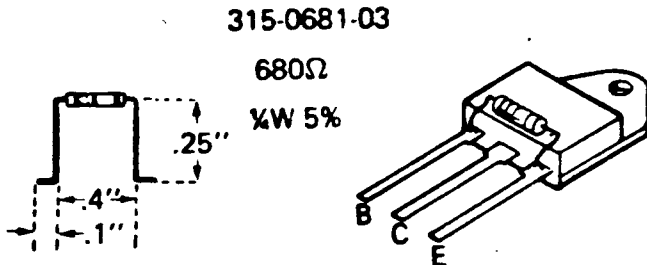
Transistor/Resistor combination

Early GMA102A Low Voltage Power Supplies (prior to serial number B060000) have shown a particular failure mode where R126, R127 and R129 overheat. Other components that typically fail as a result are CR681, Q101, R203, R210, R301, U221 and VR210. This failure occurs when the connector on the leads of Q5008 comes loose.

- Remove R210 (680  $\Omega$ , 315-0681-03) and VR210 (120 v zener) from the 670-5105-04 power supply board. The board level changes to -07 as a result.
- Add another 680  $\Omega$ , 315-0681-03 resistor to Q5008 across the base-emitter junction (see figure). The leads of

R210 will be too short to use; the resistor must not obstruct connecting Q5008's socket.

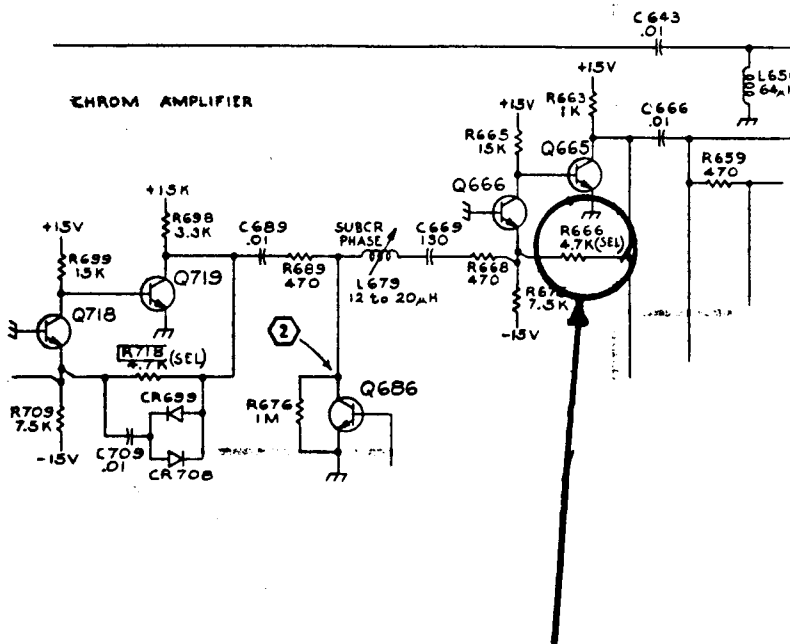
Transistors from different vendors are showing widely varying response characteristics (151-0190-00). This part is used in Q665, Q666, Q718, Q719 and Q715

In the past these transistors have had to be hand selected to keep phase shift with a change in burst gain within specifications.

Add C667 in parallel with R666 and select a value between 0 and 4.7pf to obtain minimum phase change with burst gain change, as necessary. See the illustration.

Add C667  
281-0670-00  
(Nominal 1.8pf)

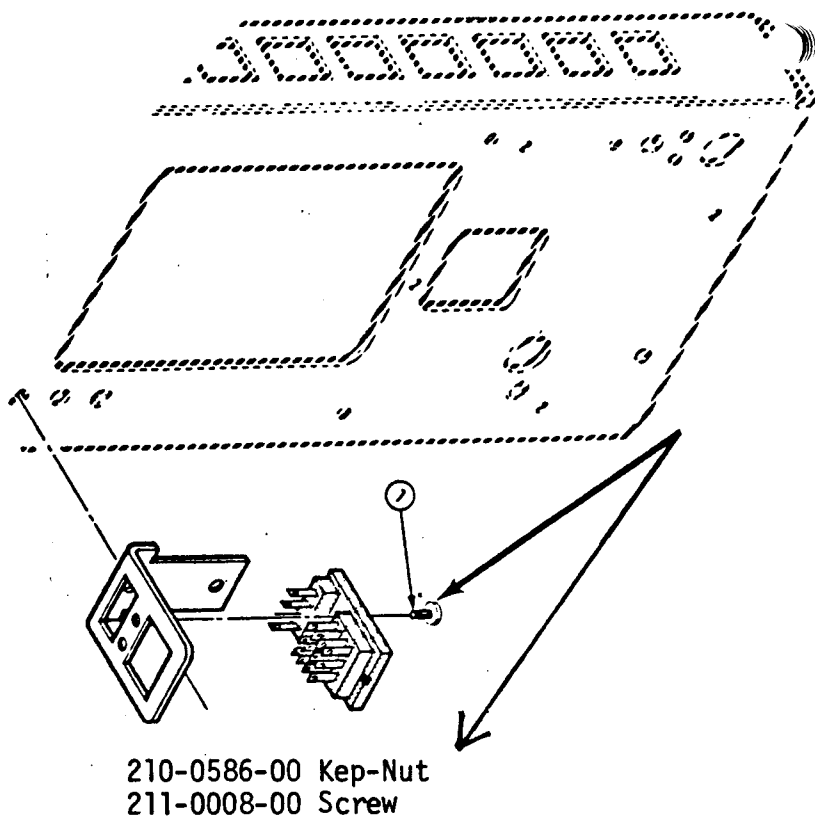
The screw on the Relay Assembly is not long enough, thereby allowing the parts to loosen.

Replace the self-taping screw on the relay assembly with a 210-0586-00 Kep-Nut and 211-0008-00 screw whenever a unit is in for service (see diagram).

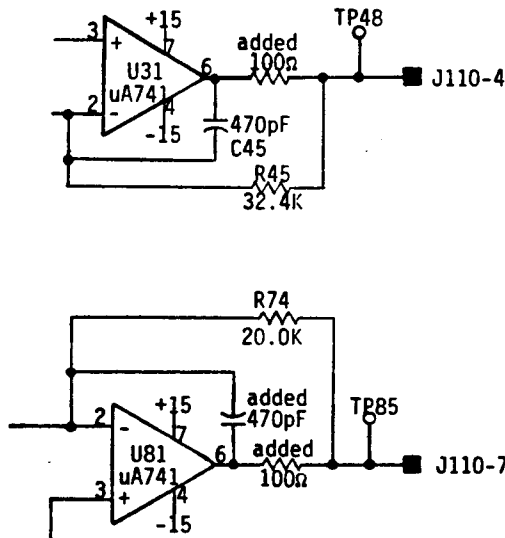
Hard copy image is noisy at the top, or weak at the bottom of the page. The "interrogate" scan line may be broken up (or a series of dots) at one end. The slow ramp may start one inch to the right of where it should start.

Load capacitance can cause the uA741 Op Amps--Slow and Fast Ramp Drivers--to oscillate. Usually this is due to long (ARTICLE CONTINUED ON THE NEXT PAGE)

Add 100 ohm resistors in series with the ramp outputs. Add a 470 pF capacitor from pin 6 (output) to pin 2 (inverting input) of U81. Note schematic corrections below.

1. Orient the board with edge connector toward you, component side up.
2. Lift pin 6 of U31. Lift the right end of C45 (on top of R45) and solder it to the lifted pin 6. Solder a 100 ohm, 1/4 w, 5% resistor, p.n. 315-0101-00, from the right end of R45 to the lifted pin 6, U31.
3. Lift pin 6 of U81. Solder a 470 pF capacitor, p.n. 281-0580-00 across

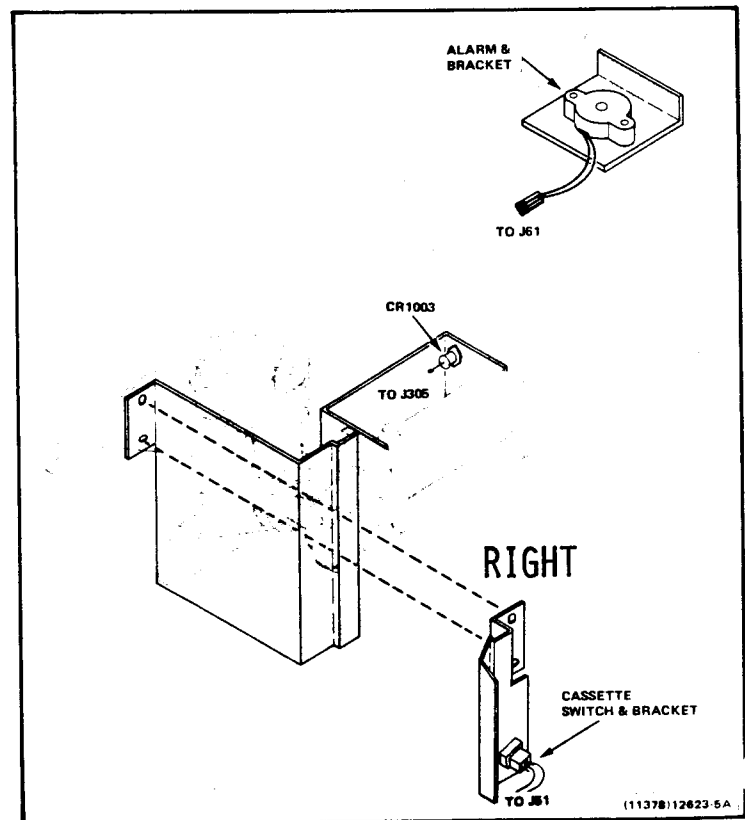
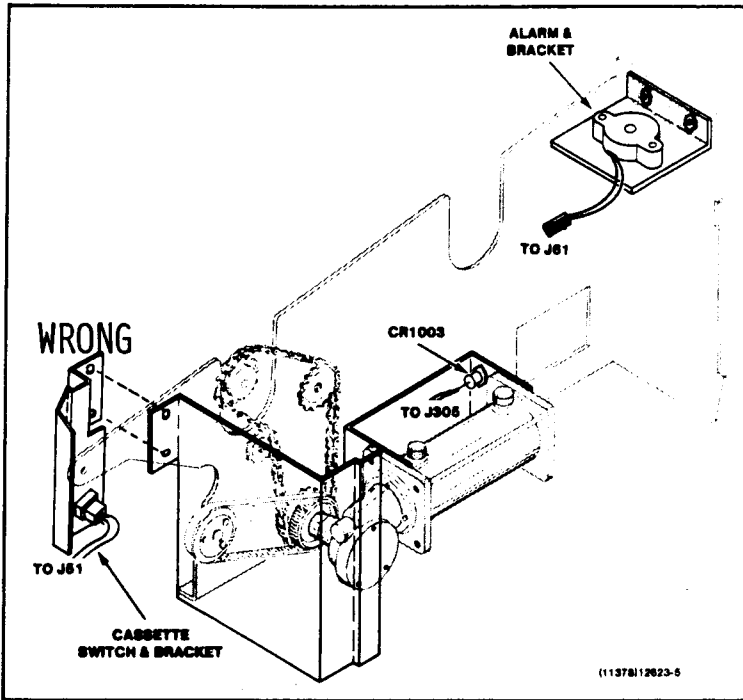
Figure 2-6. Attached Parts Location.

An error in the installation instructions for the (jam) Detector Board Kit, CM020-0814-00, may confuse both Tektronix and OEM customer service personnel. On page 2-9, Figure 2-6 shows the cassette switch bracket mounted to the left of a flange from the front subpanel. The correct mounting location is on the right side of the flange. The figures below should clarify.

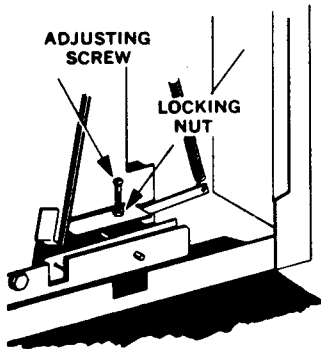
Elevation Brake Adjustment

If brake mechanism for tablet elevation does not release when brake pedal is depressed or if brake does not hold positively at desired elevation, it is possible that one or both brake mechanisms need adjustment. The brake mechanisms are located inside the end panels of the pedestal.

If the brake did not release when the foot pedal was activated, loosen the locking nut on the pre-determined side and tighten adjustment screw by turning clockwise. When the brake is adjusted properly, re-tighten the locking nut.

If the brake mechanism slipped when tested, loosen the locking nut on the pre-determined side and turn the adjusting screw counterclockwise to increase the brake tension. Re-tighten the locking nut after adjustment.

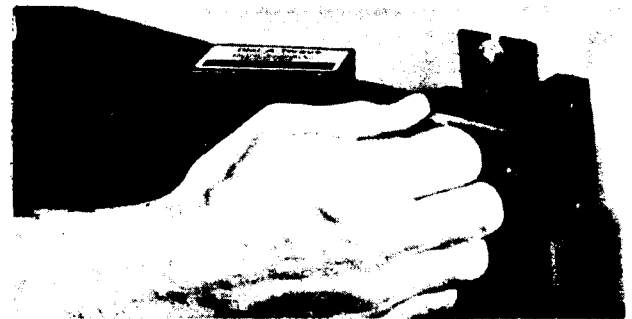
Tilt Lock Adjustment

In locked position, brake should be tight enough to hold board horizontally with about 25 to 50 lbs. of pressure applied to edge away from digitizer. Be sure when checking brake that tablet surface is elevated slightly above bumpers. Having brake set too tight may damage locking mechanism.

Tilt brake locking pressure can be changed by removing the "Dial-A-Torque" cover and loosening the two hex head cap screws. Using an Allen wrench, small rod or screw driver as a lever, turn the adjusting nut clockwise to increase tilt brake pressure or counterclockwise to decrease tilt brake pressure. Tighten the two hex head cap screws. In extreme adjustment cases, it may be necessary to loosen the screws on one of the tablet surface support arms.
