492P/496P
520A

SERVICETEKNOTES

TABLE OF CONTENTS

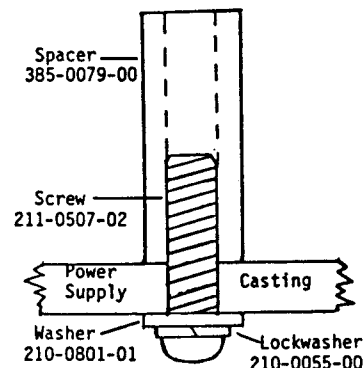
To replace one or both of the press-fit spacers that the Plastic Power Supply Grille is attached to, the following procedure has been developed.

Attach Hex Spacer (385-0079-00) to the Power Supply Casting using screw with

nylon lock patch (211-0507-02), washer (210-0801-01), and lockwasher (210-0055-00). See drawing below. The washer and lockwasher must be used to provide adequate clearance within the spacer between the spacer attaching screw and the grille attaching screw.

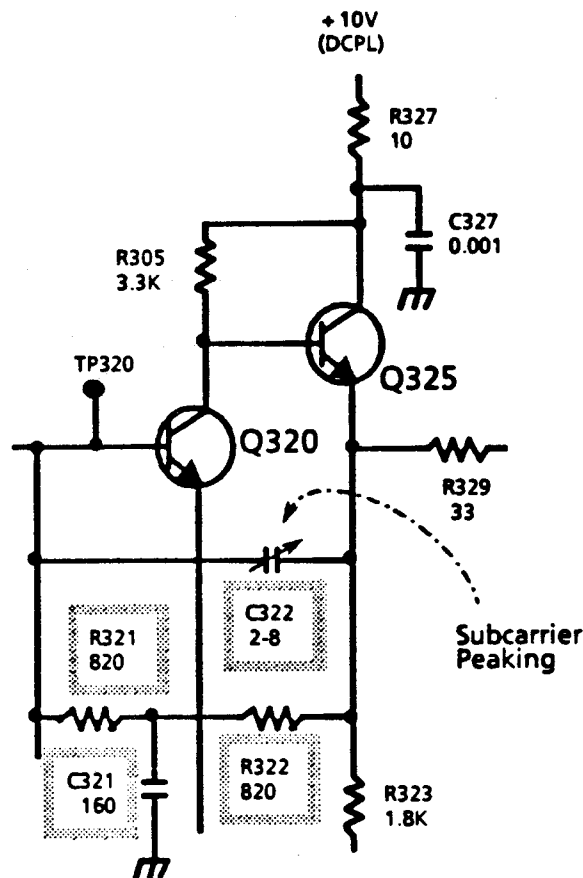
Partial A9 showing added parts

On the following page is a manual correction for 520A Series Vectorscopes that have been affected by Mod 56023.

TEXT, SCHEMATIC, and PARTS LIST CHANGES**SECTION 2 ELECTRICAL MAINTENANCE, ADJUSTMENT PROCEDURE,
Page 2-12.****CHANGE new step 18 (per M46781) TO READ:****18. ADJUST SUBCARRIER OSCILLATOR OUTPUT FILTER and PEAKING**

Depress CH A, FULL FIELD, A Φ /B Φ ALT, and VECTOR pushbuttons. Connect the test oscilloscope probe to TP2460 on the Subcarrier Regenerator circuit board, A2. Adjust L2450 on A2 for maximum subcarrier amplitude.

Connect test oscilloscope probe to TP325 on the Input Sync circuit board, A9. Adjust C322 on A9 for maximum subcarrier amplitude.

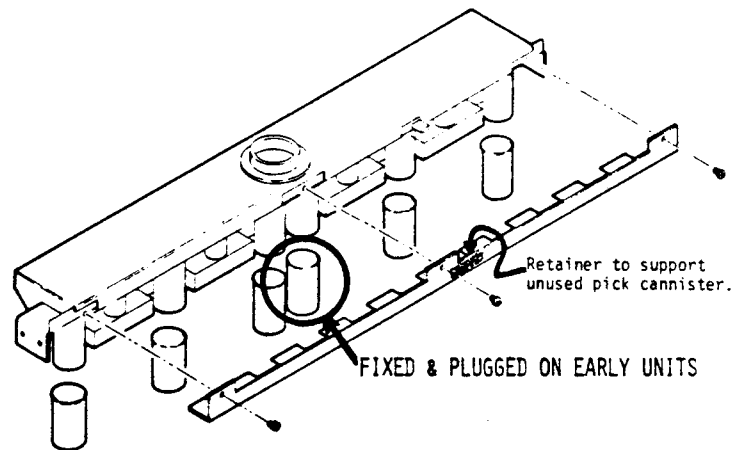
Figure 1.

Some of the retainer assemblies that arrived in the field have the small rectangular piece of metal glued to the retainer, such that it fixes up the left center suction cannister instead of the right center suction cannister. This will cause problems when picking paper and especially transparencies.

Later version 4691s, which have the middle suction cannisters spaced further apart, do not have the right middle suction cannister fixed and plugged.

The situation can be remedied by prying off the small piece of metal with an exacto knife and regluing said piece in the correct position. Please remember to clean the surface of the retainer so that the small rectangular piece of metal will stick properly.
