# SERVICETEKNOTES

#### TABLE OF CONTENTS

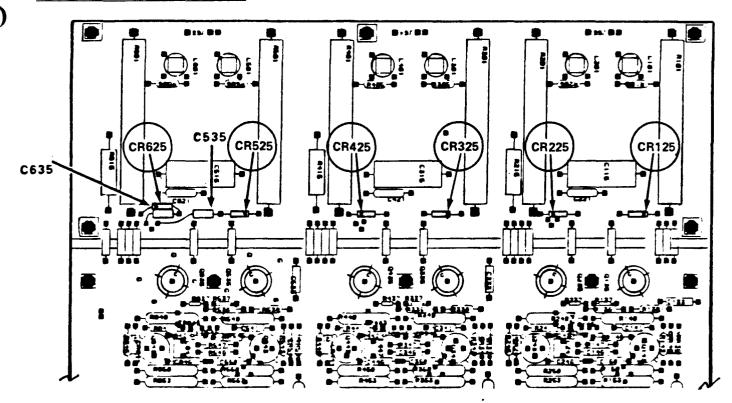
### 4115B FET KIT (050-1829-00) AND DIODES FOR ARC PROTECTION (CONT.)

The new bipolar transistors on the Video Amplifier, for the 4115B, will fail on occasion with CRT arcing. Six diodes P/N 152-0333-00 have been added to the video output circuitry to provide protection from CRT arcing.

The cathode end of the diode is connected to a by-passed 62V supply and the anode end connects to the collectors of each of the video output bipolar transistors. See figure for placement; note, cathode band for polarity.

The Video Amplifier board rolls to 670-7651-02. The FET replacement kit 050-1829-01 will contain the six new diodes.

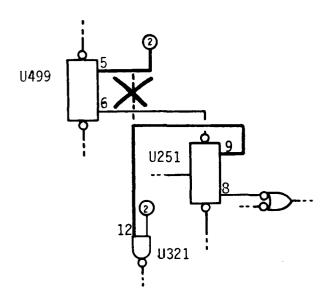
Figure 1.

The trace from pin 5 of U499 to pin 12 of U491 is in error. A correct schematic showing pin 9 of U251 to pin 12 of U491 is given below.

Corrected Schematic for CM670-6391-53 Logic Board

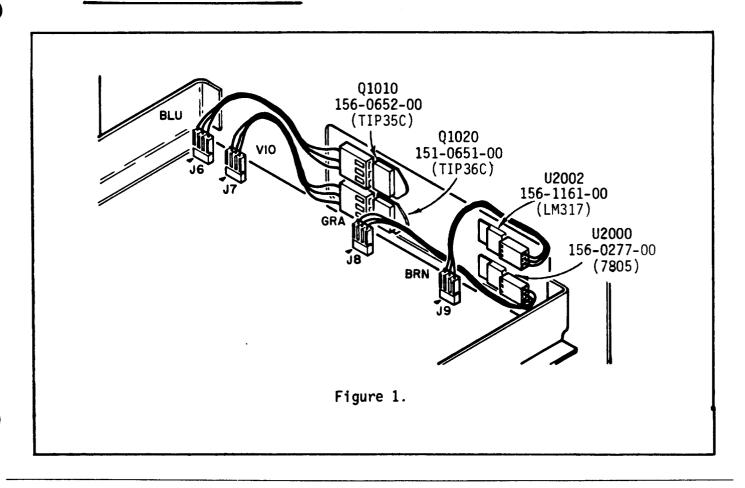
Mainboard replacement in the 4635 requires removal of the mainboard from the backpanel and heatsink. Once the assemblies connecting Q1020, U2000 and U2002 are removed from J6, J7, J8 and J9, it is easy to mistakenly swap leads and create a To reduce this occurrence, failure. the configuration of proper devices and heatsink power their connecting cables is illustrated below. This illustration also applies to 4633A modified products such as the 4633AJE, 4633AJR, 4633A Mod JL/JN and 4633A Mod VA/VB/VC.

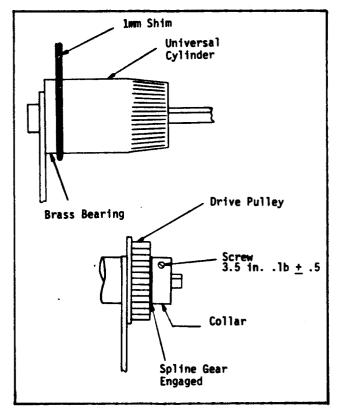
Figure 1.

Improper positioning of the Spline Gear on the Tractor Drive Shaft will alter the required engagement force and lead to any number of paper motion related problems. Anytime any maintenance is performed on the 4643 in the field that alters the Spline Gear position, such as replacing the collar, the following Spline Gear adjustment procedure must be performed.

- A. Loosen the screw on the collar so that the Spline Gear moves freely on the shaft (Figure 1).
- B. Insert a 1mm (.039") shim (feeler gauge) between the universal cylinder and the brass bearing located on the left side assembly (Figure 1).
- C. While pushing the right end of the tractor drive shaft to the left (with even pressure), slide the Spline Gear into the drive pulley and tighten the screw in the collar (3.5" lbs). (Figures 1 and 2)

- D. Remove the shim (Figure 1).
- E. Press down on the universal cylinder until it contacts the universal hub and hold it in that position (Figure 3).
- F. The distance between the drive pulley face and the Spline Gear face should be a minimum of 2mm (.078") (Figure 3). If the gap is less than 2mm, repeat the procedure.

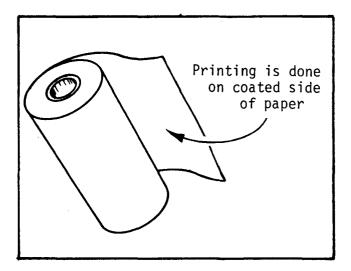
Figure 1.

Bad batches of paper have been found that failed to accept ink altogether, but confusion has also produced some false alarms. To reduce the confusion, please recognize that the 4695 paper is made to accept ink on only one side; the coated side. This coated side feels finely abrasive, tacky when

moistened and has a matte finish (no The uncoated side is smooth luster). low lustre. and has a concluding that a given roll of paper is bad, check that the paper is loaded correctly. Figure 3-4 operator's manual illustrates the loading of paper. If this is not the problem, check that the roll is wound correctly. The coated side of the paper should be on the inside of the roll (see figure 1 below). As a check, tear off a portion of paper and run it through the copier "inside out."
